Four Squares Estate

7th November 2012

Arup commission

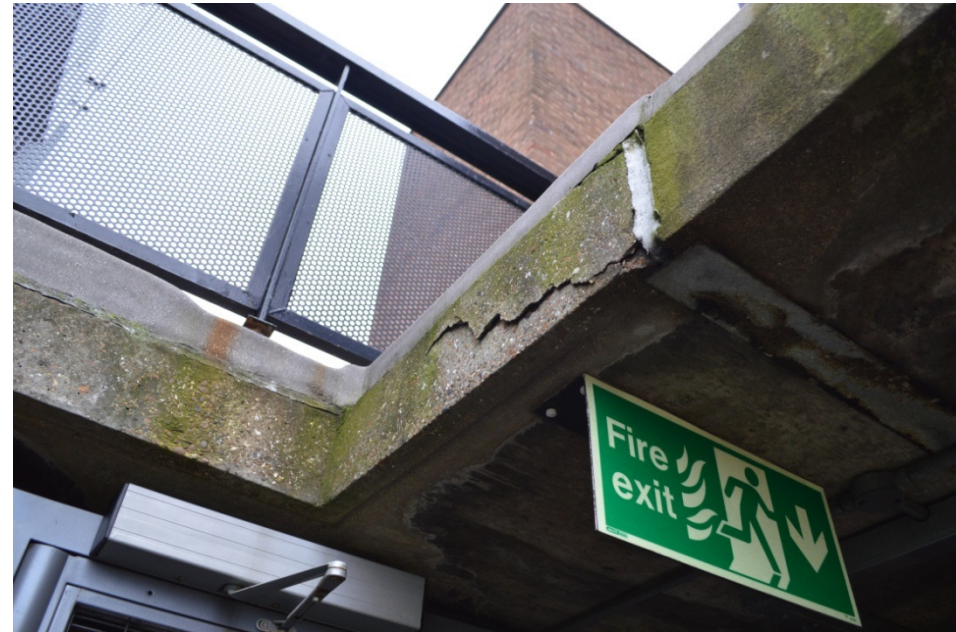
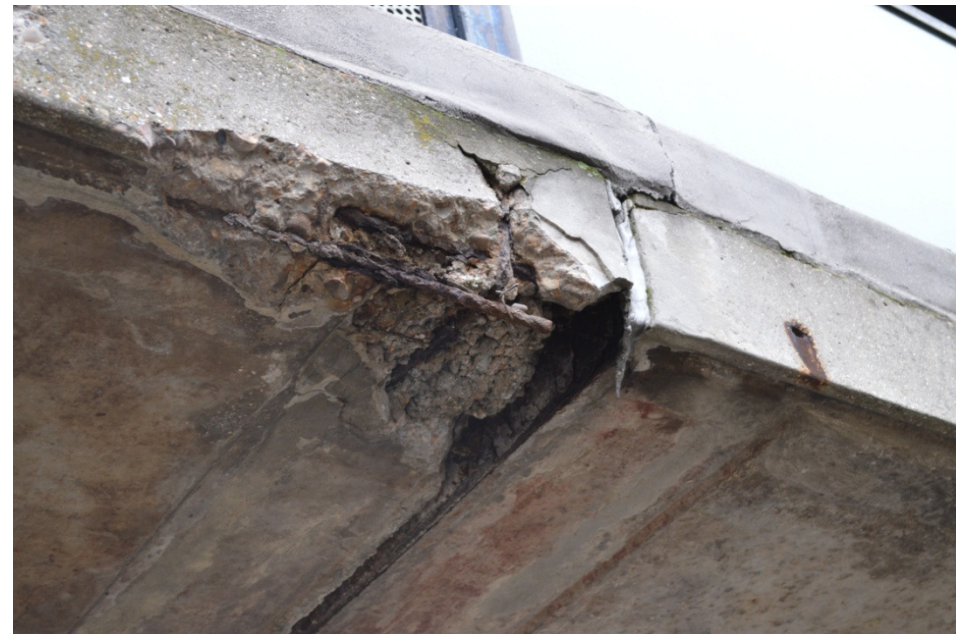
Concrete

- The structures are in good condition for their age (subject to testing)
- Some localised deterioration on exposed elements (i.e. walkways)
- Replacement of waterproofing on walkways (already in investment programme of works)

- Testing to walkways and garage areas (collection of drilled dust samples, small number of cores)
- Investigation and repair of above ground drainage (rainwater pipes)
- Some localised repair *
- Replacement of waterproofing on external slabs *
