London Borough of Southwark
Ledbury Estate Tower Blocks
Pilot investigation and strengthening
study

Issue 1 | 24 October 2019

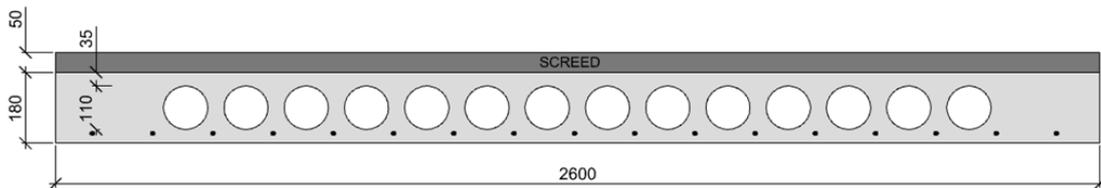
Floor panels

Typical floors investigated were found to be 180 mm deep hollow core planks with a 40-50 mm screed. The hollows in typical floor panels were 110 mm diameter and had a spacing of approximately 150 mm. The panels had bottom reinforcement of 10 mm bars at 150 mm centres as shown below:

The voids in the kitchen panel were irregularly spaced and did not seem to follow any pattern.

In general, the concrete covering the bottom reinforcement was found to be quite variable ranging from 10 to 32 mm.

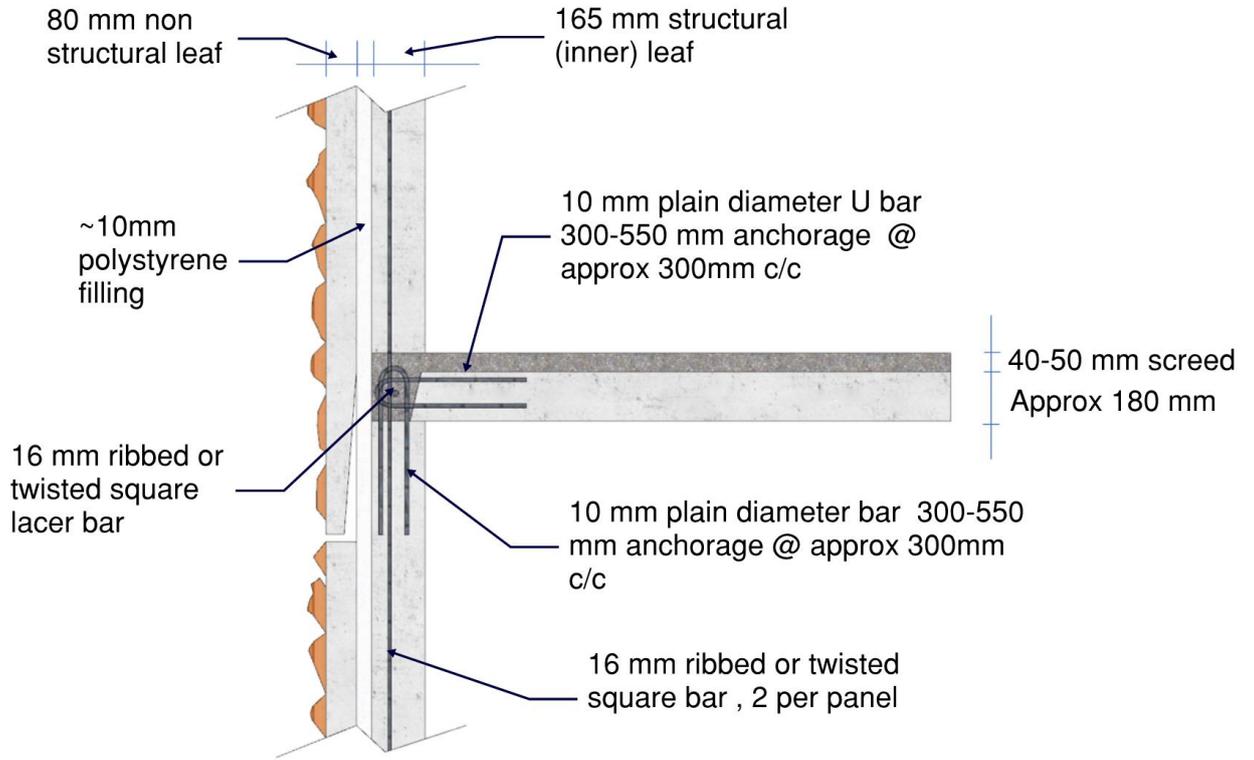
Flank wall/floor/flank wall connection

The connections in Large Panel Systems are known to be vulnerable to the quality of the site workmanship. Evidence of poor site workmanship was found during the investigations with sand instead of grout found in one of the wall to wall connections.

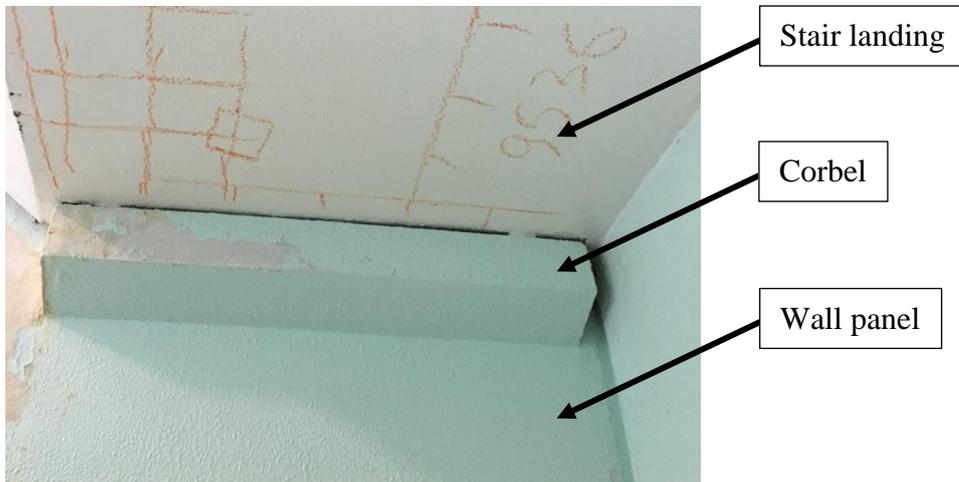
Stair to wall connection

The stairs are supported at each landing by spanning onto ledges in the wall panels known as corbels. These are shown in the photo below. There is a horizontal gap between the stairs and the wall panels along the side of the stairs. It is therefore assumed that the stairs do not provide any lateral restraint to the wall panels.

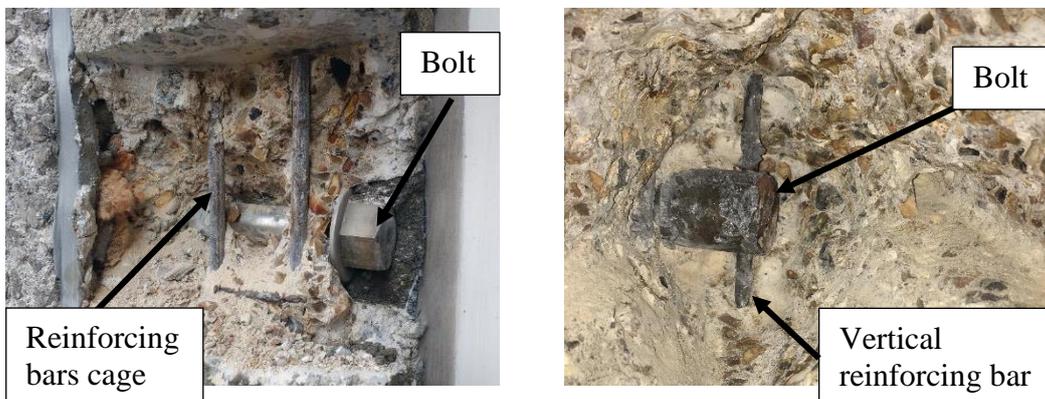
Outer wall/ outer wall corner connection

The outer wall panels are connected at the corners by stainless steel bolts. The diameter of the bolts was confirmed as 34 mm. The anchorage of the bolts in the connecting wall has been confirmed through intrusive investigation in three locations. The anchorage length was found to be 120 mm and a vertical reinforcing bar was found to be welded to the bar as show in the photograph below. There are four bolts up the height of each panel.

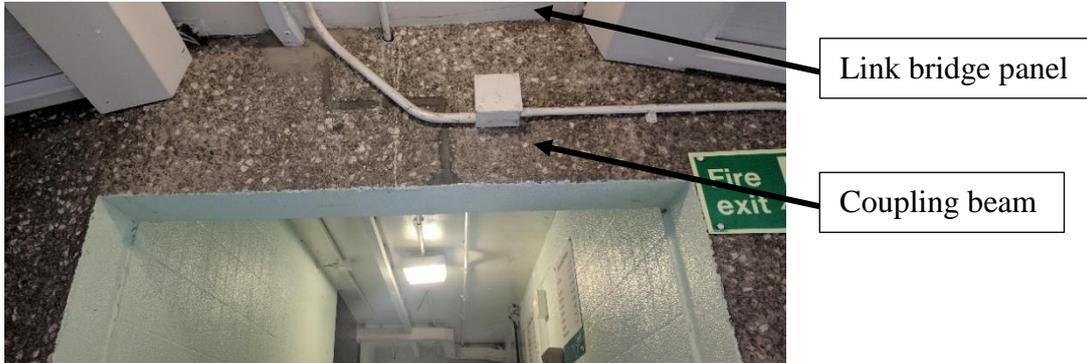
Coupling beam connection

The outer walls on each side of the stair core are connected over the opening for the link bridges by the coupling beam shown in the photograph below. Ferro scans of the beams showed that they were reinforced but they did not confirm the connecting detail. These connections were not investigated intrusively as it could not be done safely as it provides the gravity load path for the floor slab.

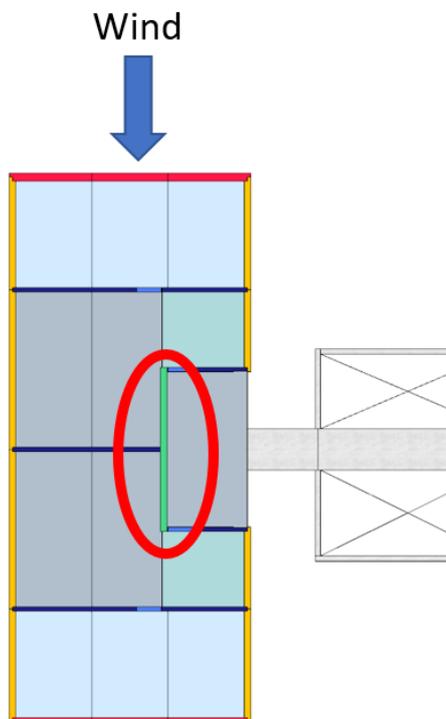
The residential blocks have only one shear wall to resist wind on the narrow face:

Since this wall is very lightly reinforced (as shown in Section 2.1.2) it is susceptible to “second order” effects. Calculations show that this shear wall is just strong enough to resist modern wind loads.

Whilst the superstructure is adequate for modern wind loading, the anchorage of the shear walls into the raft foundation was uncertain since very little information about the foundation is known. As a result, it has not been possible to confirm the foundation's ability to resist the wind "overturning" forces at the base of the shear wall.

Since the anchorage of the shear wall reinforcement into the foundation is unknown (and likely to be deficient since the wind loads the building was designed for are known to have been too low) and the workmanship of the connections in the shear wall at every joint at floor level is unknown (but known to be vulnerable to poor site workmanship; sand was found in one of the wall to wall connections), it is proposed to include enough steel reinforcement for modern wind loading within the new jacketing.

In addition, since it has not been possible to gain sufficient confidence in the capacity of the existing raft foundation or the anchorage of the main shear wall reinforcement into the raft (and again since these are likely to be deficient since the wind loads the building was designed for are known to have been too low), it is proposed to cast a new raft foundation over the existing raft.

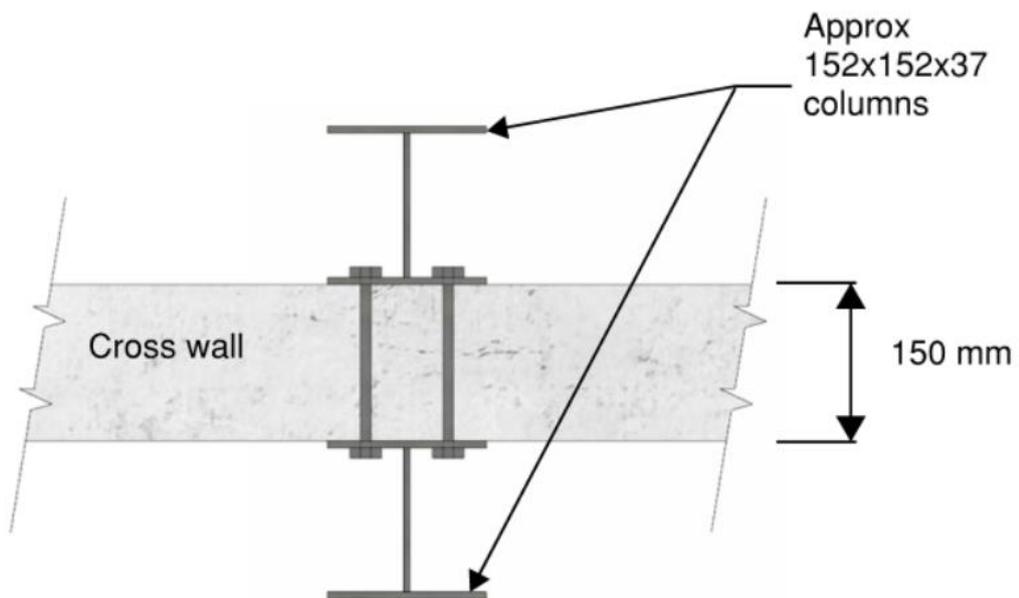
7. Cross walls separating 1 and 3 bedroom flats (Floors G to 4) – Add steel columns.

The cross walls separating the 1 and 3 bedroom flats (Floors G to 4) are not able to withstand 17 kPa by arching as they have no load from the floors above. As such it is proposed to install steel columns and beams designed to act as key elements to withstand 17 kPa to create an alternate load paths in the event of loss of this cross wall (see image below).
