Cabinet

| Report title: | | Marie Curie – Safety works and resident rehousing offers | |

Independent Review in respect of Fire Safety Issues relating to Marie Curie House

Marie Curie House - Fire Safety Investigation Report

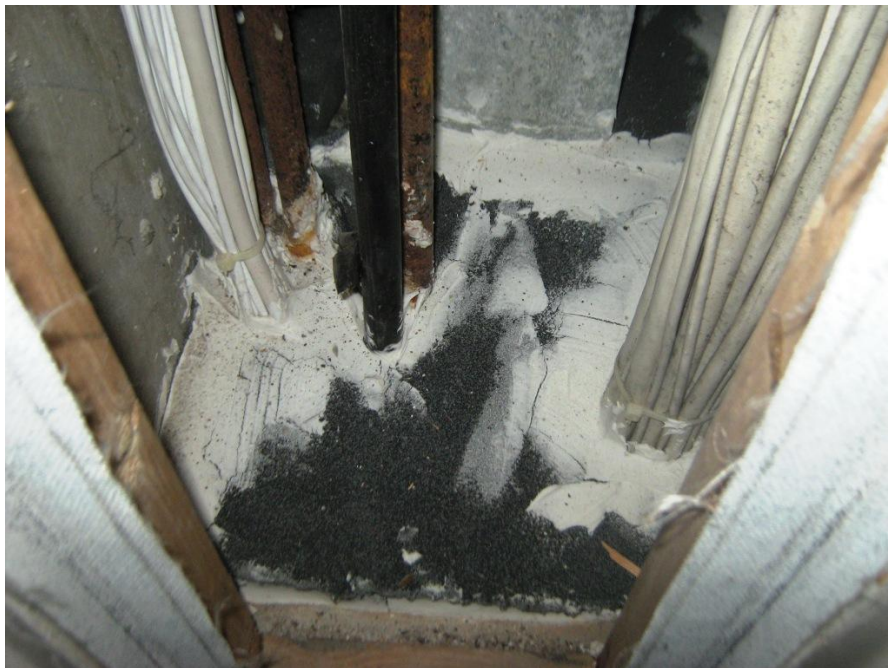
The other duct in the lift lobby containing the current telecom and electrical cables was also inspected and found to have satisfactory fire-stopping within (see photo 3).

Photo 3 - Common area riser duct - Fire-stopping

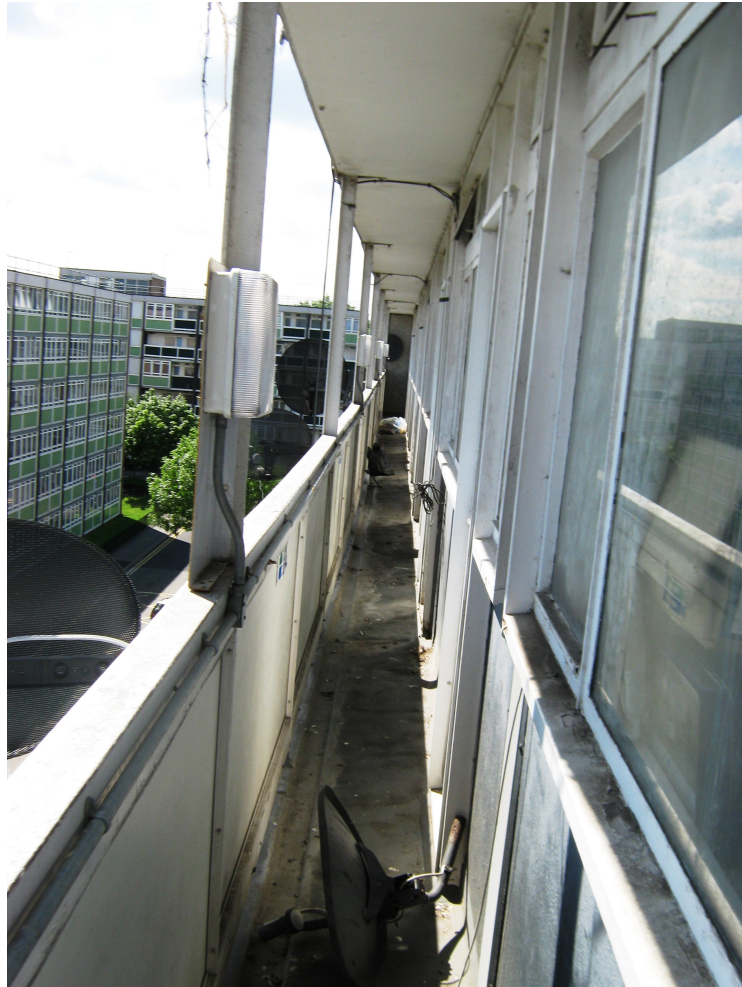
During the inspection it was noted that the external emergency escape balcony visible to the author had several deposited obstructions along its route, namely a disconnected satellite dish and partially filled refuse sacks (see photo 4). It is recommended that the Council resolve this issue to prevent continuation and additional occurrences.

Photo 4 – Obstructions to emergency escape balcony.

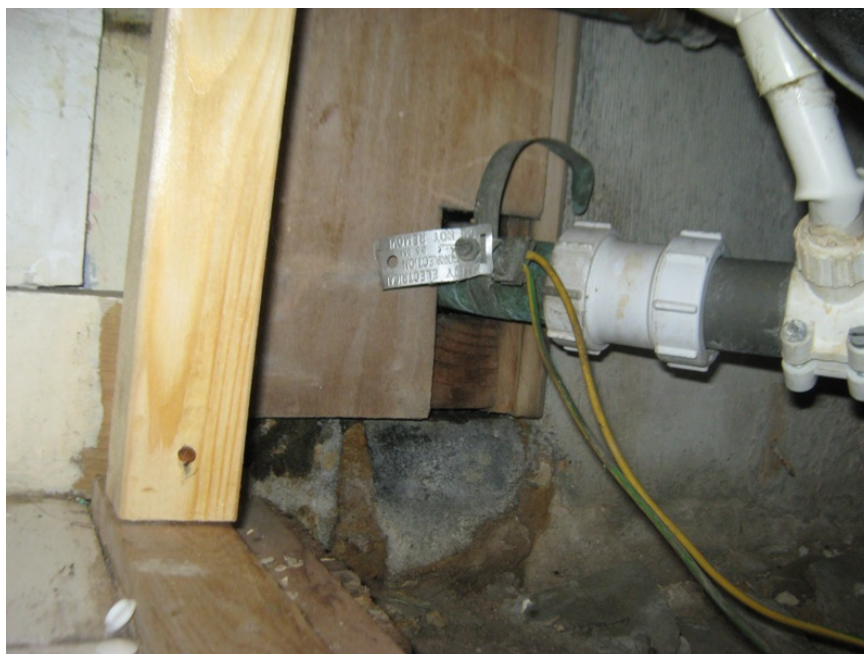
Although this arrangement does not necessarily present a significant risk to spread of flame or smoke in a fire condition, the author recommends that further investigation and possible fire protection works should be considered in this area.

Photo 5 - Plywood panel behind bath.

It is understood by the author that the Council are scheduling a 'Warm, Dry and Safe' upgrade programme for this block that may include bathroom refurbishment. This would produce the ideal opportunity for any necessary upgrade works in this area.

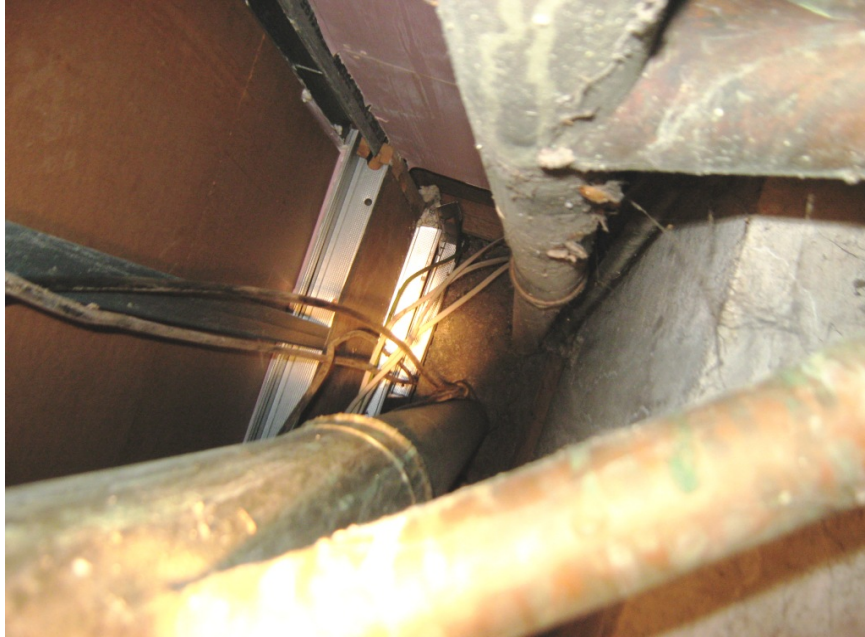
Photo 6 - Partition to adjoining property (bathroom services duct).

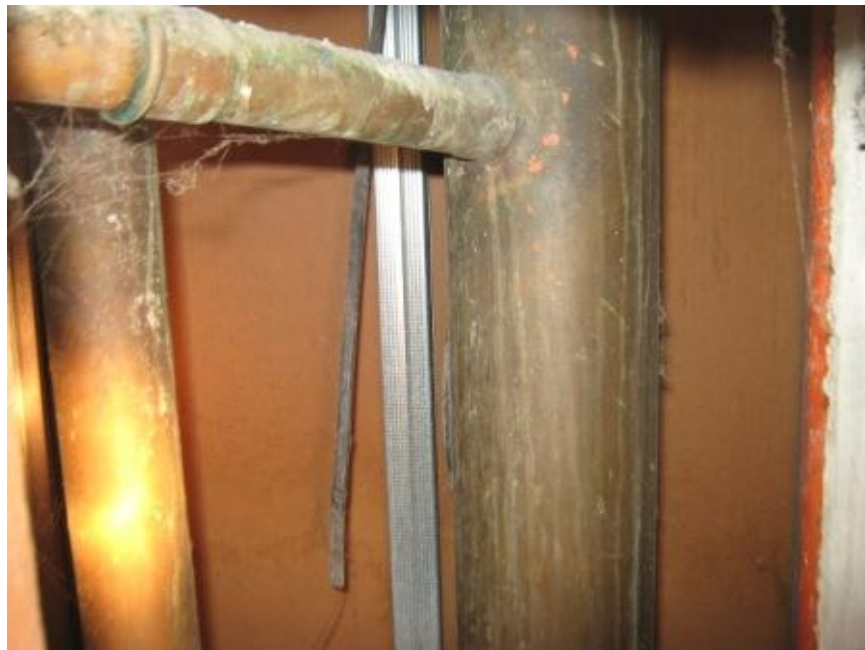
Photo 7 - Inside bathroom duct, showing partition.

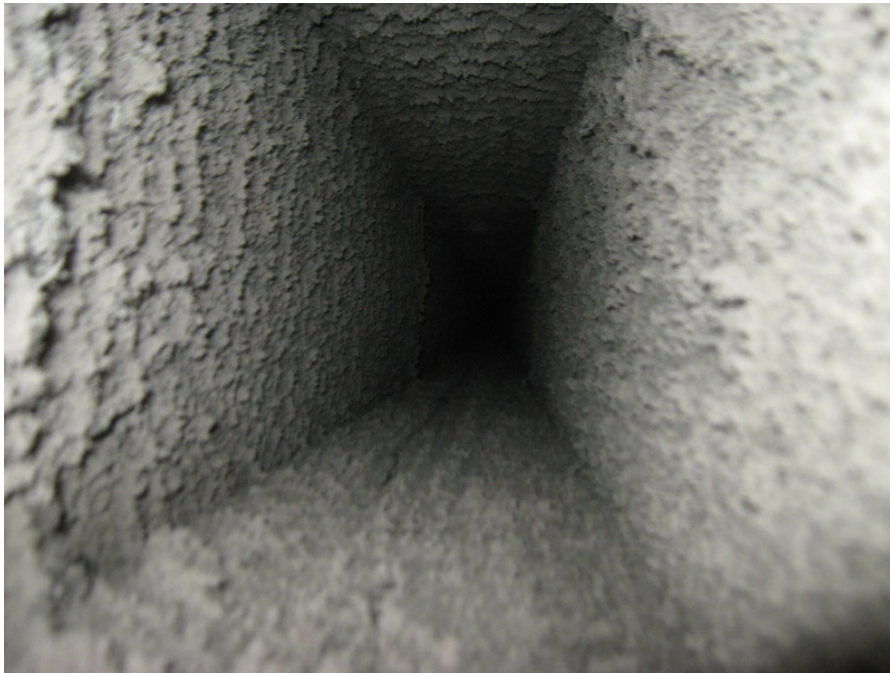
The air extraction system vent positioned at high level on the bathroom wall was removed to allow inspection of the ductwork. The ductwork appeared to be in good condition and well fitting but was displaying a high build-up of dust internally (see photo 8). Ducts of this type should be periodically cleaned to prevent this condition.

Photo 8 - Inside air extraction duct (note dust build-up).

It is understood that the Council has scheduled this block for an imminent clean of these ducts.

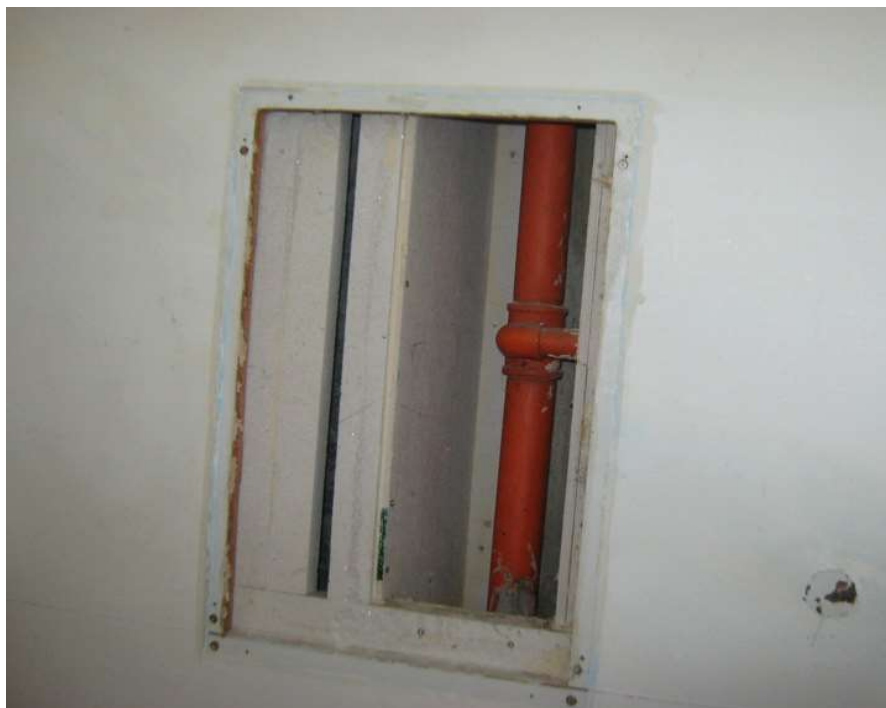
The external lining to this duct housed a non fire rated electrical light switch plate with metal patress. Current good practice would include for a fire rated patress and switch to partitions between compartments however, due to the reasonable level of compartmentation and fire-stopping in this duct it should not be necessary to upgrade the current fittings.

Due to the low fire loading and satisfactory fire-stopping within the duct, the duct outer linings being of securely fixed 25mm melamine board and plasterboard are reasonable. It is not known whether these panels are decorated with a fire retardant paint system that would further increase fire resistance of the duct.

Photo 9 - Riser duct in apartment with access panel removed.

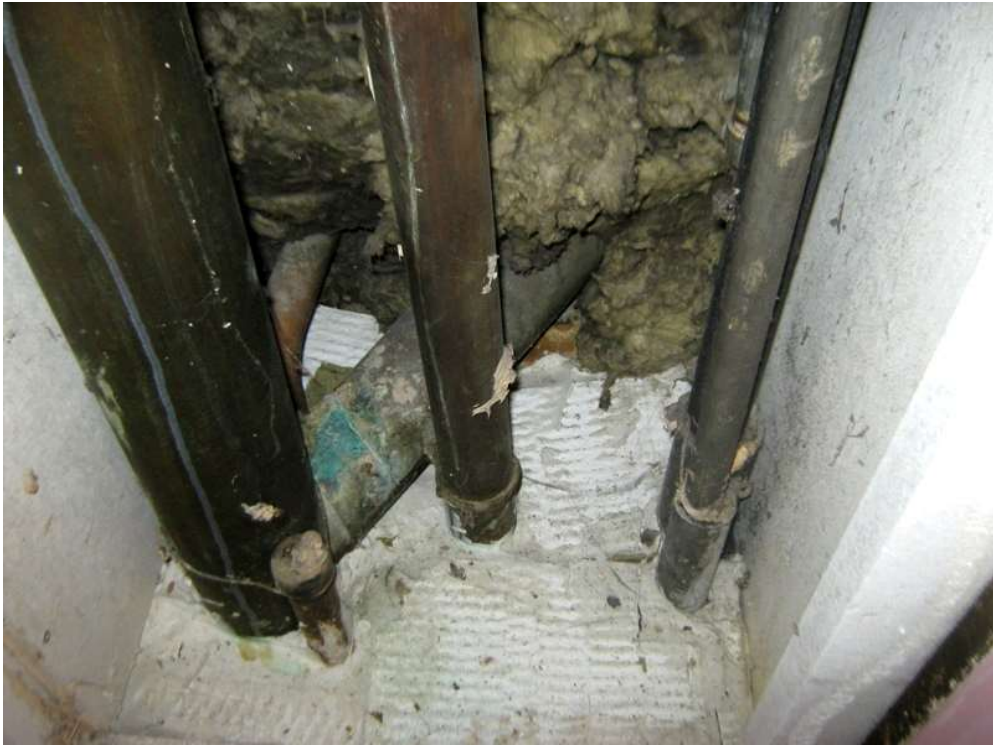
Photo 12 - Lower level duct exposed. Intumescent pads to concrete floor slab.

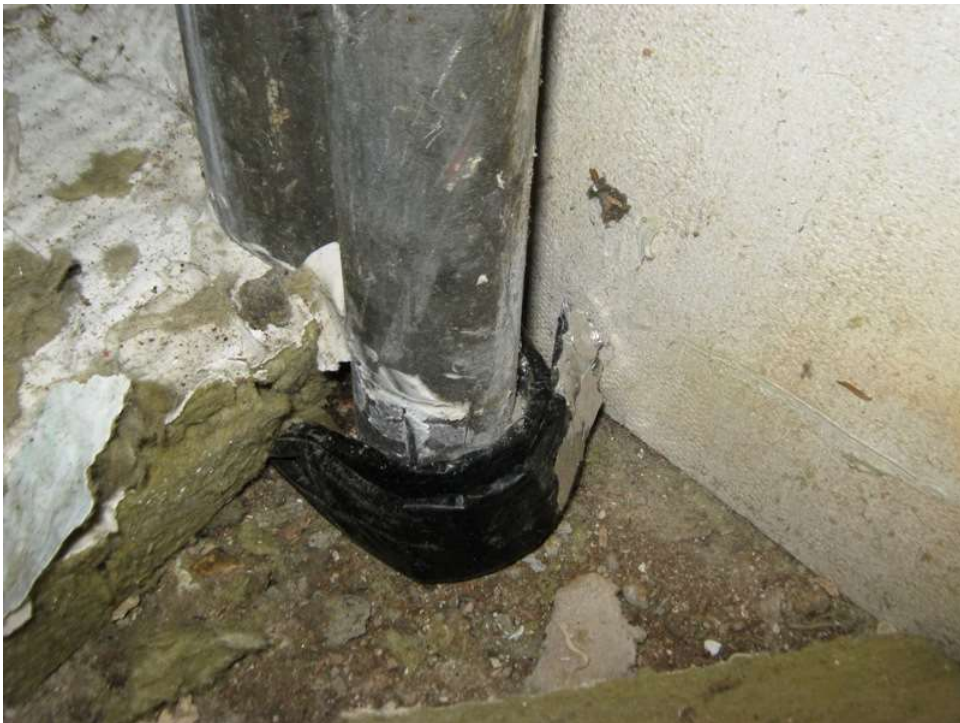
Photo 13 - Lower level duct – fire-stopping to floor slab.

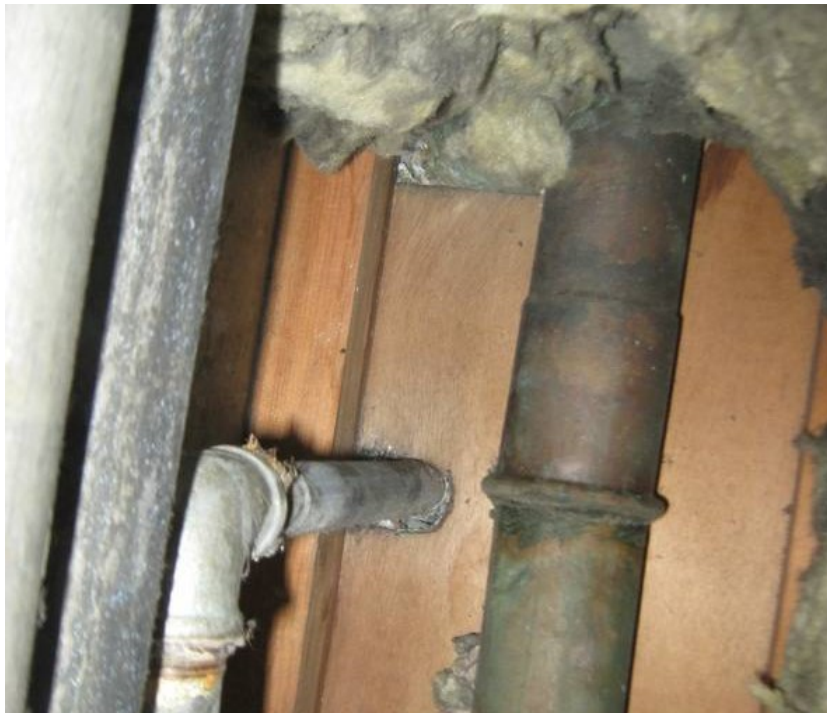
Photo 14 - Lower level duct – plywood panel.

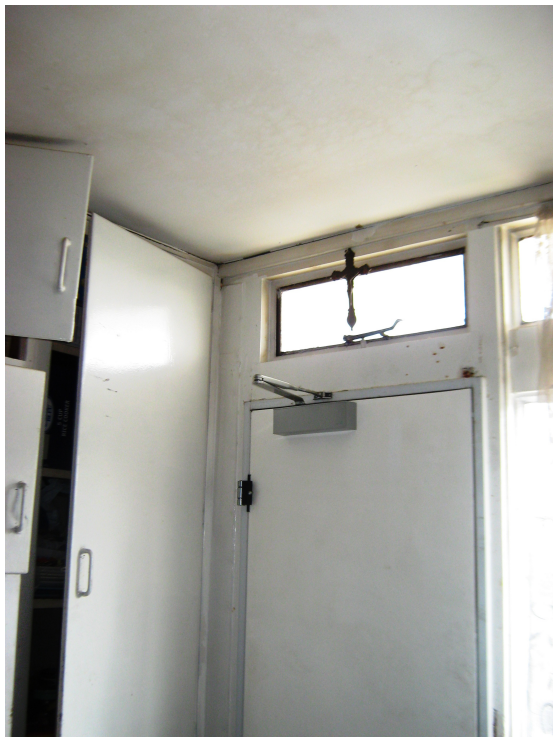
To the external (front elevation) wall in the Kitchen there is internally a sheet material cover panel (assumed to be approx 10mm thick plywood) that runs full storey height beside the emergency escape door and is penetrated by service outlets at high level (see photo 15). This panel is mirrored externally by a separate, more substantial plywood panel (see photo 16). It was not possible to remove these panels for inspection without dismantling of the existing services therefore, it is not known if there is any fire protection within the space between the internal and external panels. Due to this arrangement providing a possible weakening of the compartmentation between the Kitchen and the emergency escape balcony and possibly contributing to external spread of flame, consideration should be given to further investigation of this issue and possible upgrade if found necessary. It is understood that this consideration has been adopted for the second phase of external fabric works.

Photo 15 – Plywood panel (behind escape Cupboard).

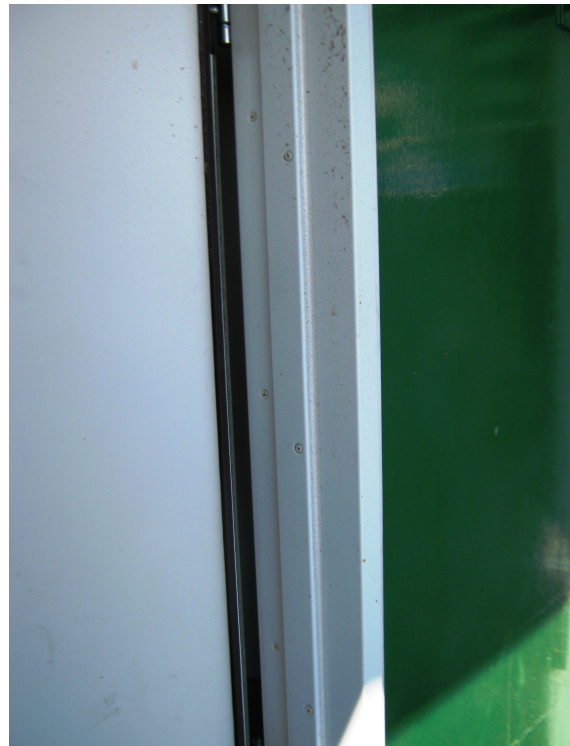
Photo 16 – Plywood panel on external emergency escape balcony.
