**SOUTHWARK COUNCIL
HOUSING AND COMMUNITY SERVICES
COMPLIANCE OPERATIONS TEAM**

Report into asbestos exposure incident – Westonbirt Court

Date: 09 July 2013

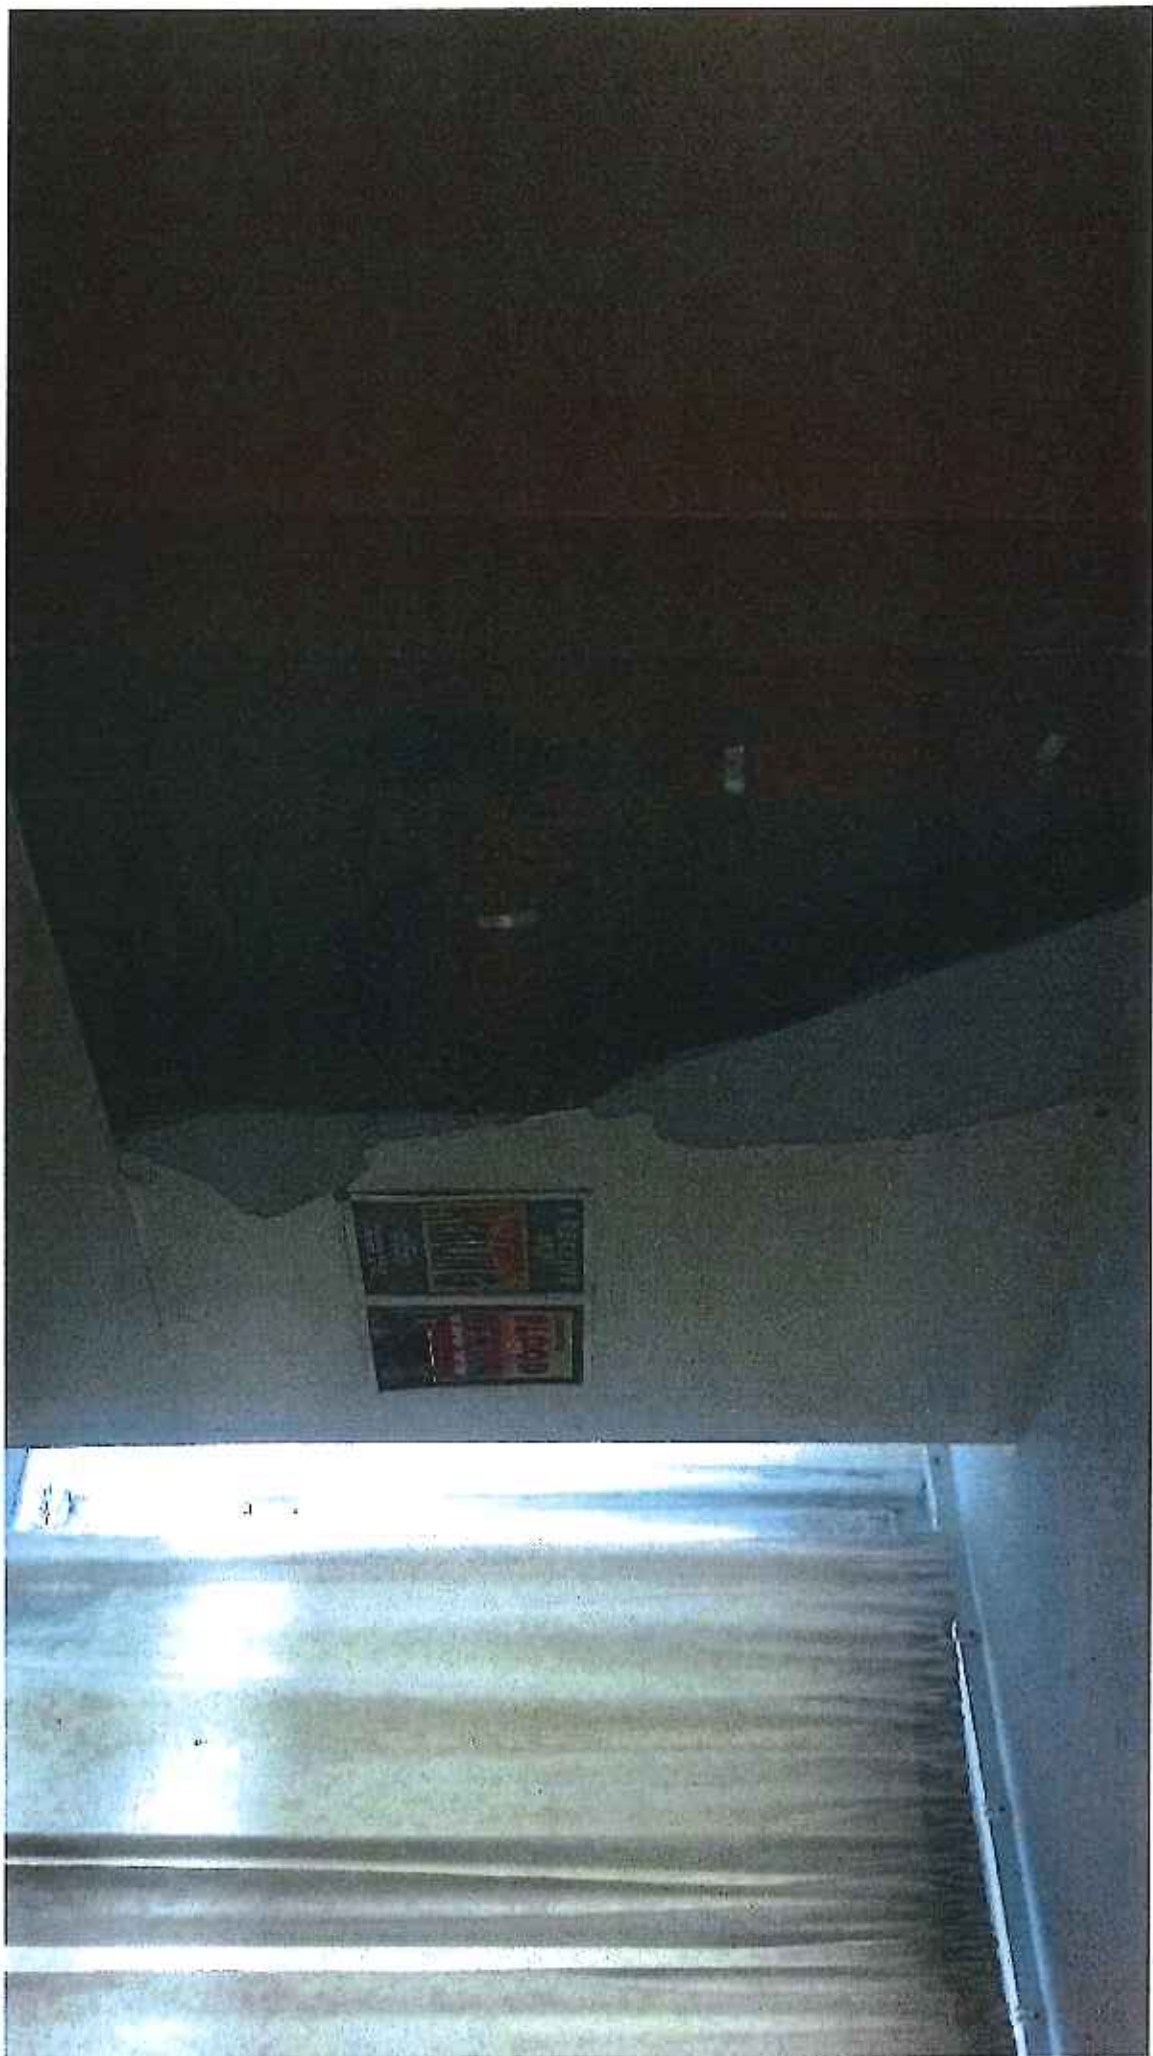
FIG 1

- Fig 1. Damaged panel in flat
- Fig 2. Damaged panel in flat
- Fig 3. Asbestos debris on floor in flat
- Fig 4. Damaged panel in flat showing asbestos fibres
