**Ledbury Estate**

Structural Assessment of Bromyard,  
Peterchurch, Sarnsfield and Skenfrith  
House

Issue 2 | 24 November 2017

Job number 245112-05

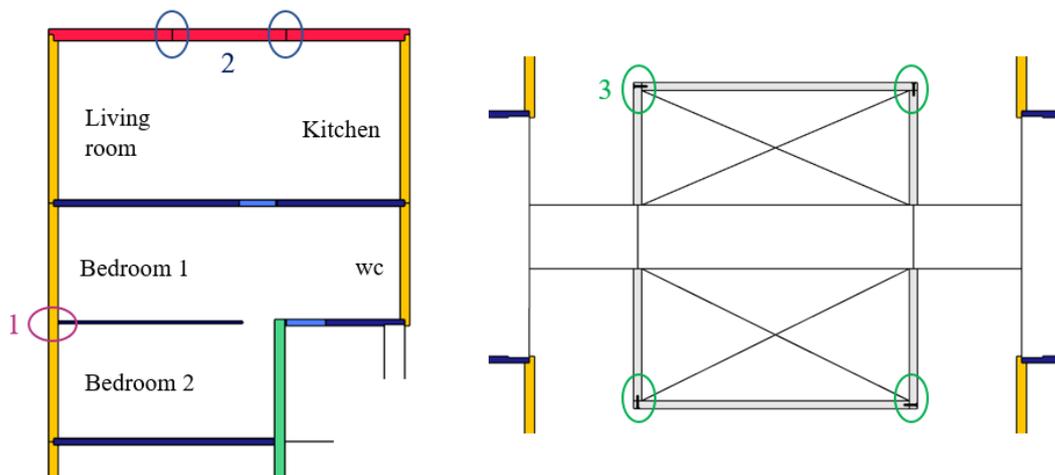
‘Cracks’ up to 30mm wide reported were reported by both residents and surveyors. Crack patterns are repeated throughout the tower blocks with the largest cracks always occurring in the same position (between the external wall panels and intermediate cross-wall separating the two bedrooms, location 1, Figure 6.

1. Gaps between the external wall panels and internal walls and floors, location 1, Figure 6
2. Gaps between adjoining precast concrete panels, location 2, Figure 6
3. Gaps between the precast staircase landings and the external stairwell walls, locations 3, Figure 6

Figure 6 Approximate floor-plan of a two-bedroom flat; locations of the primary ‘cracks’ reported are marked (LHS). Approximate floor-plan of the lift and stair core, showing the locations of the primary ‘cracks’ reported (RHS)

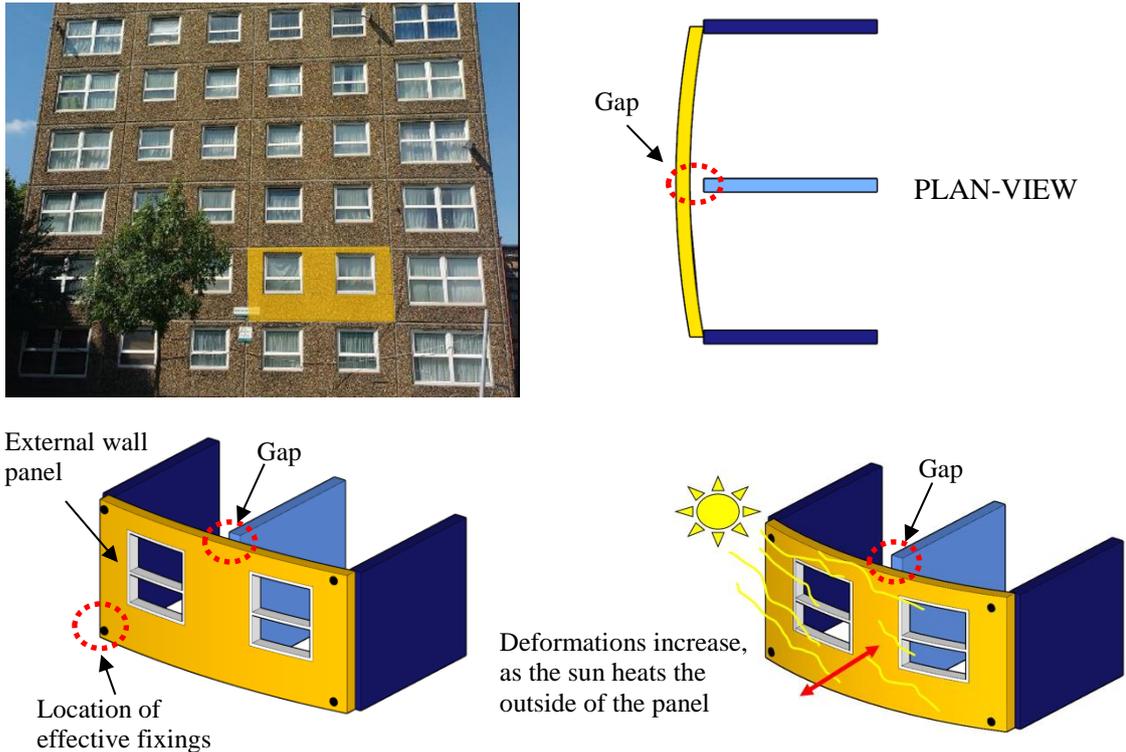
gaps to form over the full storey height between the centre of the bowed panel and intermediate cross-walls. Horizontal gaps also form between the external wall panels and the floor slabs. Additionally, temperature changes cause the gaps to further open/close, see Figure 7.

This is consistent with what has been reported by residents (gaps have been present for 17+ years and open and close depending on weather conditions) and is also consistent with gaps reported between the external wall panels and the internal walls in the 1985 BRE report [1].

Figure 7 Floor to ceiling vertical gap between the intermediate cross-walls and the external wall panels

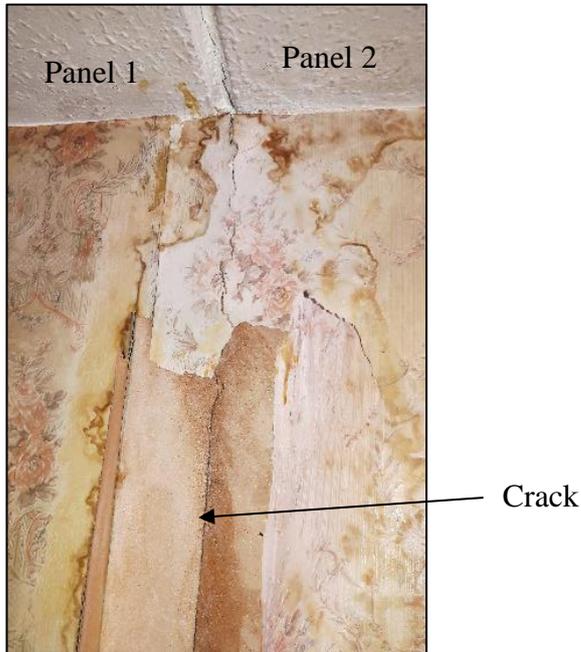
Cracks occur in the internal finishes (plaster/paint) where two precast concrete panels meet e.g. at location 2, Figure 6. An example of this can be seen in Figure 8.

All buildings move slightly due to thermal movements and wind. The building is made from large panels, made in a factory, small movements between those panels is to be expected.

Figure 8 Cracks occur in the internal finishes (plaster/ paint) where two precast concrete panels meet

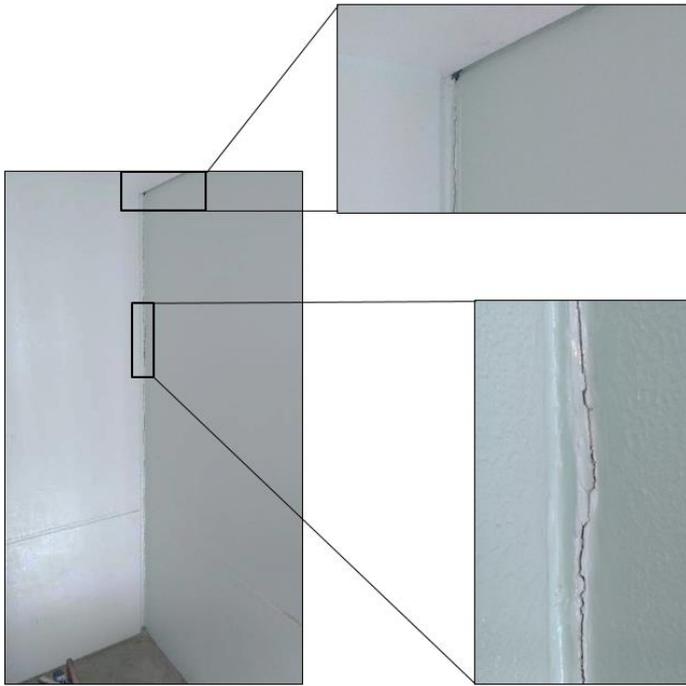
Gaps have opened up at the corner of the stairwell where two panels meet, see Figure 9. The horizontal gaps between the staircase landings and the walls is typically 5-6mm.

Figure 9 Gaps between adjacent wall panels in the lift and stair cores

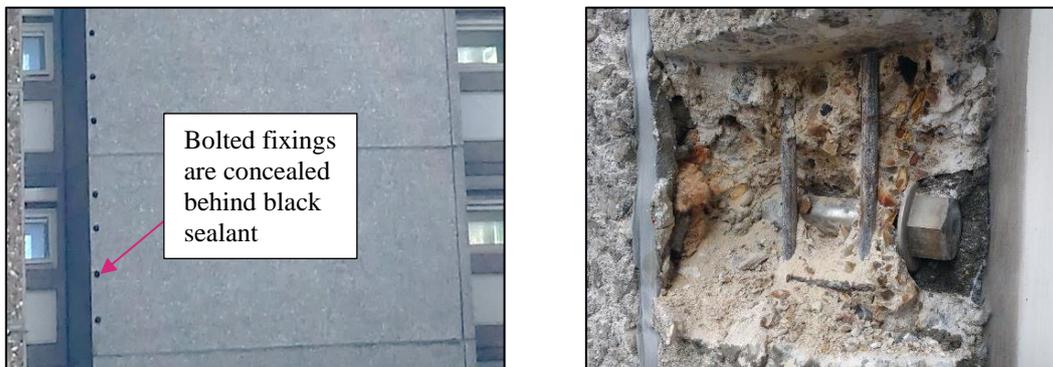
Three of the fixings bolts were exposed by breaking away the surrounding concrete, see Figure 10. These were exposed on Bromyard, Sarnsfield and Peterchurch House.

Stainless steel bolts, 34mm in diameter, sitting in slightly oversized holes (by 5-6mm) were exposed. The fixings and the surrounding reinforcement cage were found to be in very good condition, with no evidence of corrosion.

Figure 10 Fixings bolts are concealed behind black sealant (LHS). Fixing bolt exposed by breaking away surrounding concrete (RHS)

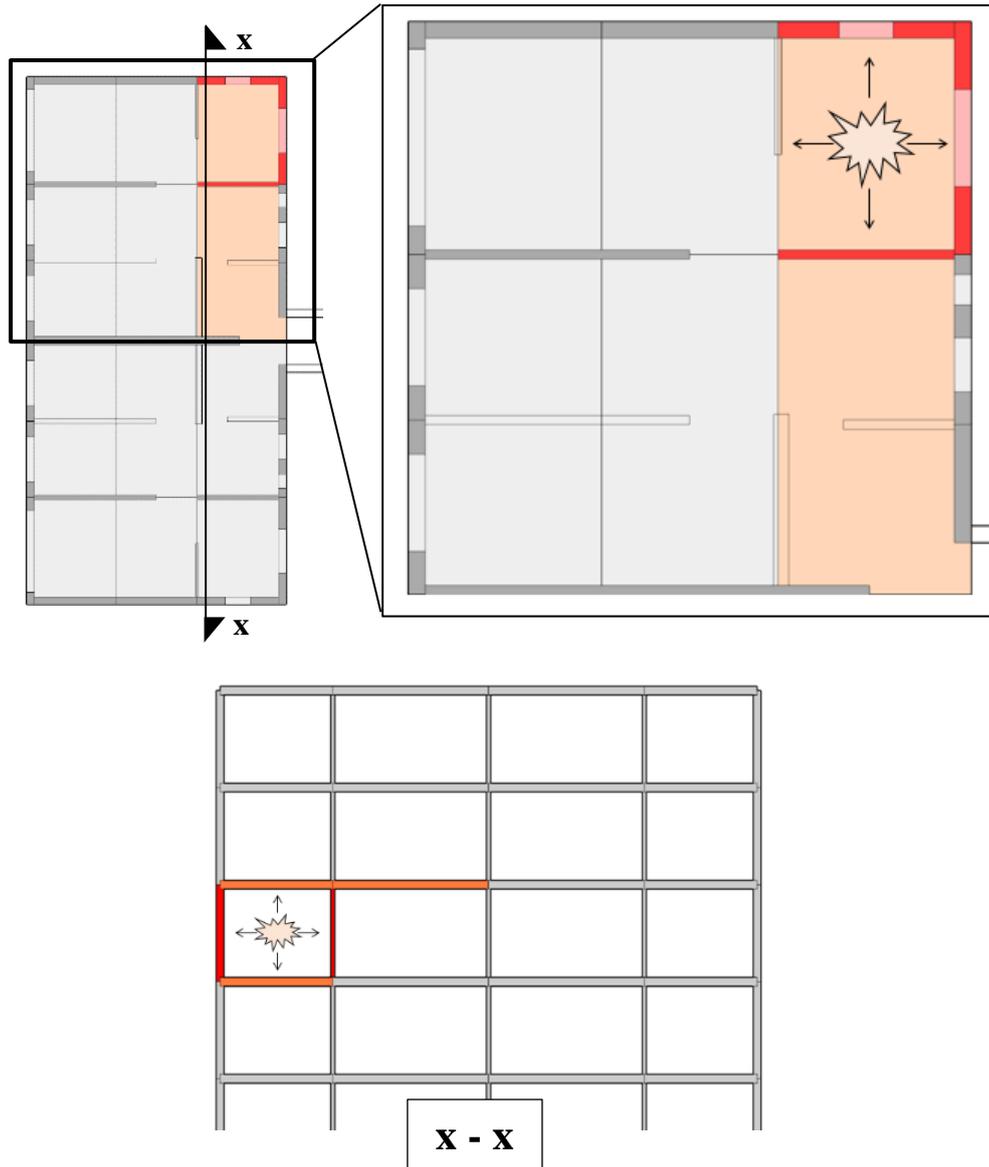
Our investigations indicate that the flank have minimal reinforcement\*, while the cross-walls are unreinforced concrete. As such the walls do not have sufficient capacity to resist 34kPa (accidental load requirement for a block with piped gas) or 17kPa (accidental load requirement for a block with bottled gas) and as such the walls surrounding the explosion will fail. This has consequences to the floor immediately above which relies on the walls for support.

There is likely to be significant damage to the floor slabs in the room where the explosion occurs. The walls and floors that that would be affected by an explosion in the kitchen can be seen in Figure 13.

Figure 13 Plan view (above) and section view (below). The walls affected by an explosion occurring in the kitchen are highlighted in red. The affected floor slabs are highlighted in orange.

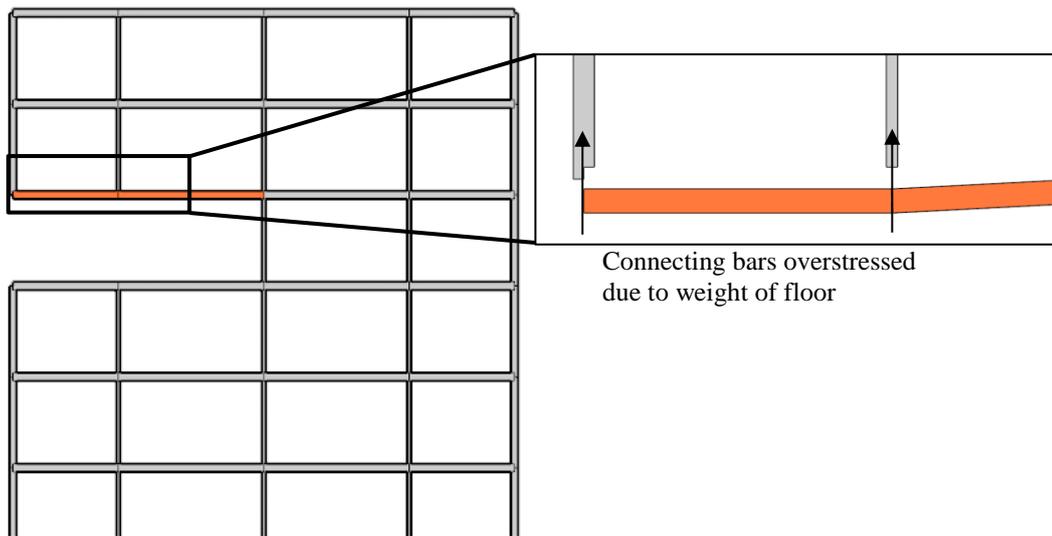
With the loss of the flank wall and the first internal wall, the floor on the level above the explosion will no longer have support from below and will try to vertically suspend from the wall above. Our investigations indicate that the floor slabs are connected to the wall below but are not directly connected to each other or to the wall above. Our investigations indicate that there are only two vertical bars per wall panel which continue from the wall panel to the wall panel above. The vertical bars are not capable of supporting the weight of the slab in tension and as such in the event of the wall failing below, then the floor previously supported by that wall would also collapse, see Figure 14. The area of the floor that would fail is greater than 15% of the total floor area (at that level) which is not compliant with the regulations for disproportionate collapse, see Figure 15.

Figure 14 With the loss of the flank wall and the first internal wall, the floor on the level above the explosion will no longer have support from below and will try to vertically suspend from the wall above. The connecting steel reinforcement bar would become overstressed due to the weight of the floor, leading to the tensile failure of this connection.

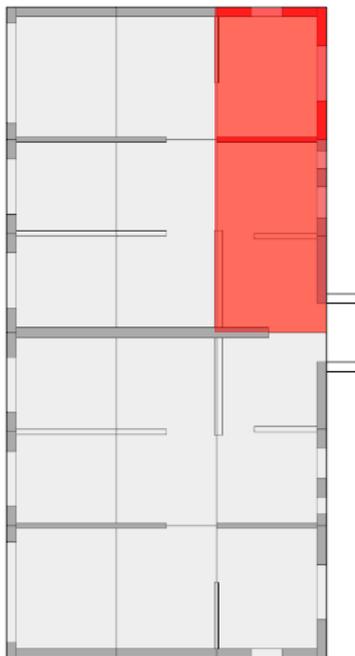
Figure 15 The area of the floor that would fail (highlighted in red) is greater than 15% of the total floor area (at that level)

Therefore, as described above, in the event of a gas explosion the walls are not able to resist the blast load of 34kPa (for piped gas) or 17kPa (for bottled gas) and therefore would fail the LPS Criterion 2 (as defined by BRE [2]). With the flank wall and/or the first internal wall removed, the floor slabs of the level above are not adequately tied to the walls above or to each other and thus there is no reliable alternative path of support and therefore cannot be shown to meet LPS Criterion 3 (as defined by BRE [2]).
