Internal Review of the Canada Estate (Phase 2) 2017/18 QHIP Major Works Project, Fair Street/Devon Mansions 2018/19 QHIP Major Works Project and the Kirby Estate 2018/19 QHIP Major Works Project

Report of the Task and Finishing Team

June 2025

Canada Estate, Columbia Point & Regina Point, London, SW16

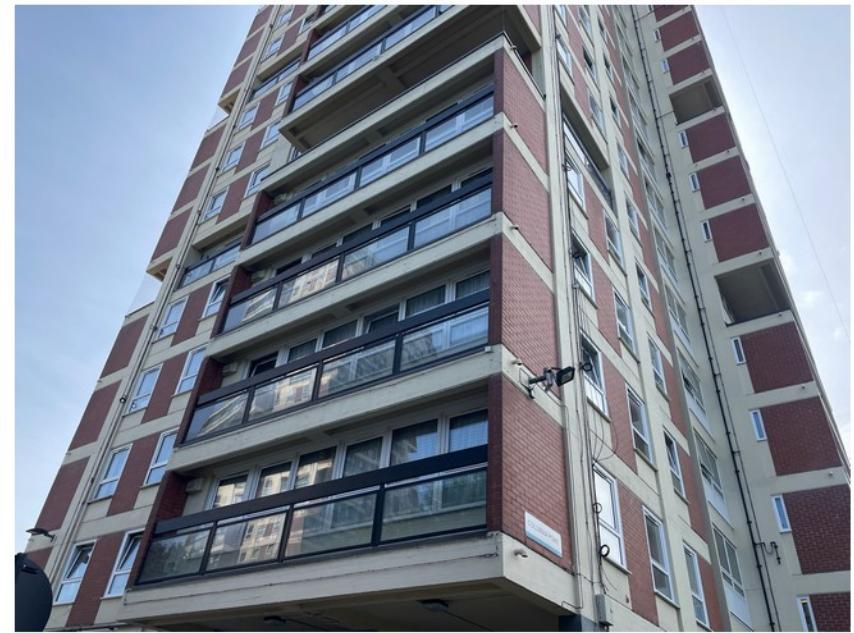
2. External balcony construction

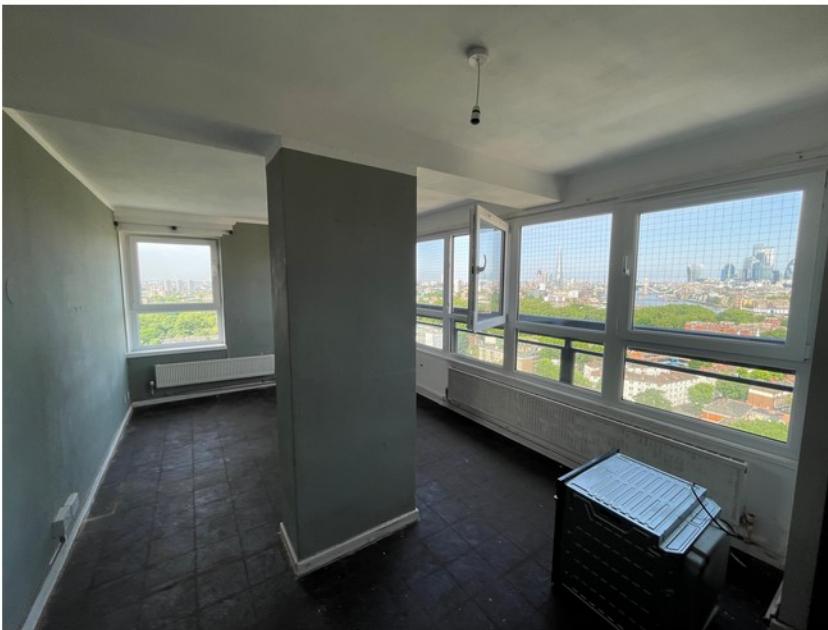
5. Window configuration at Unit 79

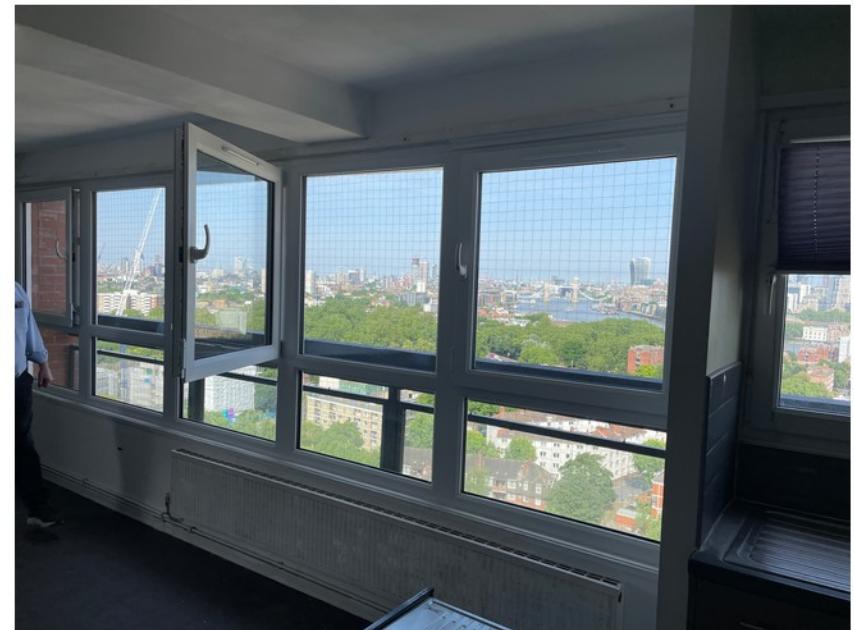
6. Operable casement windows

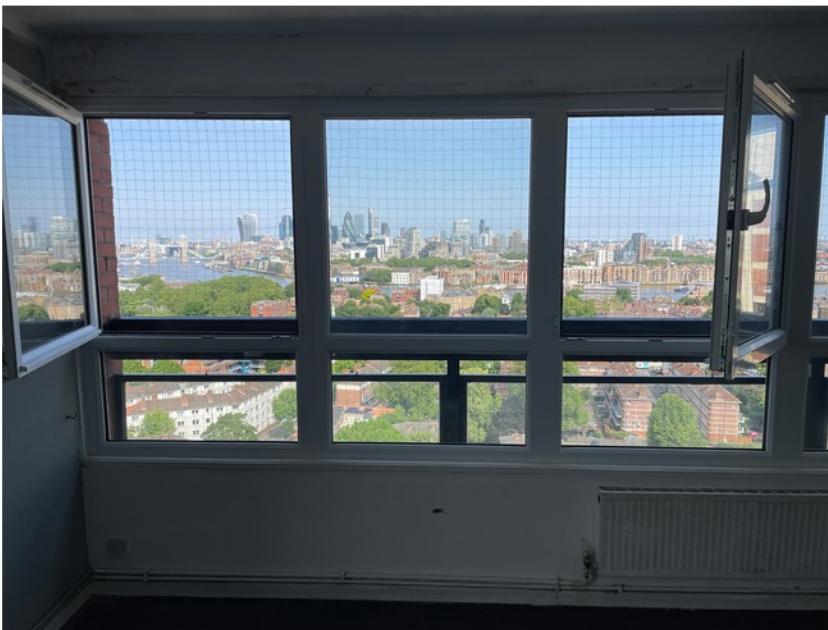
7. Operable casement windows

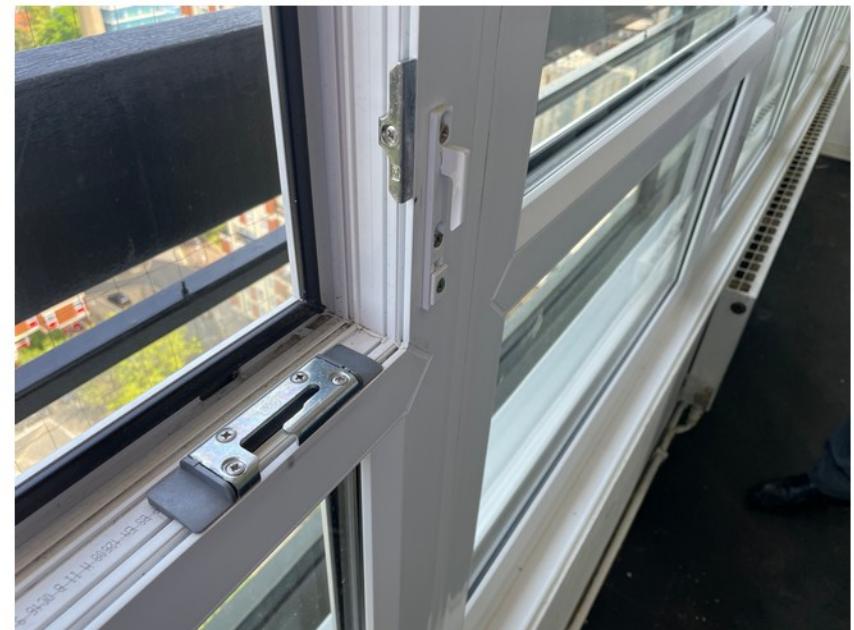
8. Hinge and fenestration details

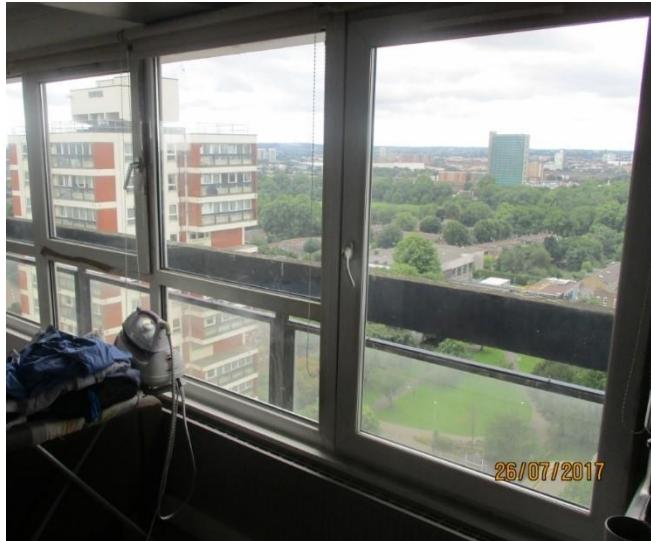
The floor to sill height of the large window is 0.65m, which is below the 1.10m level needed to meet the requirements of the Building Regulations. However, externally there is a recess (approximately 400mm deep) with a balustrade that is in excess of the 1.10m in height, if measured from the lounge floor.

Windows are current inward opening with lockable handle. The inward opening of the window allows for cleaning of the external face.

Due to the current design of the windows within Columbia & Regina Point there is an increased risk of falls from height.

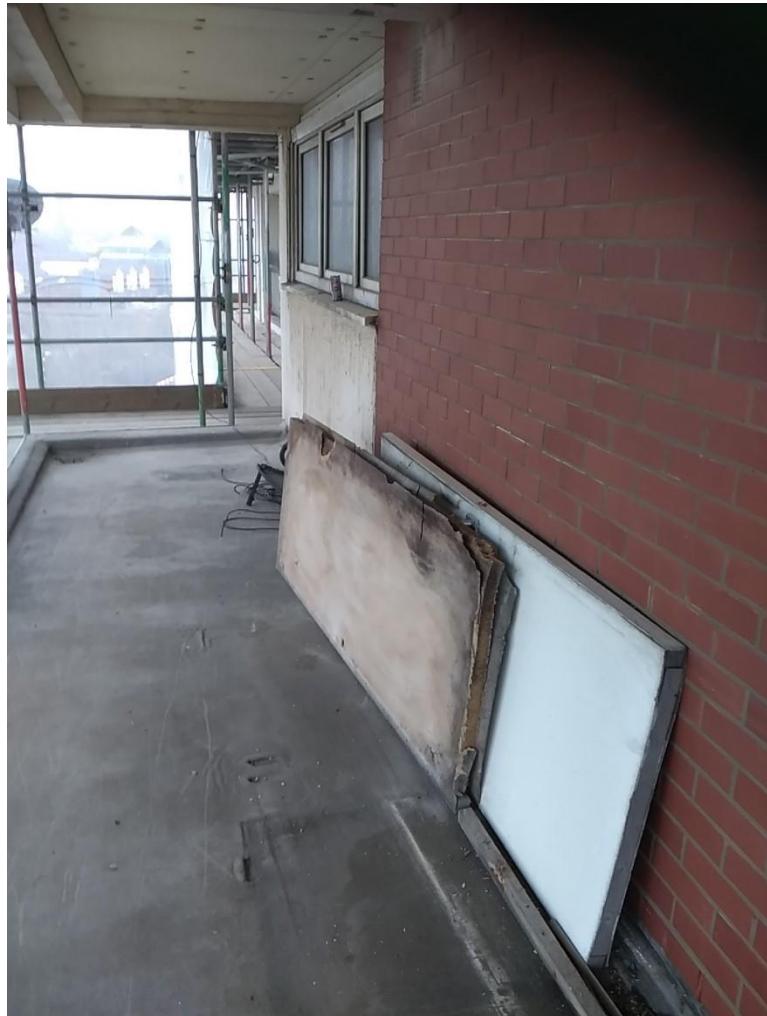
Personal items, waste, and residents have been seen using the unprotected flat roof areas. It has been established with the London Borough of Southwark that these are and always have been no access areas.

Certain areas of the flat roofing have netting installed. This netting is however only in place to prevent birds from nesting and fowling. The netting is by no means a form of fall restraint or protection.

*Items stored on Unprotected Flat roof.

“ A form of external mounted restriction system should therefore be considered. To prevent access out onto the roof.

Restricting any access onto the flat roofs would mitigate the risks outlined in this Risk Notice. There is still the potential residents would find an alternate means to use the flat roofing areas (removing restrictors). 1100mm edge protection should be considered to further protect against falls. It must however be understood that by installing edge protection this does not make the flat roof a useable area and this would need to be communicated to residents to ensure future compliance.

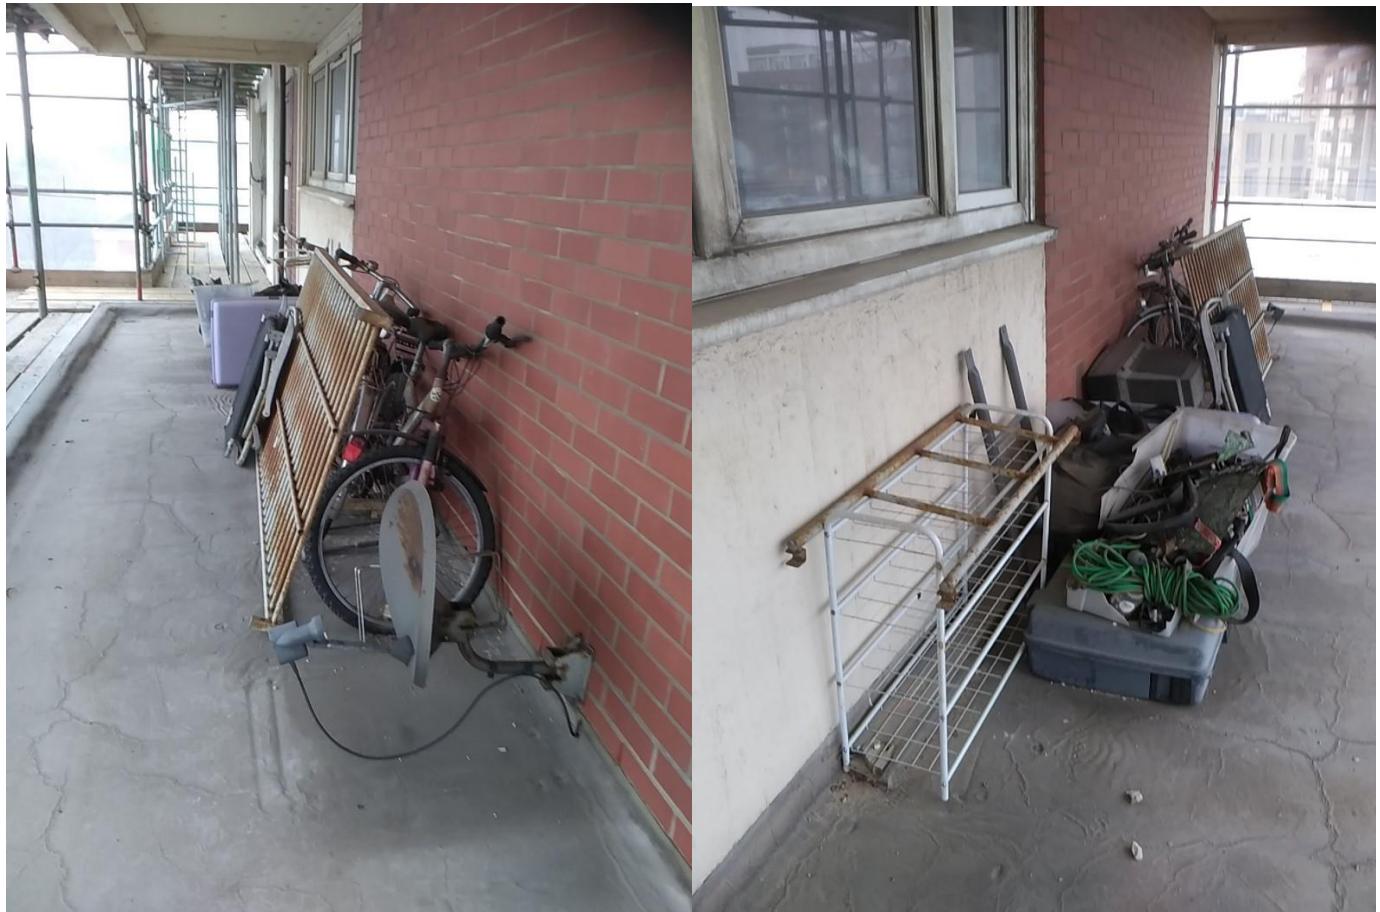
*Addition Images of Storage on unprotected Flat roofs

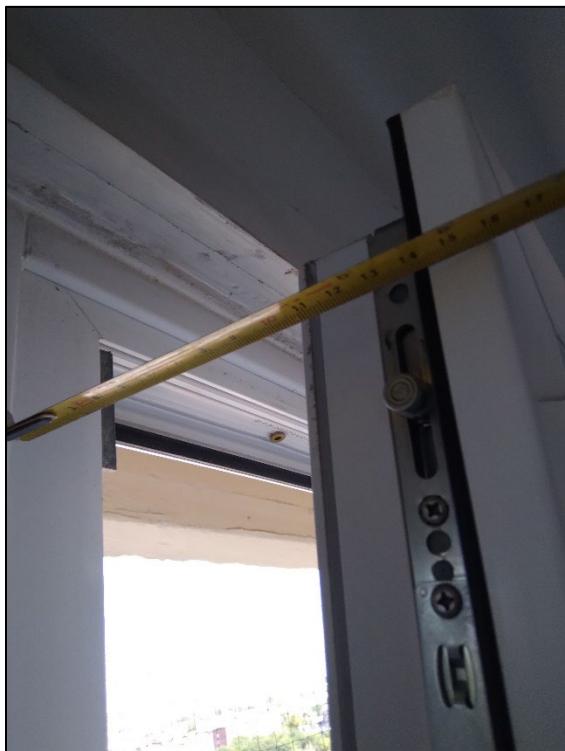
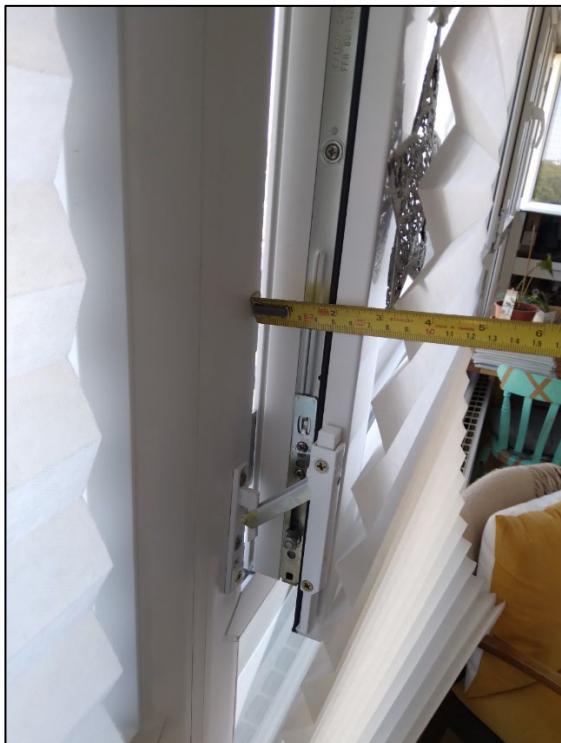
Restriction of opening light

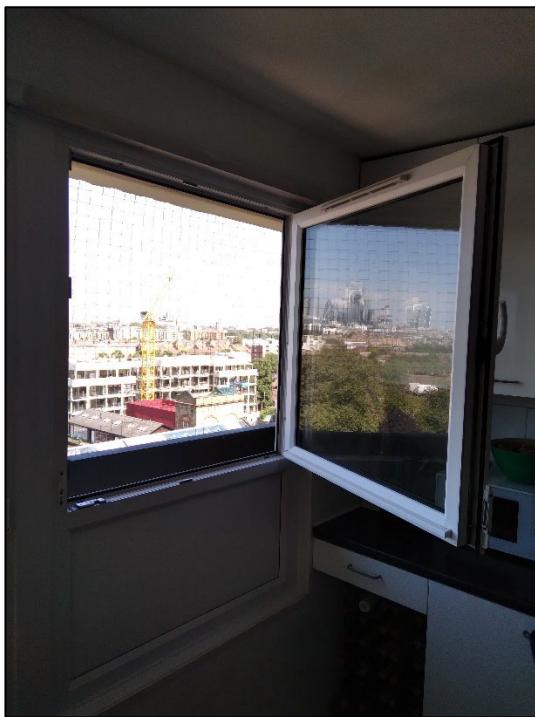
Fully open opening light to allow cleaning/maintenance

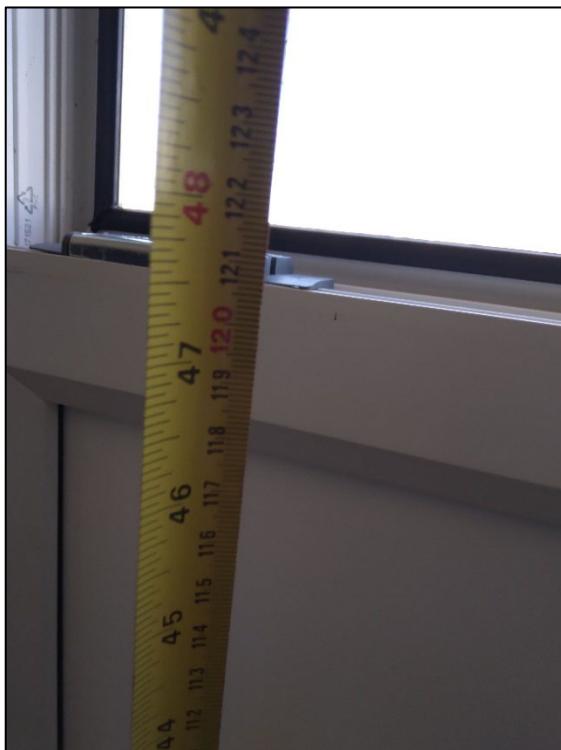
Record of compliant height of 'barrier' to fenestration

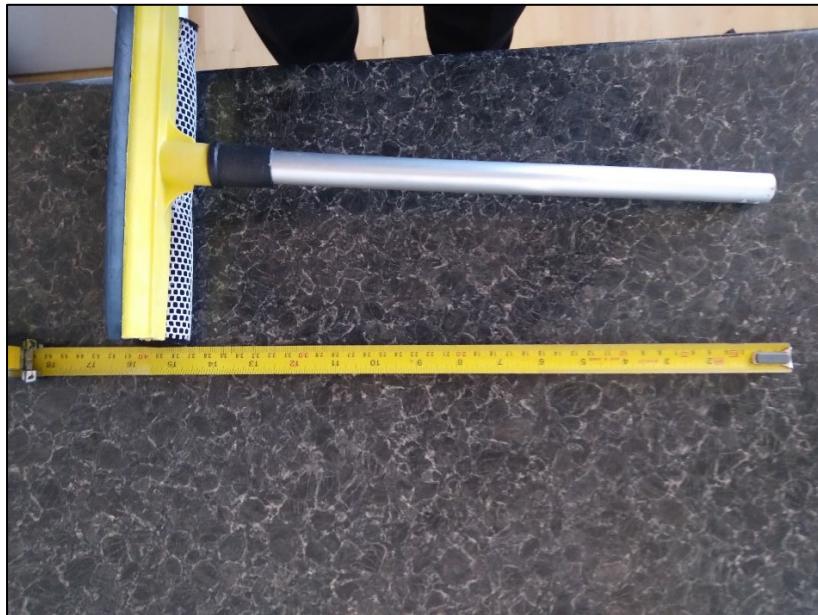
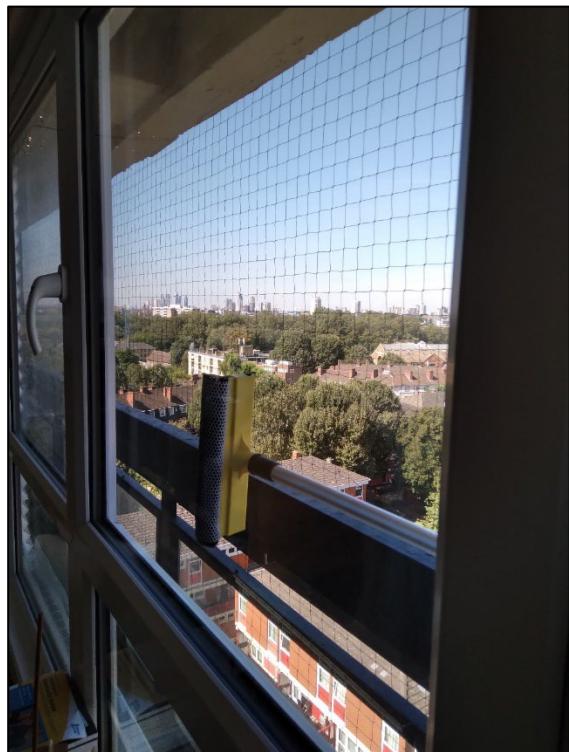
Example of cleaning equipment to assist with reach
