London Borough of Southwark
Ledbury Estate Tower Blocks
Pilot investigation and strengthening
study

Issue 1 | 24 October 2019

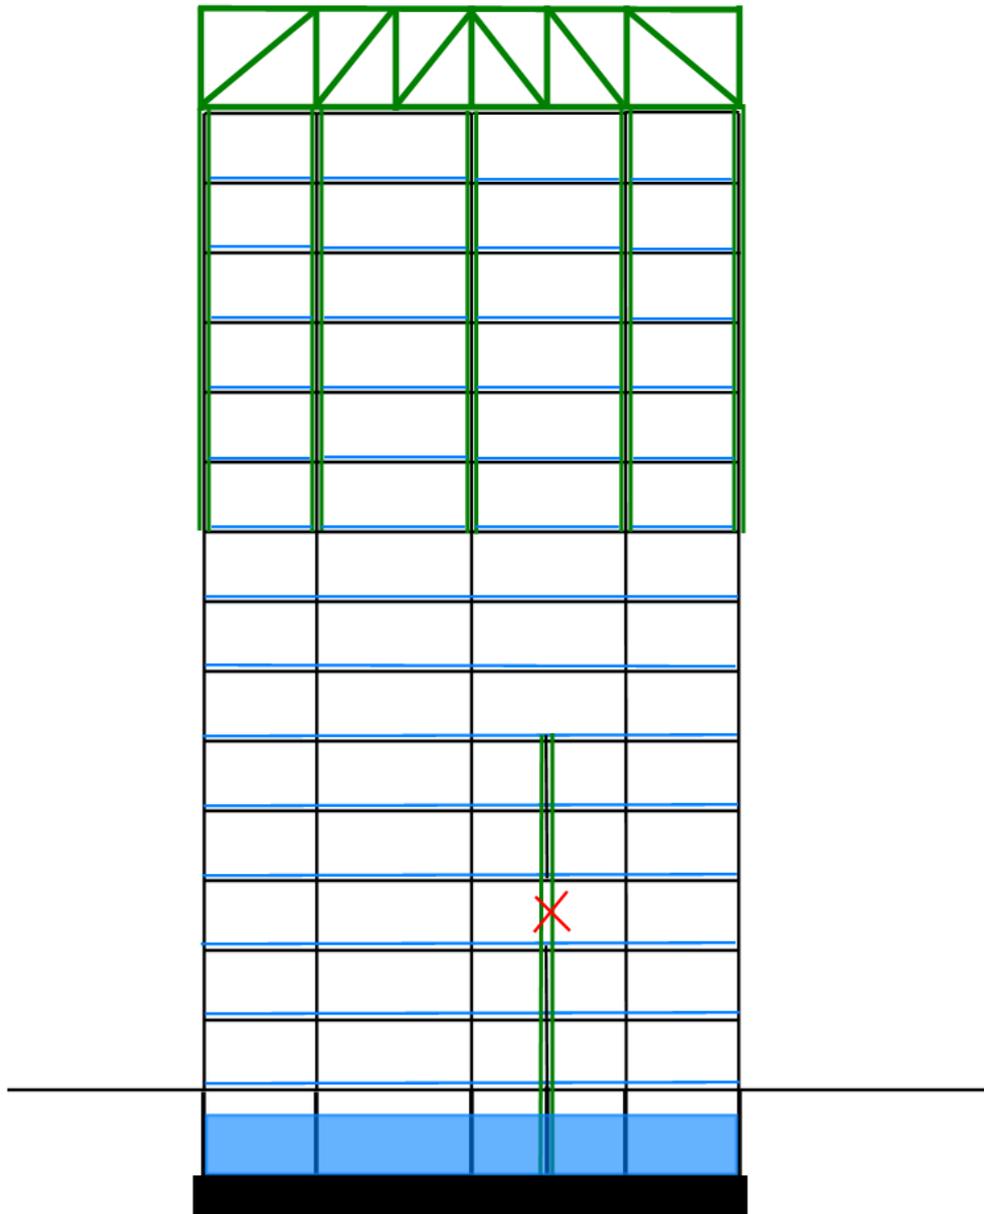
The cross walls separating the 1 and 3 bedroom flats (Floors G to 4) are not able to withstand 17 kPa by arching as they have no load from the floors above. As such it is proposed to install steel columns and beams designed to act as key elements to withstand 17 kPa to create an alternate load paths in the event of loss of this cross wall (see image below).

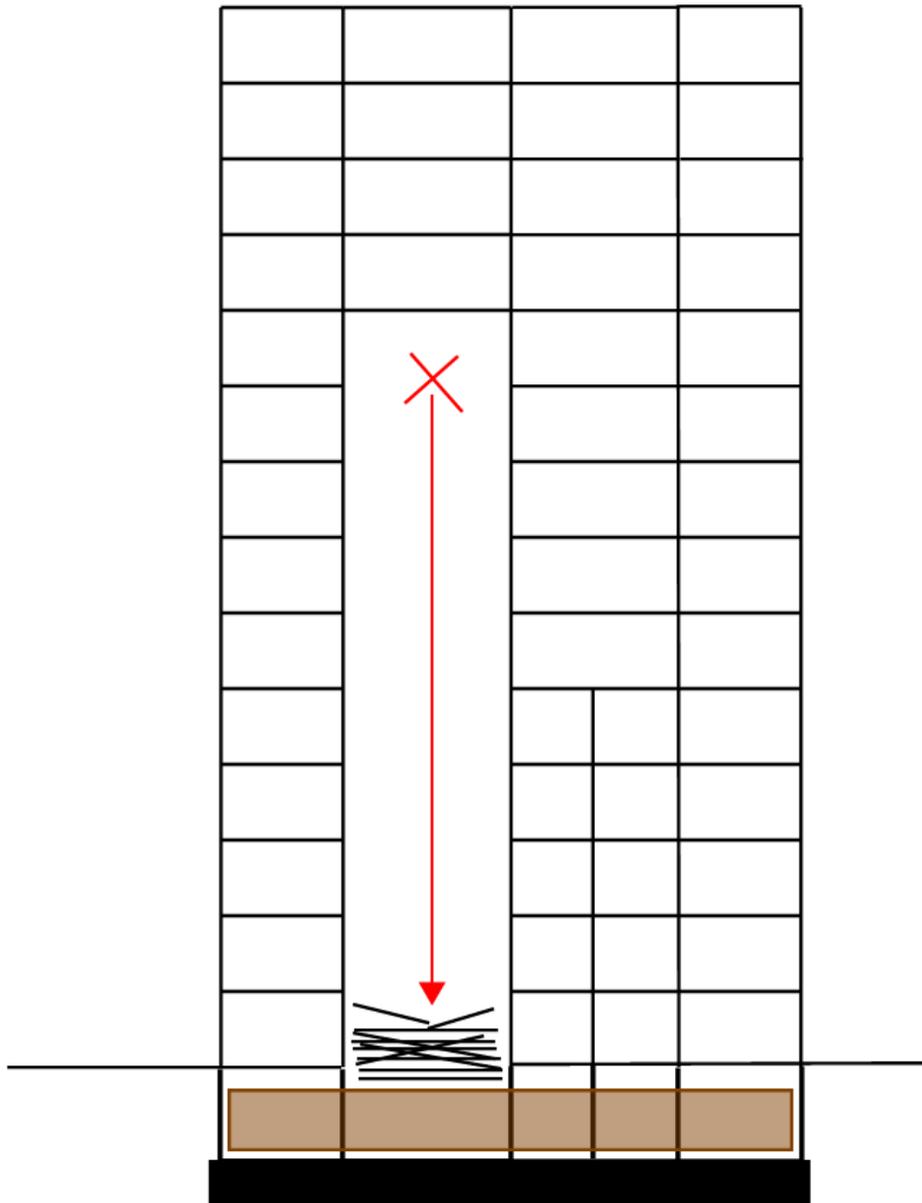
The floors in Ledbury not only support themselves and their loads but also provide buckling restraint to the flank walls, cross walls and to the main shear wall. A possible accidental event such as the explosion of a gas canister would cause one or more floor panels to fail. Failure of a single floor could cause ‘pancaking’ whereby the failed panel falls onto the floor below, putting additional weight onto that floor leading to disproportionate collapse as seen at Ronan Point.

Further the loss of floors could also lead to the disproportionate collapse of the structural walls as the loss of horizontal restraint would mean that the walls would buckle. Hence the floors cannot be allowed to fail.

Therefore, it is proposed to strengthen the floors to withstand 17 kPa. Strengthening the floors also usefully means that they would be able to provide lateral restraint to the flank walls in the event of an internal pressure of 17 kPa being applied to the flank walls.
