**Ledbury Estate**

Structural Assessment of Bromyard,  
Peterchurch, Sarnsfield and Skenfrith  
House

Issue 2 | 24 November 2017

Job number 245112-05

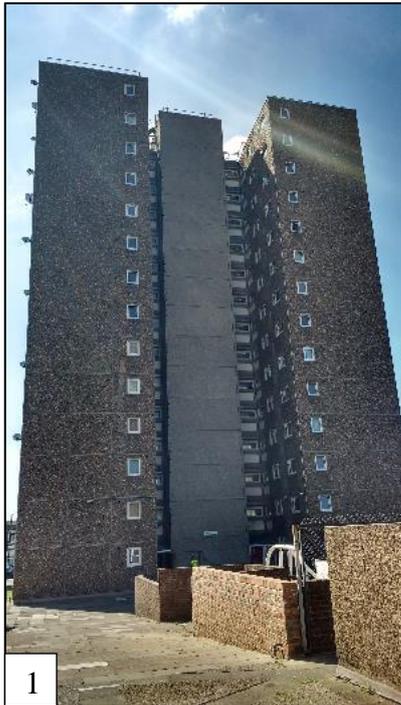
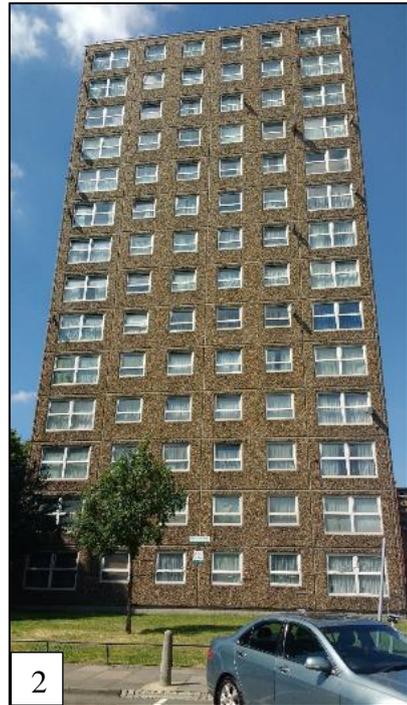
Figure 1 Peterchurch House

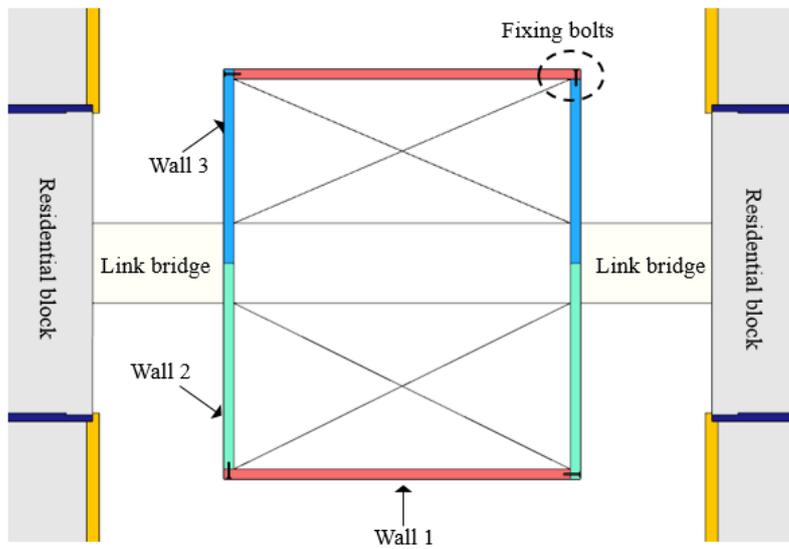
The lift/stair area is comprised of three different wall panel types, which are stacked upon each other and bolted together at the corners, see Figure 4. All wall panels are approximately 185mm thick and 2.7m high.

Figure 4 Lift/stair area comprised of three different wall panel types, which are bolted together at the corners

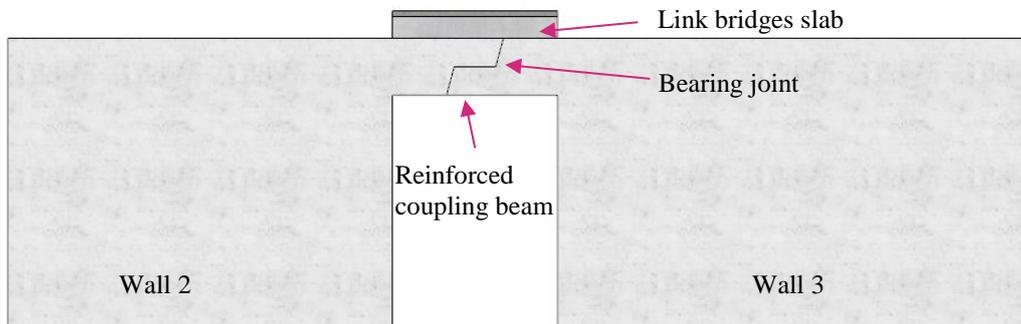
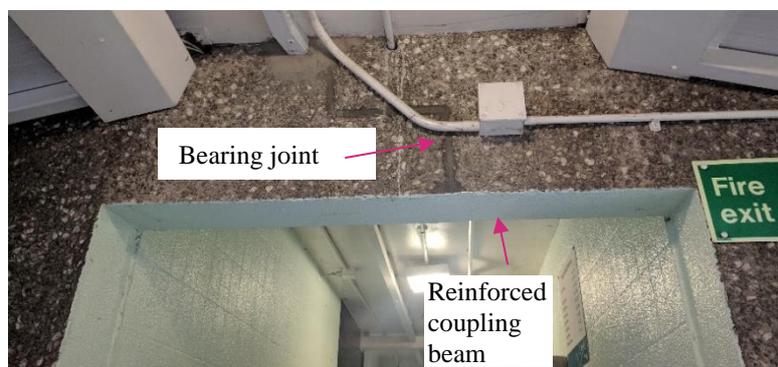
Wall types 2 and 3 are connected at the centre of the link bridge via a reinforced coupling beam. The coupling beams extend from the wall panels on either side and form a bearing joint at the centre, see Figure 5.

Figure 5 Lift/stair core walls are connected via a coupling beam with a bearing joint at the centre. Sketch of the wall panels (above), photograph of the bearing joint (below)

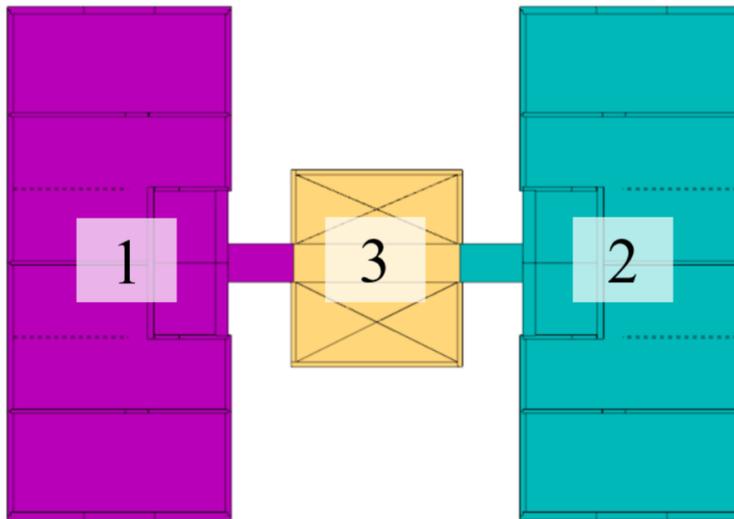
For the purposes of lateral stability, the tower blocks are conservatively considered as three separate structures, see Figure 11. This is because the link bridges have tensile connections in the form of steel straps on each floor to the residential blocks, but they are not connected with tensile connections to the central core.

Thus, wind load acting on the core is resisted only by elements in the core, and wind load on the link bridges and residential block is resisted by elements in the residential blocks.

Figure 11 The tower blocks can be considered as three separate buildings; the residential blocks together with the link bridges and the lift/stair core alone

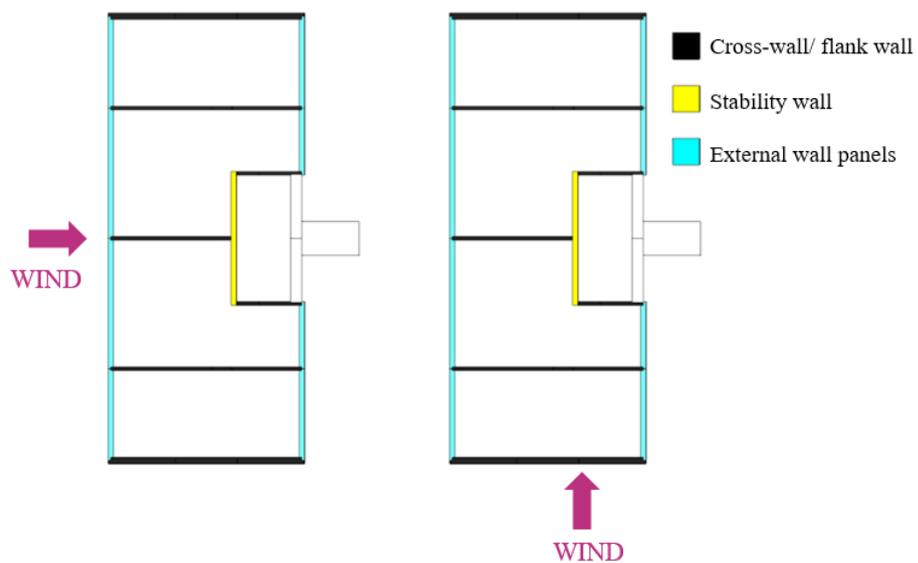
In this direction, the wind load is aligned with one internal loadbearing wall: the stability wall indicated in Figure 12. It is also aligned with the external wall panels and the non-loadbearing internal concrete walls to the bathrooms and between the kitchens and living rooms.

- the contribution of the internal non-load bearing walls to overall building stability is negligible
- the connections of floor plate to the external walls panels (indirectly via the cross-walls) are stiff enough to transfer horizontal loads into the external walls
- the stability wall alone is not stiff nor strong enough to resist all of the wind load in this direction
- the external wall panels will attract some lateral load, and therefore must resist it alongside the stability walls

Figure 12 Wind loading perpendicular to each building face of the residential block was considered
