Objections and comments on the planning application at 84-90 Lordship Lane London Se22 8HF. Reference 14/AP/0280.

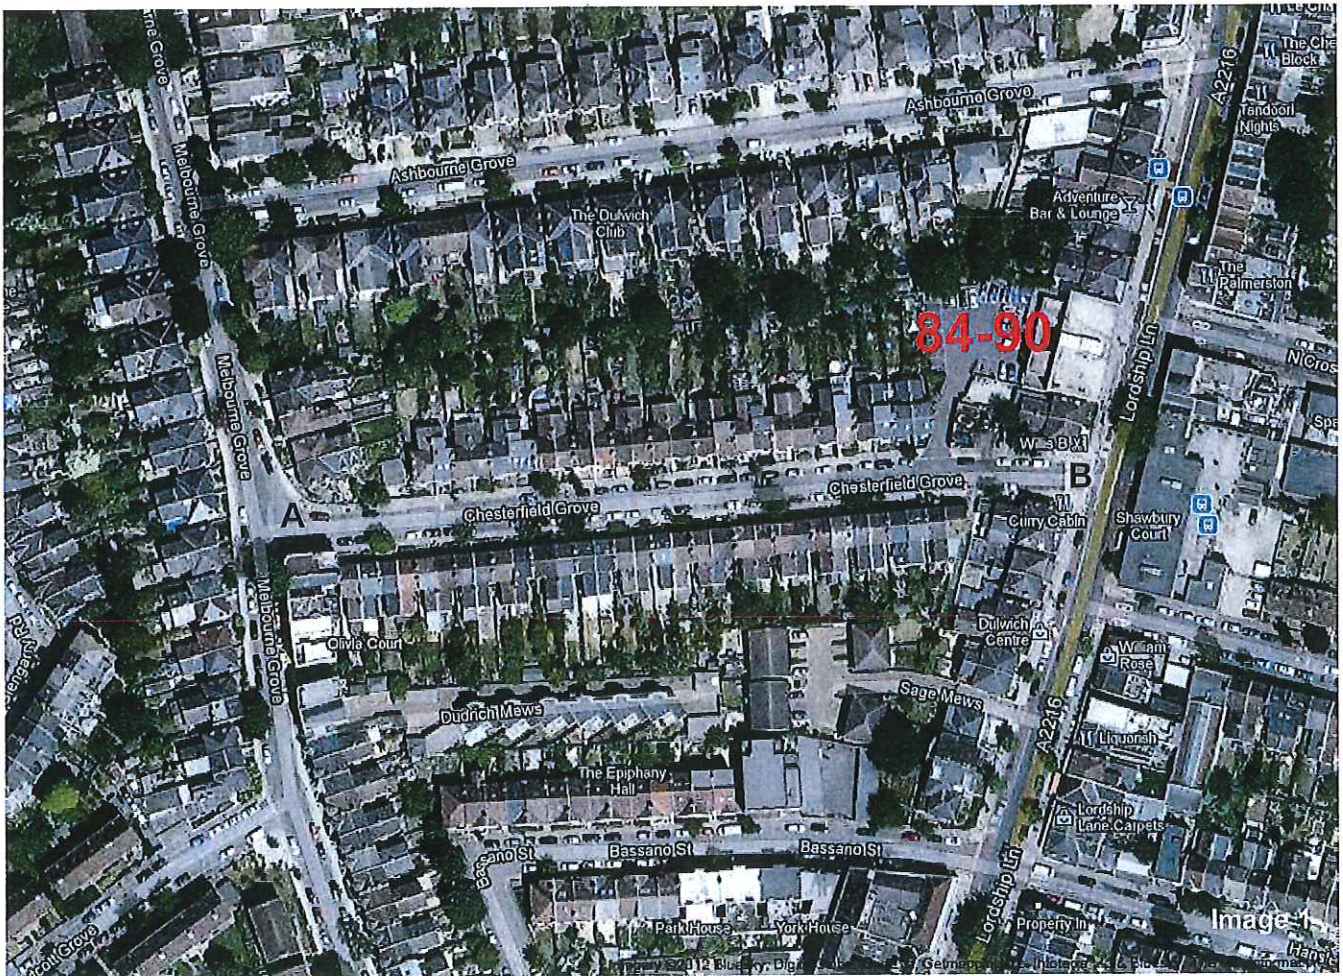
Image 1 Item A Melbourne Grove junction with Chesterfield Grove. Item B Lordship Lane junction with Chesterfield Grove.

1.06. Iceland vehicles always try and approach the site from Melbourne as mentioned above. There also a benefit that junction between Chesterfield Grove and Melbourne Grove is wide and will allow the lorries to turn around, unlike the restricted junction off Lordship lane see image 1.

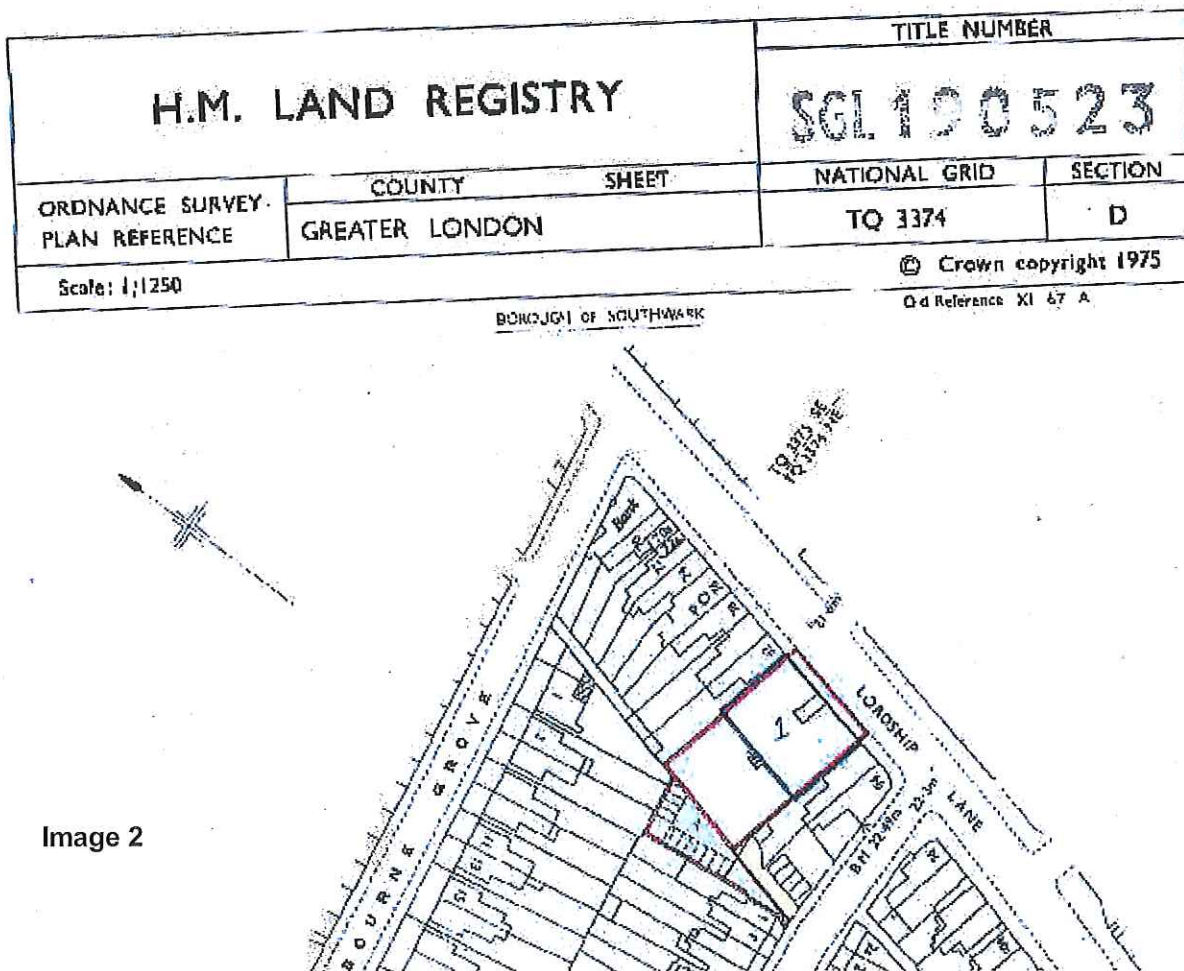
3.01. Image 2 below shows an extract of the plan from the registry land title to 84 to 90 Lordship Lane, title number SGL 190523. It shows the title comprises of two parcels of land, a rectangular area edge in red, and a triangular piece of land edge in red and lettered A. Land registry have confirmed that area lettered A refers to all of the triangle as coloured blue. The area A was added to the title in April 1982. I believe the reason for this was the application made 1974 included part of rear garden [REDACTED] No 1 Chesterfield Grove, a line can be seen in the plan below, but this did not receive planning approval, and as works had commenced on this development some of the built works had to be amended, and it probably took until 1982 to sort out both a new planning application

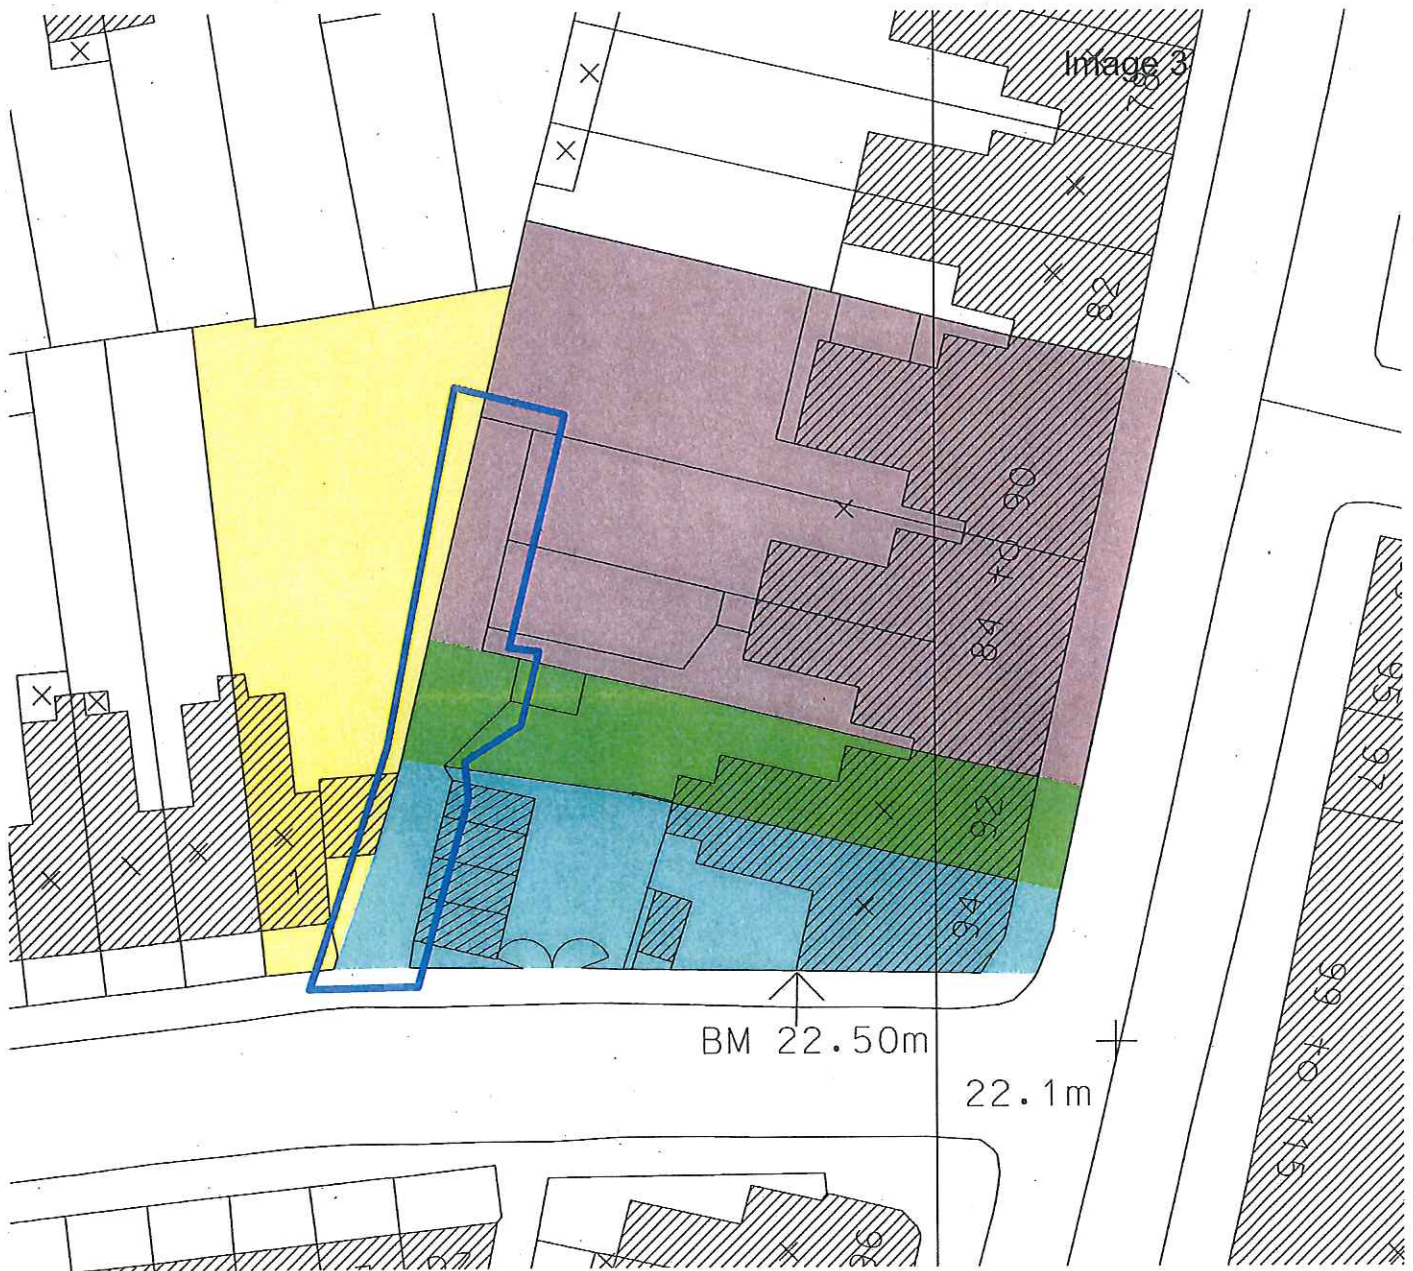
3.02. The shape to the parcels of land that forms the land title to 84 to 90 Lordship Lane can be explained by looking at previous title boundaries. Image 3 below shows the approximate title boundaries in 1972, of No 1 Chesterfield Grove, 94, 92 and 84 to 90 Lordship Lane.

3.03. Image 3 shows the land titles in 1972. 1 Chesterfield Grove is tinted yellow, 94 Lordship lane tinted blue, 92 Lordship lane tinted green. The title areas to 84 to 90 Lordship lane tinted purple. The purple area corresponds to the rectangular parcel of land shown on current registry land title to 84 to 90 Lordship Lane, SGL 190523 shown in image 2. The area enclosed by blue shape outlines the access to the rear of 84 to 90 Lordship lane from Chesterfield Grove. This route to the area tinted purple of 84 to 90 Lordship lane has been maintained in the current registry land title, and this the only access to the site.

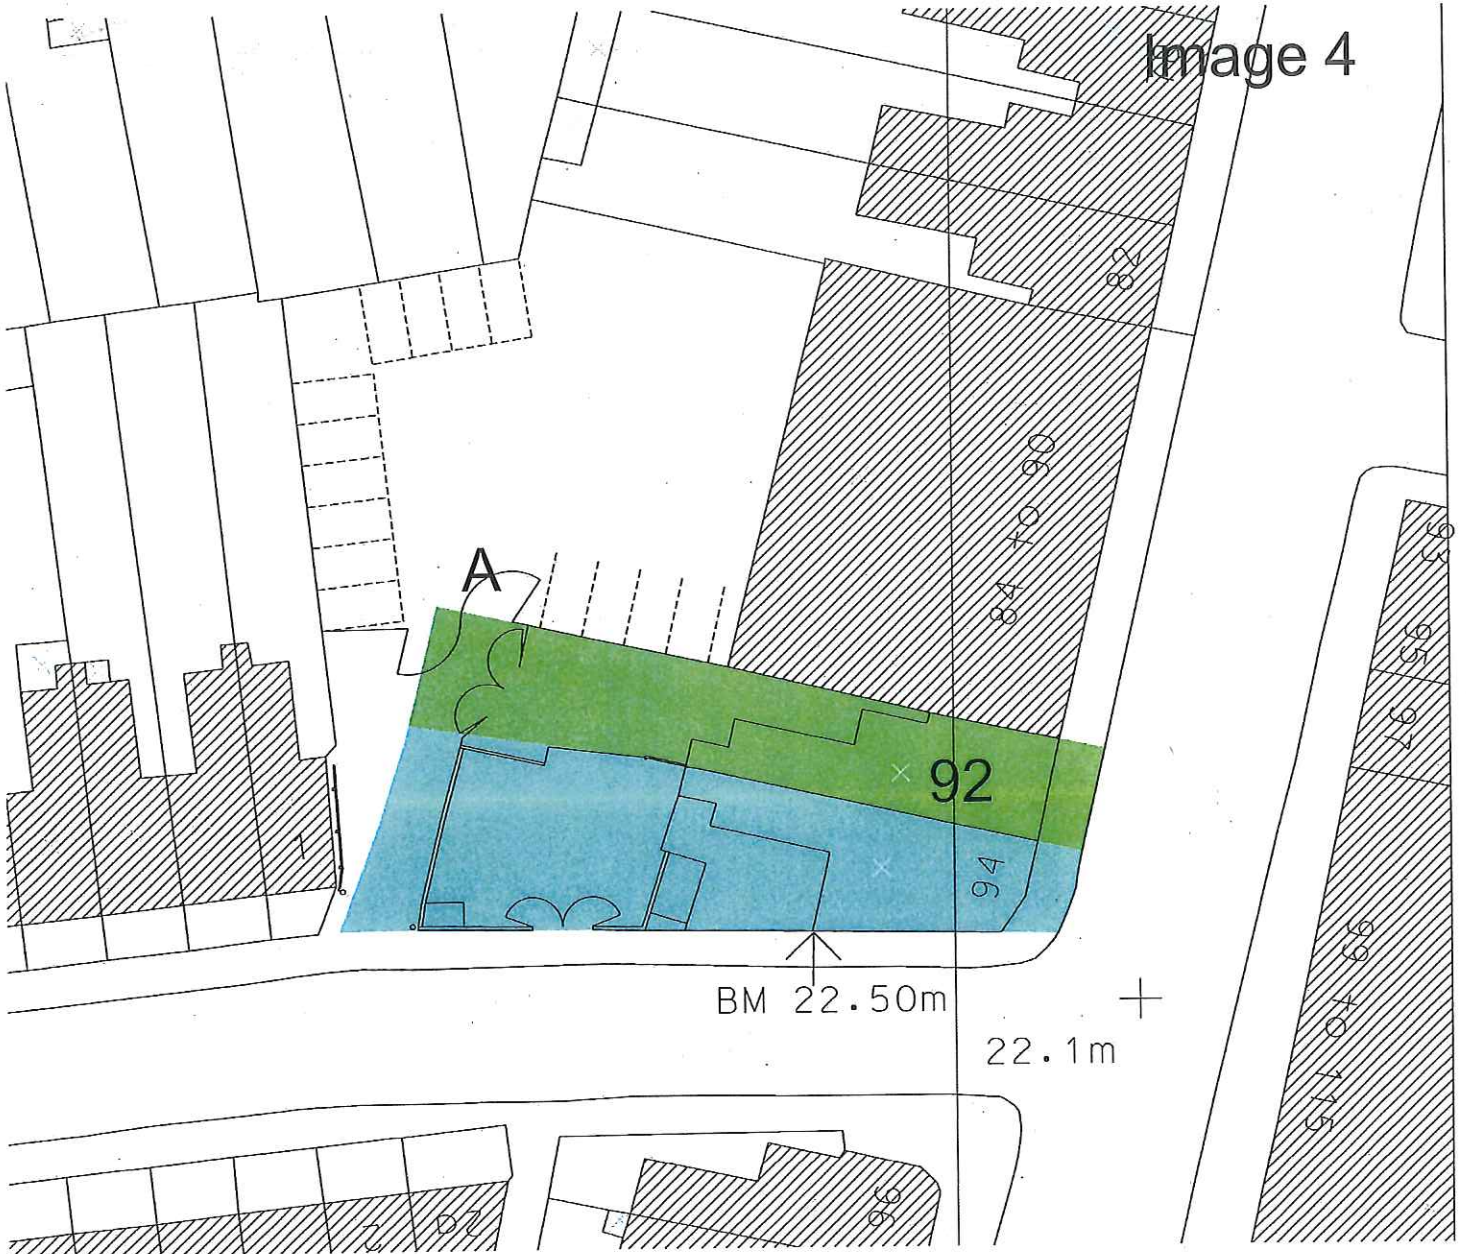
3.04. Image 4 on page 8 shows the registry land title to 92 Lordship lane (tinted green) and to 94 Lordship Lane (tinted blue with the current site layout of 84 to 94 lordship Lane

Image 2 shows the land titles to 92 and 94 Lordship lane with the current access to 84 to 90. The current access is via lockable metal gates, item A

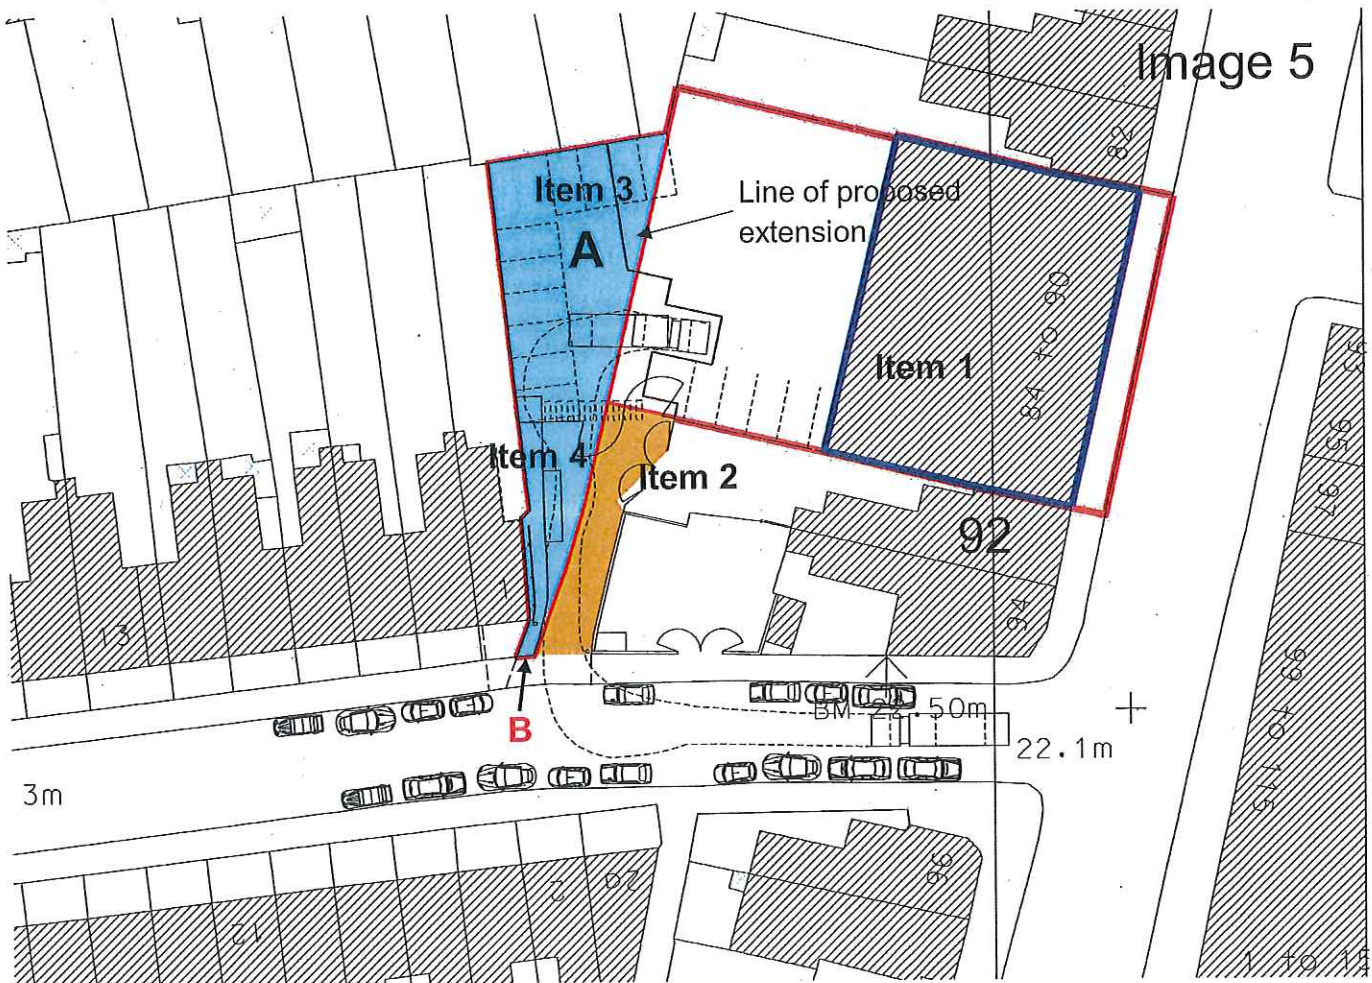
3.05. The above listed items has been added to image 5 below that shows the existing site with the outline of the proposed planning application, and proposed vehicle service route. Image 5 illustrates that the planning proposal does not consider the restriction that occur in title regarding access to land A item 4. The only access to land lettered A from Chesterfield Grove is by a strip 1275 mm wide (item B on image 2). This strip also contains rights of way to No 1 Chesterfield Grove.

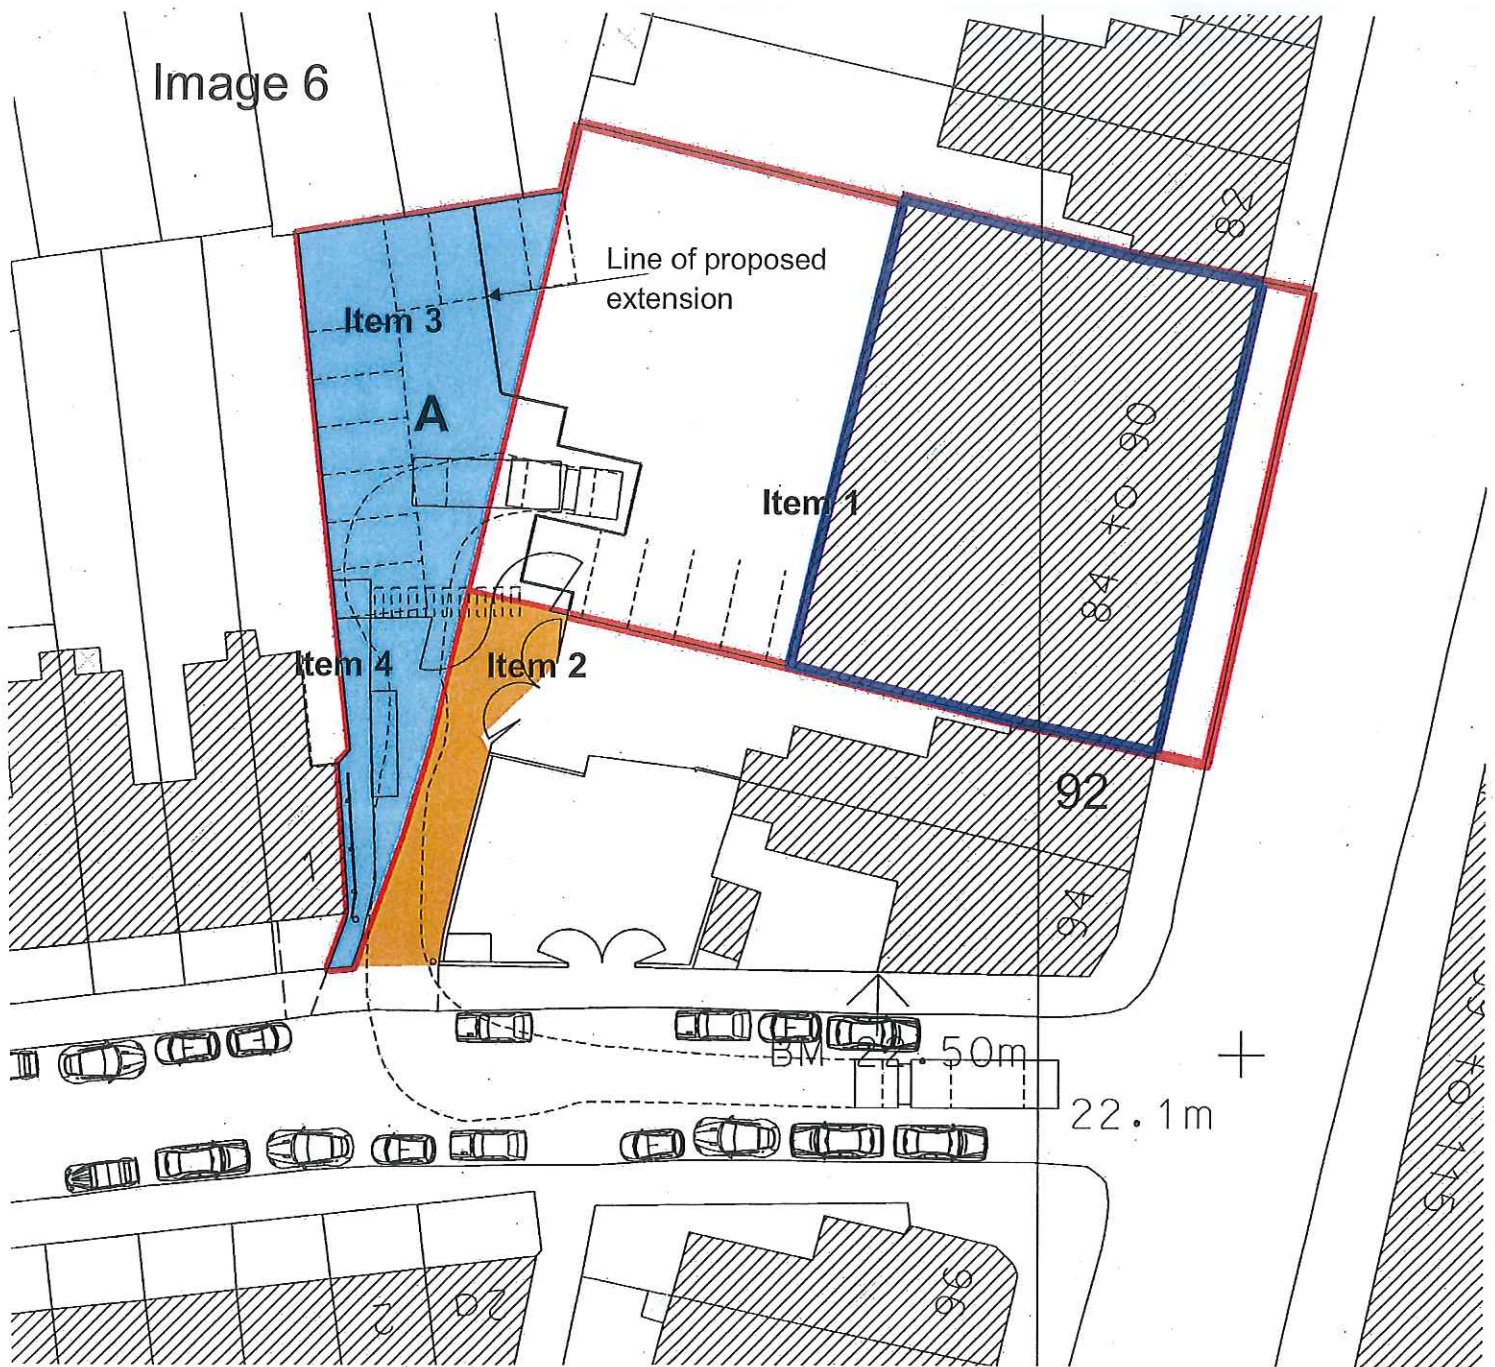
Image 6

3.06 Image6. The existing access to the land marked item 11 edged in red, is via 2 (tinted brown) and through the present gates. There is no right of way granted over land tinted brown (2) to land lettered A (tinted blue). The applicant should provide a design for planning that complies with this legal requirement, and that had been established on older registered titles as discussed in section 3.03. The access to land A by vehicle is only from the rectangular area item 1

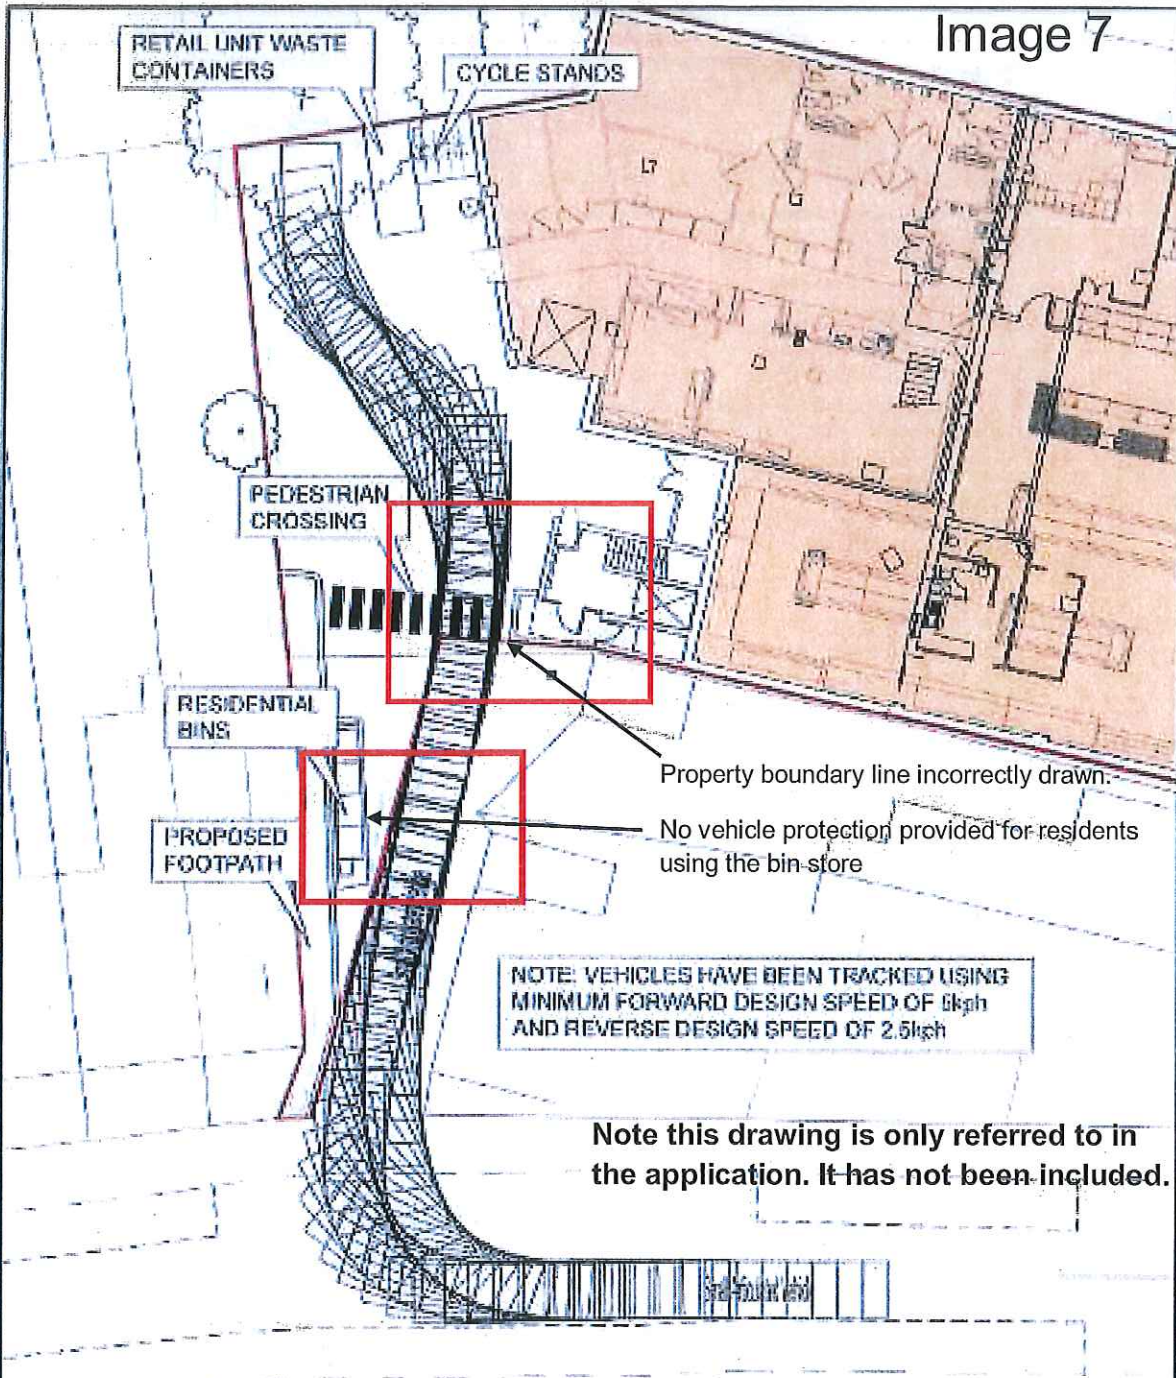
3.07 Image 7 on the next pages shows the current over optimistic swept path. This is only referred to in the application. The red line boundary shown on this drawing is incorrect, The vehicle is shown accessing the parcel of land marked A from tinted brown area, that has no rights of way to, as item 4 recorded in the property register. Ironically the present way the site is accessed is via Melbourne Grove, and this manoeuvre would comply in part with property title restrictions.. The restricted access to the bin stores, and the danger that people face when using them from vehicles hitting them because of the lack of room, has been ignored by the traffic engineers drawings, this will discussed later in the document, section 4 and 8.

Chesterfield Grove				M&S	
Service vehicle swept paths Small Articulated Vehicle (10.7m) Movement 1 - In				SBA <small>Site & Building Assessment</small>

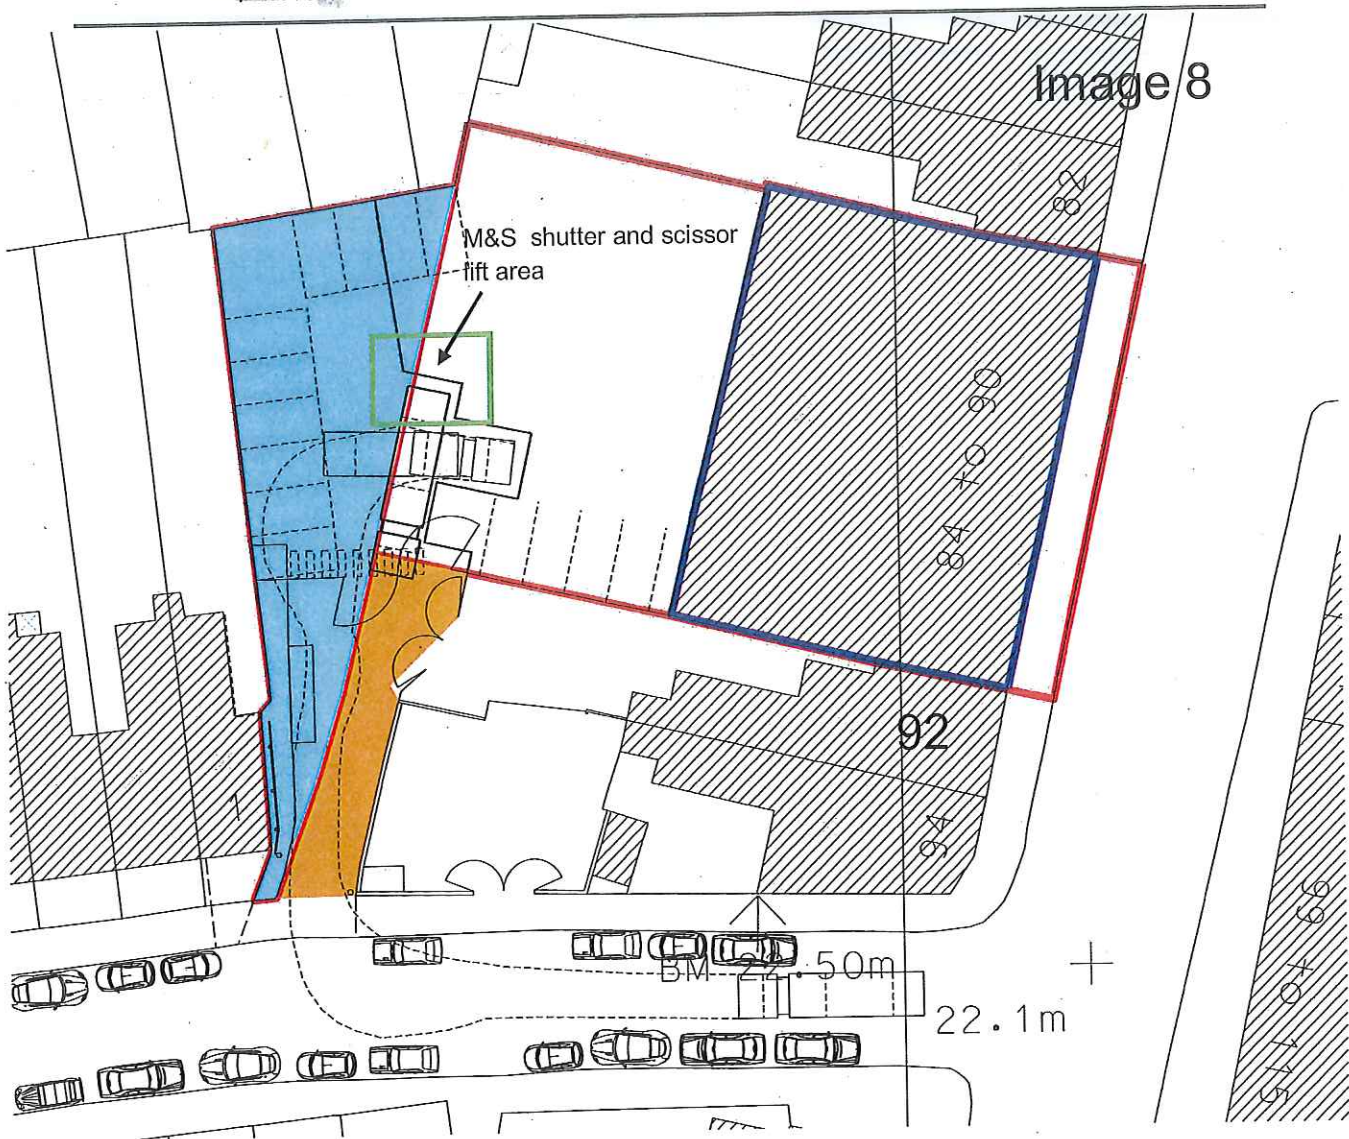
3.07. Image 8 above shows the shutter access to the goods storage. Drawing 1121/P (-) 110 rev P3 notes that there is scissor lift located behind the shutter as required by M&S. For lorry to use this it would have to reverse up to shutter as shown above in image 7. it is noted that vehicle is located such that it blocks access to the flats, and sits on land that only has rights of access over. Also I believe the shutter area is too small to include bollard protection that is an M&S requirement. The architectural drawing should be re-issued to show a vehicle using this shutter with sufficient room for building protection, and not block or endanger residents using the entrance to the flats. To do this would mean the back of house area to the M&S unit would be greatly reduced and no longer fit the store criteria.

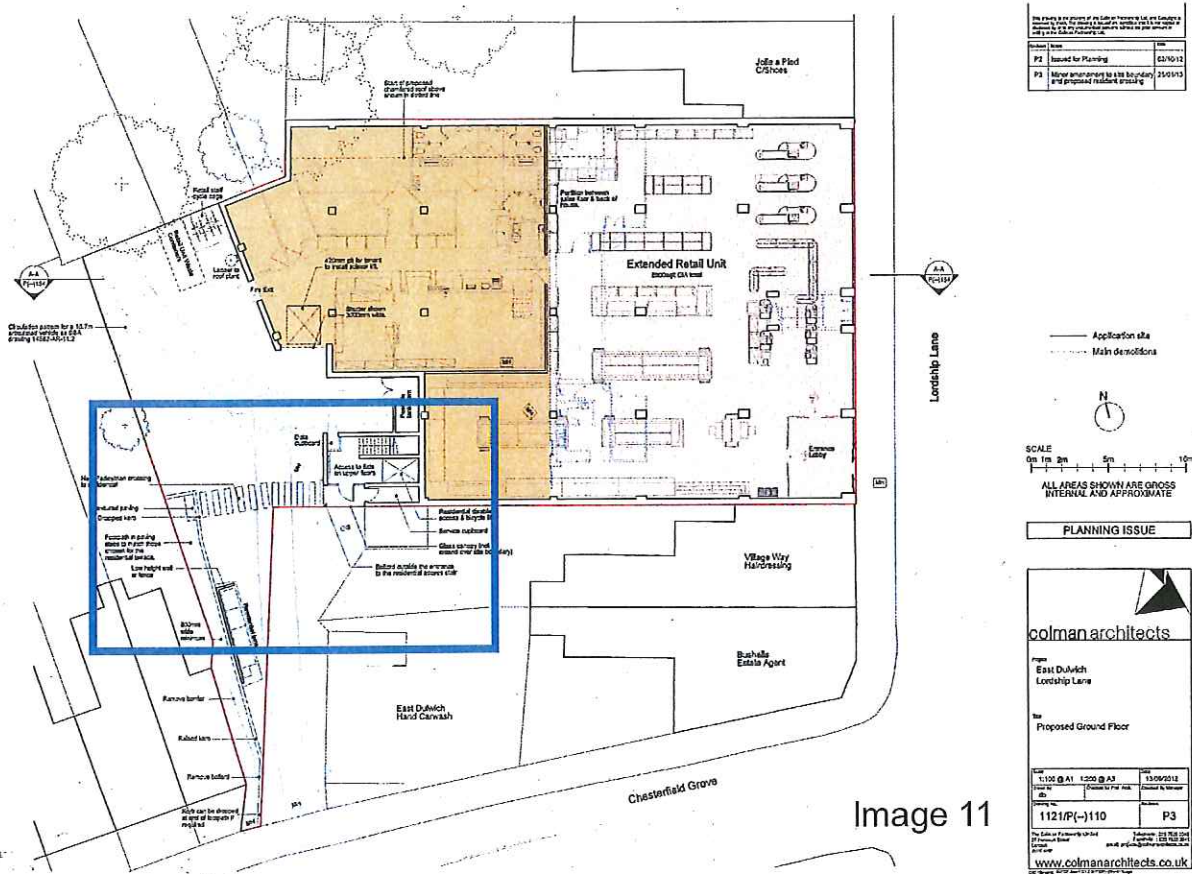
5.02. Drawing 1121/P(-) 110 P2 has the red line property boundary incorrectly shown for 84 to 90 lordship Lane. The applicant has shown works on land that do not own. This has been objected to by the owners of number 92, see section 4.02. Image 11 shows an extract of this drawing below that highlights the error. This drawing should re-issued with the correct title boundary shown on with all items raised in section 4 addressed, as they are mostly to do with title boundaries and rights of way. They must ensure that this drawing reflects accurately the items recorded in the property register for title number SGL 190523, as raised in section 3.

4.02. Item A is an objection to any work being constructed on there land. Drawing 1121/P(-)110 rev P3 (see image 11 on page 17) has been amended from refused application all works is now on the applicants land They also require the entrance of the flats to be located away from their rear vehicle entrance to there property. They consider there is possible risk of residents walking into there entrance and being hit by a car reversing out.

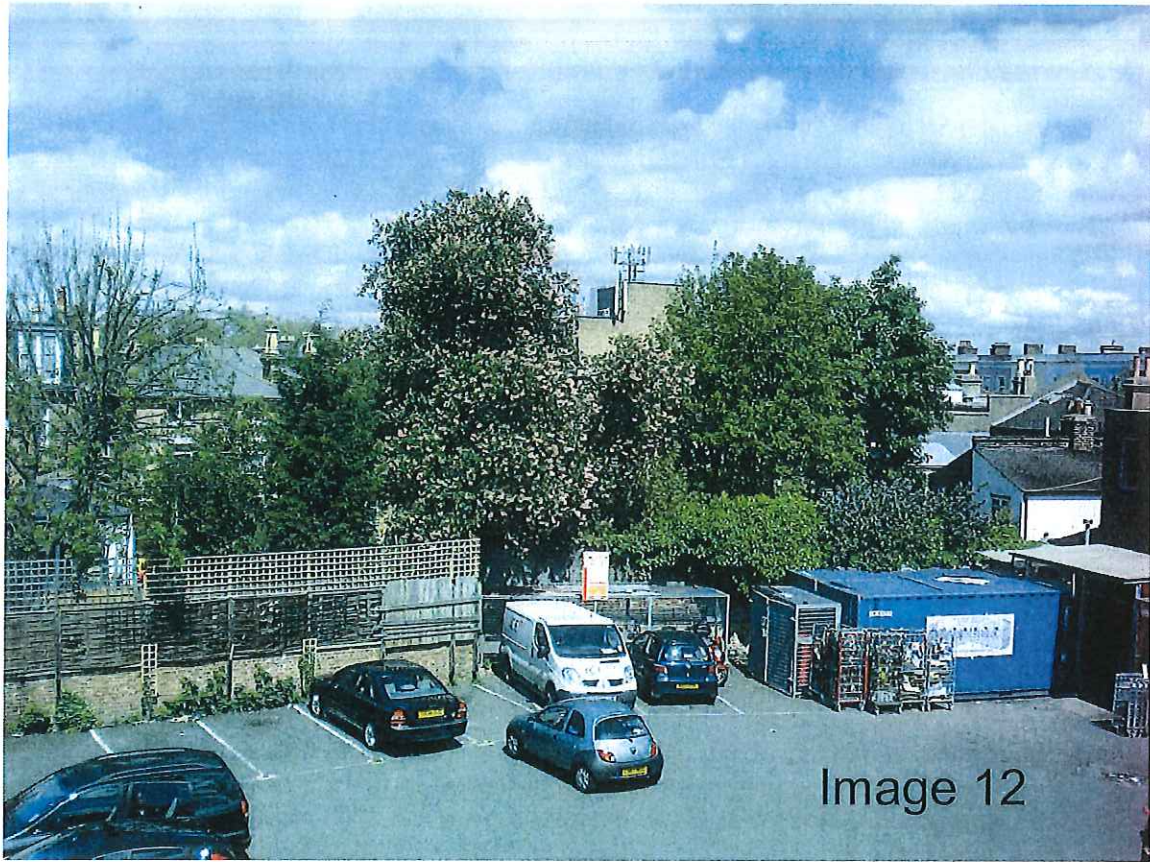
5.04. Image 12 on the next pages shows the northern boundary of this site and a large mature horse chestnut tree, whose canopy extends into the application area. A tree report has been issued generally in accordance with BS 5837:2012 (Tree in relation to Construction). However it critically make no recommendation on how this tree can kept without the construction works affecting it. It appears to consider that the large mature horse chestnut that is located in No 1 Ashbourne Grove garden is not worth saving as it can a have short life span, but they have confirmed it will be effected by the development. If the development is not redesigned it will probably kill the tree and shorten its life span further. The applicant need to readdress this matter and fully respond to BS 5837:2012 and give appropriate recommendation on how not to kill/affect this tree, and the others on the boundary. I would suggest that building is relocated away from the tree routes accordingly.

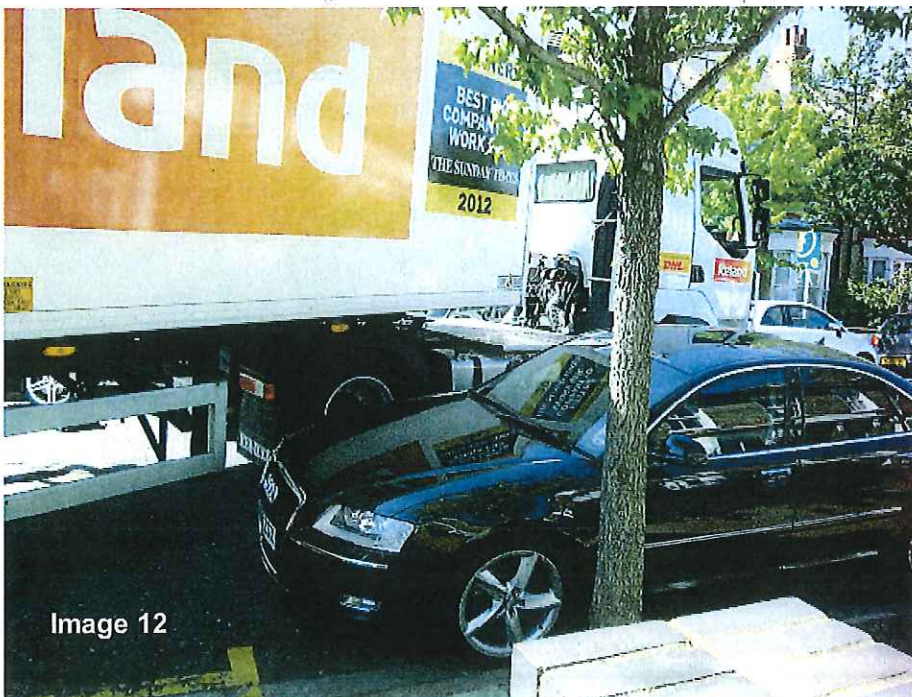
Image1. Shows a vehicle getting stuck as it leaves the site. Note the Audi is legally parked. This picture is taken from the front of No1

6.03. Image 12 to 16 show how lorries leaving the site often get stuck by cars legally parked in the street, and the assistance that is given. Under the road traffic act it is illegal to block the public highway and for the general public to help guide manoeuvring vehicles. This regularly occurs by default because of the existing entrance and the increased pressure of parking places in Chesterfield Grove.

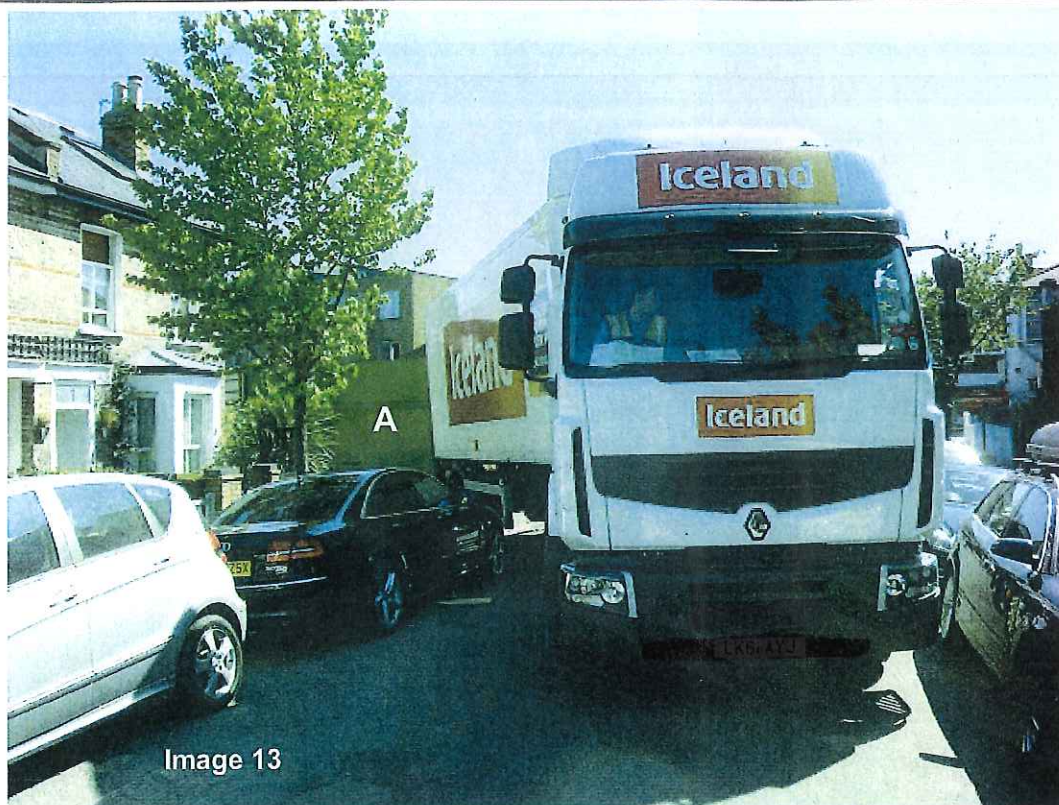
Image 13

Image 13. To get out the driver has to start reversing back towards and onto part of the pavement area, endangering any pedestrian using it. The driver would not be aware of any pedestrians in the area directly behind the trailer.

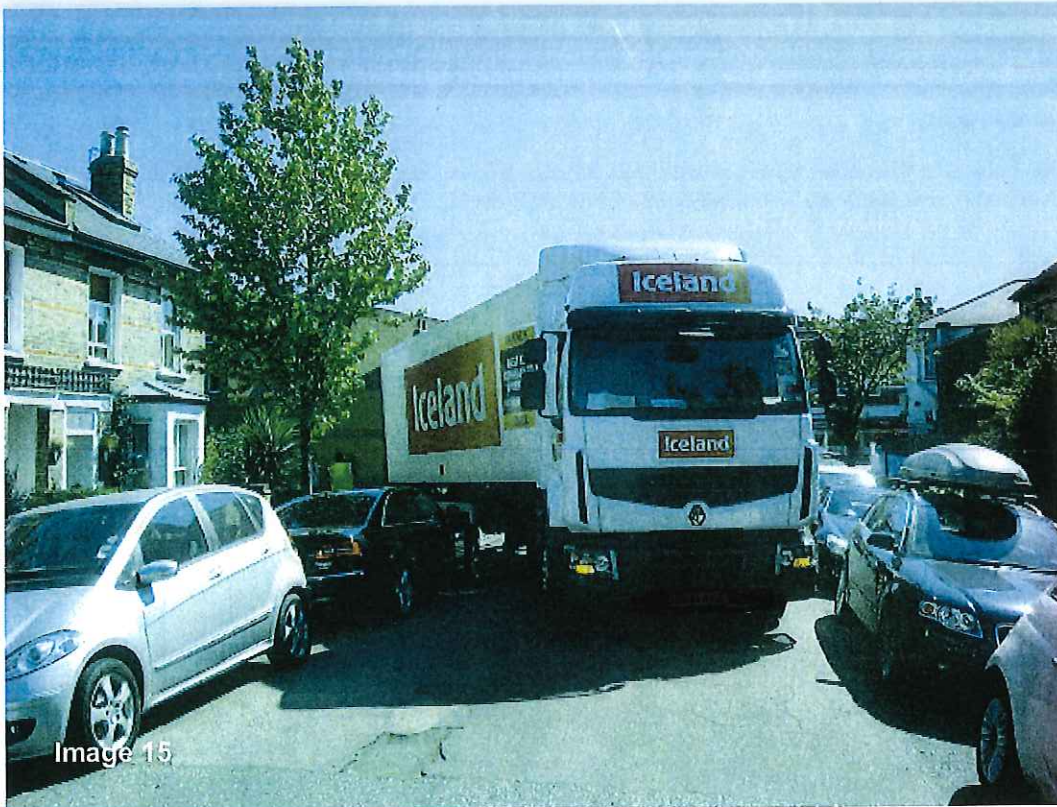
Image 4. To get out the driver has now left his cab to get assistance in reversing from one of the staff from the store. In doing this he has completely blocked Chesterfield Grove, with vehicles backing up to Lordship lane.

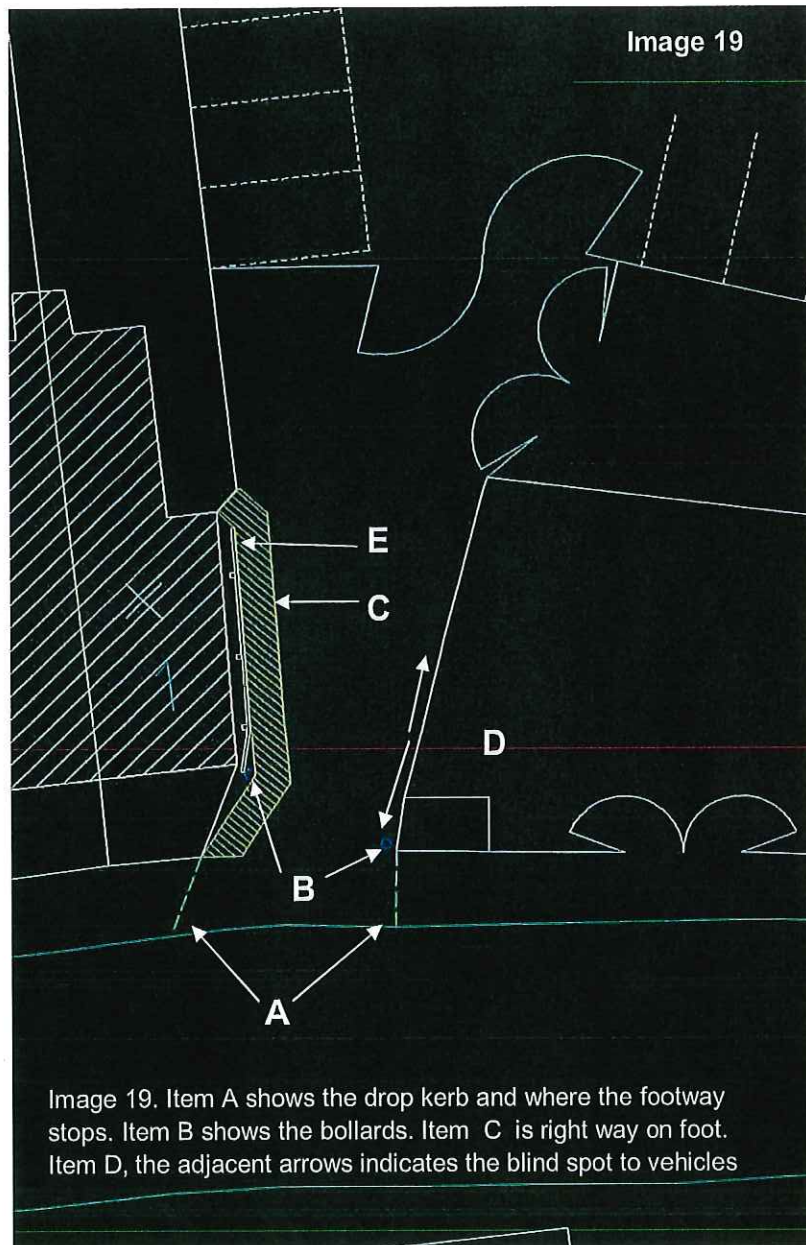
Image 19. Item A shows the drop kerb and where the footway stops. Item B shows the bollards. Item C is right way on foot. Item D, the adjacent arrows indicates the blind spot to vehicles

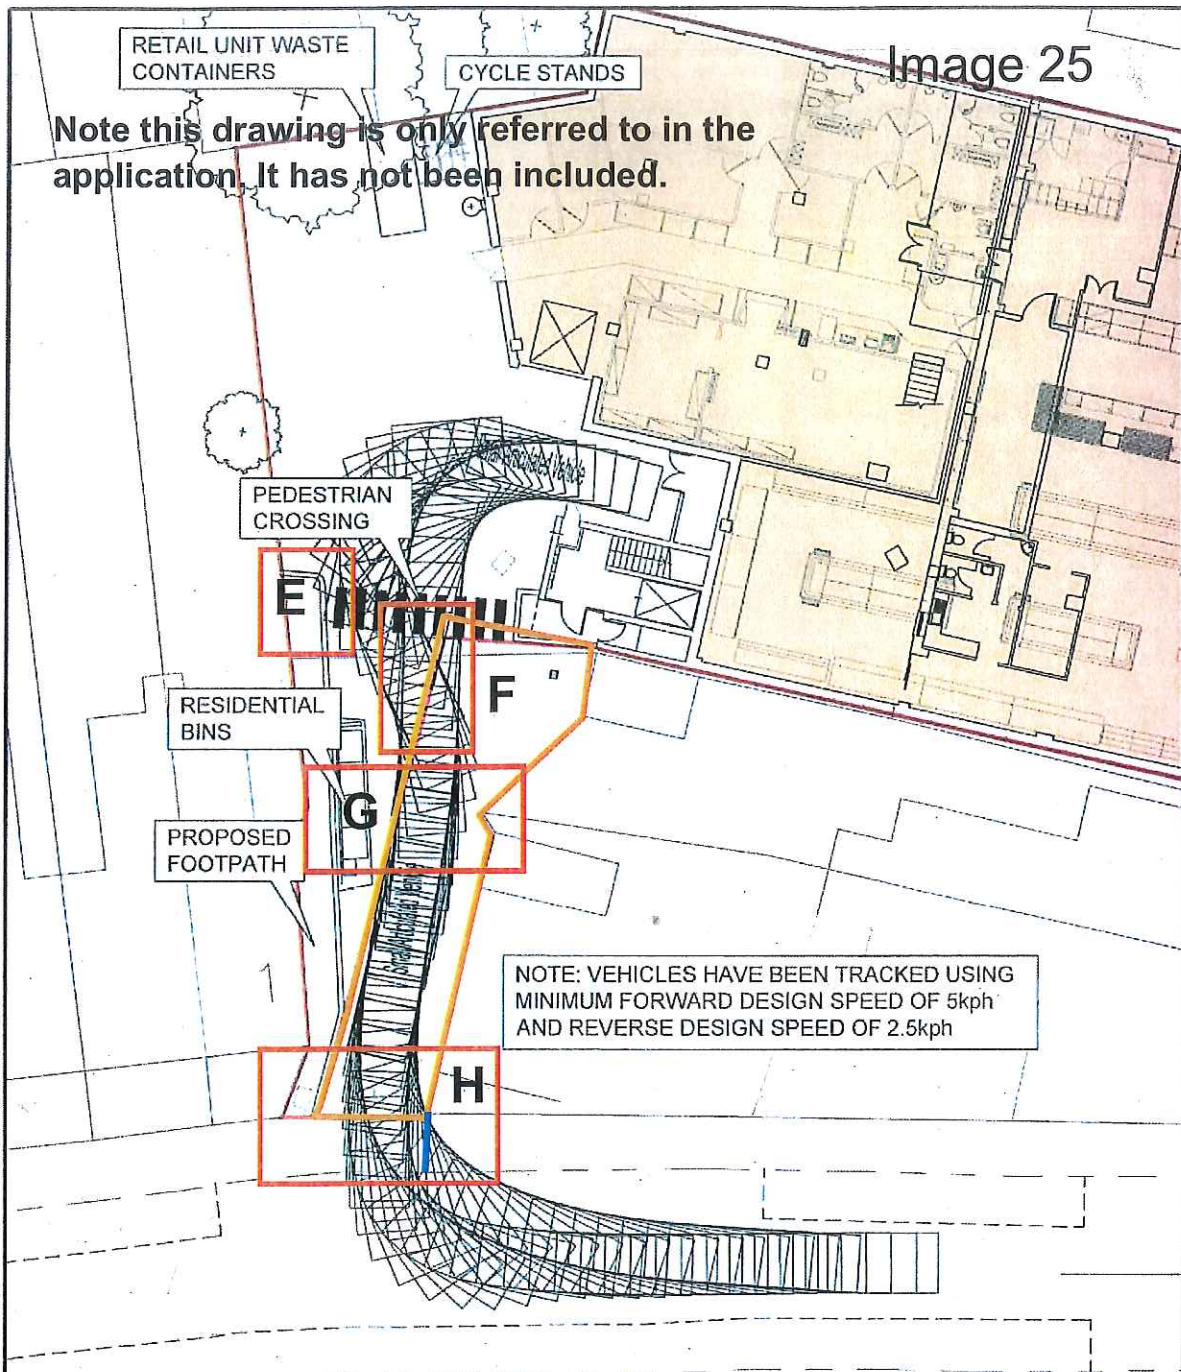
Chesterfield Grove				M&S	
Service vehicle swept paths Small Articulated Vehicle (10.7m) Movement 3 - Out				SBA part of the WYG group

100 St. John Street London EC1M 4EH t: 020 7580 8544 f: 020 7580 5818 e: sba@snaac.co.uk	
DRAWN: DW	CHECKED: AS	DATE: 02.04.2012	SCALE: 1:250 @ A4	DRAWING NUMBER: 14682-AR-11.3	REVISION: E

8.02 In the appendix D there are revised swept path diagrams for service vehicles, I have the same comments on all of them, however I am only going refer to drawings , 14682-AR -11.1 Rev E, 14682-AR -11.3 Rev E, 14682-AR -12.1 Rev D, and 14682-AR -12.2 Rev D. All the manoeuvres show in these drawing are far tighter than the previously withdrawn application, because of the footpath and location of the refuse bin located in the entrance to the site. All the swept paths shown do not comply with the Freight Transport Association 'Designing for Deliveries' who recommend larger manoeuvring areas as a matter of good practice. It is important when designing for deliveries that all drivers are considered in particular the agency ones who have no prior knowledge of the site and often get stuck when using the current entrance. Image 22 shows a more realistic swept path that an agency driver would be comfortable in attempting because of there unfamiliarity with the site.

8.04. Image 25 page 28, comments on Drawing 14682-AR-11.3 Rev E. Item E, it appears that the rear trailer will go over the pedestrian route. It is clear from this drawing that there is insufficient space in the service yard to carry out this manoeuvre. Item F, the ownership boundary is in correct on this drawing. Note the crossing was moved north on drawing 1121/P(- -)110 P03 , and this has reduced the space further for a vehicle and will add to risk of hitting a residents approaching the flat entrance. The brown tinted line shows the access rights that the applicant has, and the vehicle leaving the site does not adhere to this, see section 3. Item G no protection provided to residents using refuse area, more space required by the vehicle when it leaves. Item H, when the vehicle leaves it appears to hit the corner of the property of 94, and then mounts the pavement again, the blue line marks the kerb line.
