Objections and comments on the planning application at 84-90 Lordship Lane London Se22 8HF. Reference 14/AP/0280.

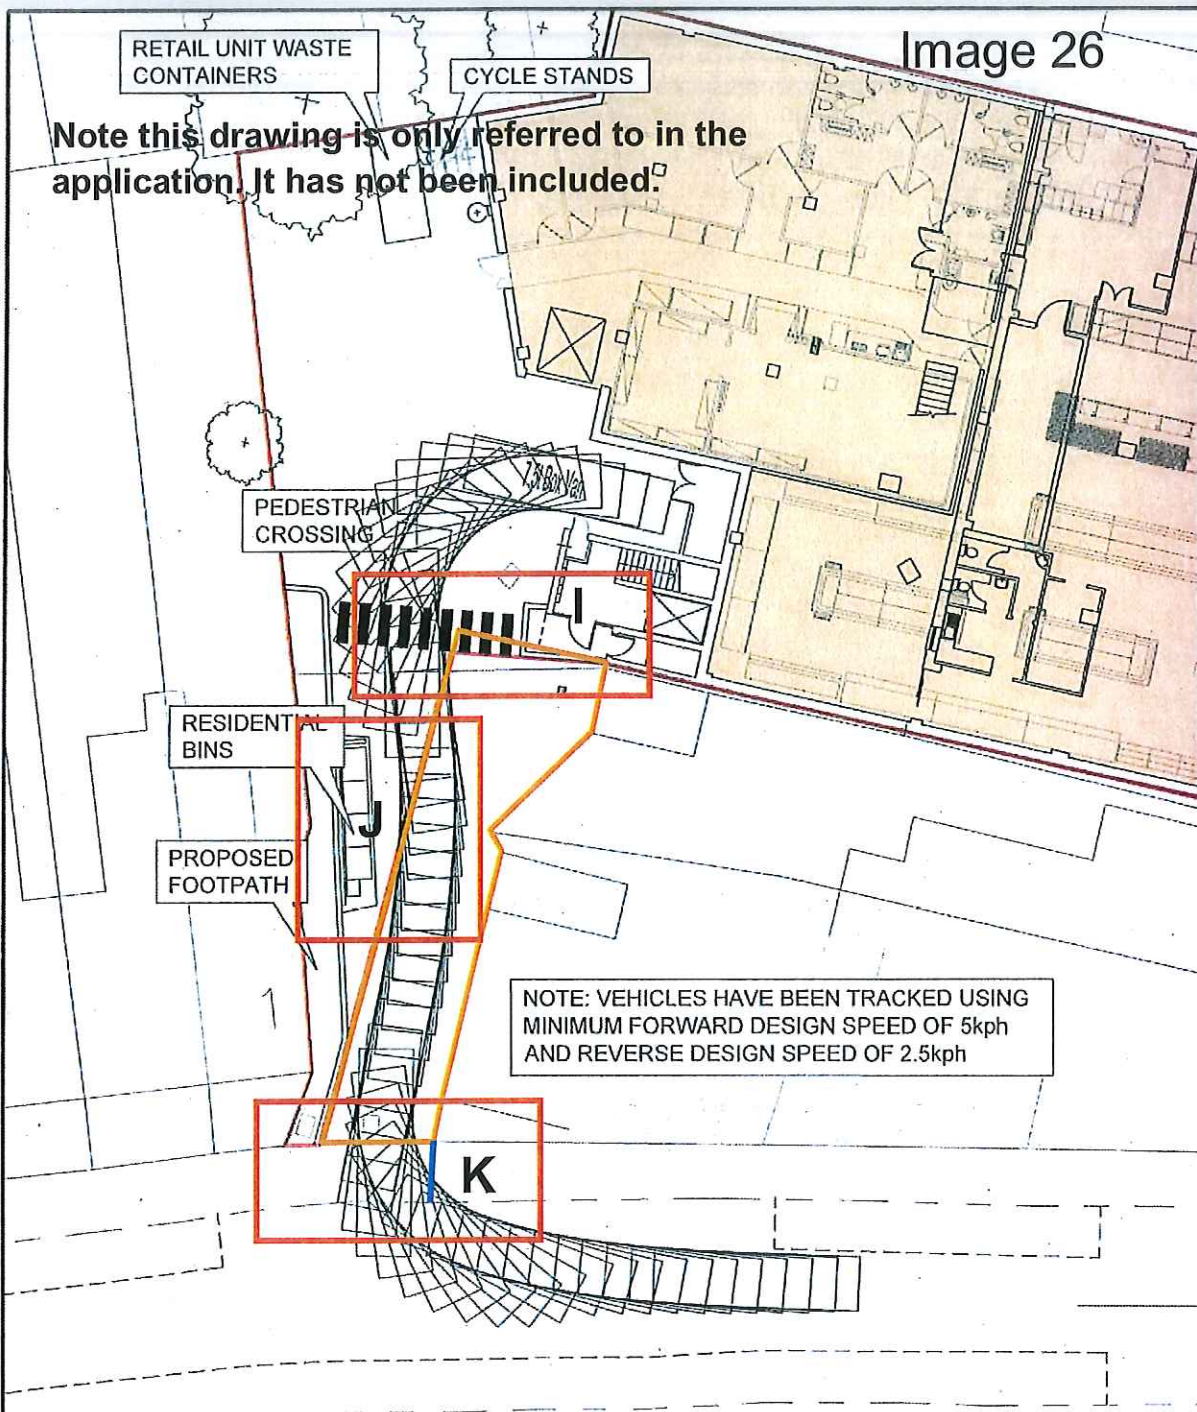
Chesterfield Grove				M&S	
Service vehicle swept paths 7.5t Box Van - Out				SBA part of the WYG group 100 St. John Street London EC1M 4EH t: 020 7550 5811 f: 020 7580 8518 e: sba@sba.co.uk	
DRAWN:	CHECKED:	DATE:	SCALE:	DRAWING NUMBER	REVISION:
DW	AS	02.04.2012	1:250 @ A4	14682-AR-12.2	D

8.02 In the appendix D there are revised swept path diagrams for service vehicles, I have the same comments on all of them, however I am only going refer to drawings , 14682-AR -11.1 Rev E, 14682-AR -11.3 Rev E, 14682-AR -12.1 Rev D, and 14682-AR -12.2 Rev D. All the manoeuvres show in these drawing are far tighter than the previously withdrawn application, because of the footpath and location of the refuse bin located in the entrance to the site. All the swept paths shown do not comply with the Freight Transport Association 'Designing for Deliveries' who recommend larger manoeuvring areas as a matter of good practice. It is important when designing for deliveries that all drivers are considered in particular the agency ones who have no prior knowledge of the site and often get stuck when using the current entrance. Image 22 shows a more realistic swept path that an agency driver would be comfortable in attempting because of there unfamiliarity with the site.

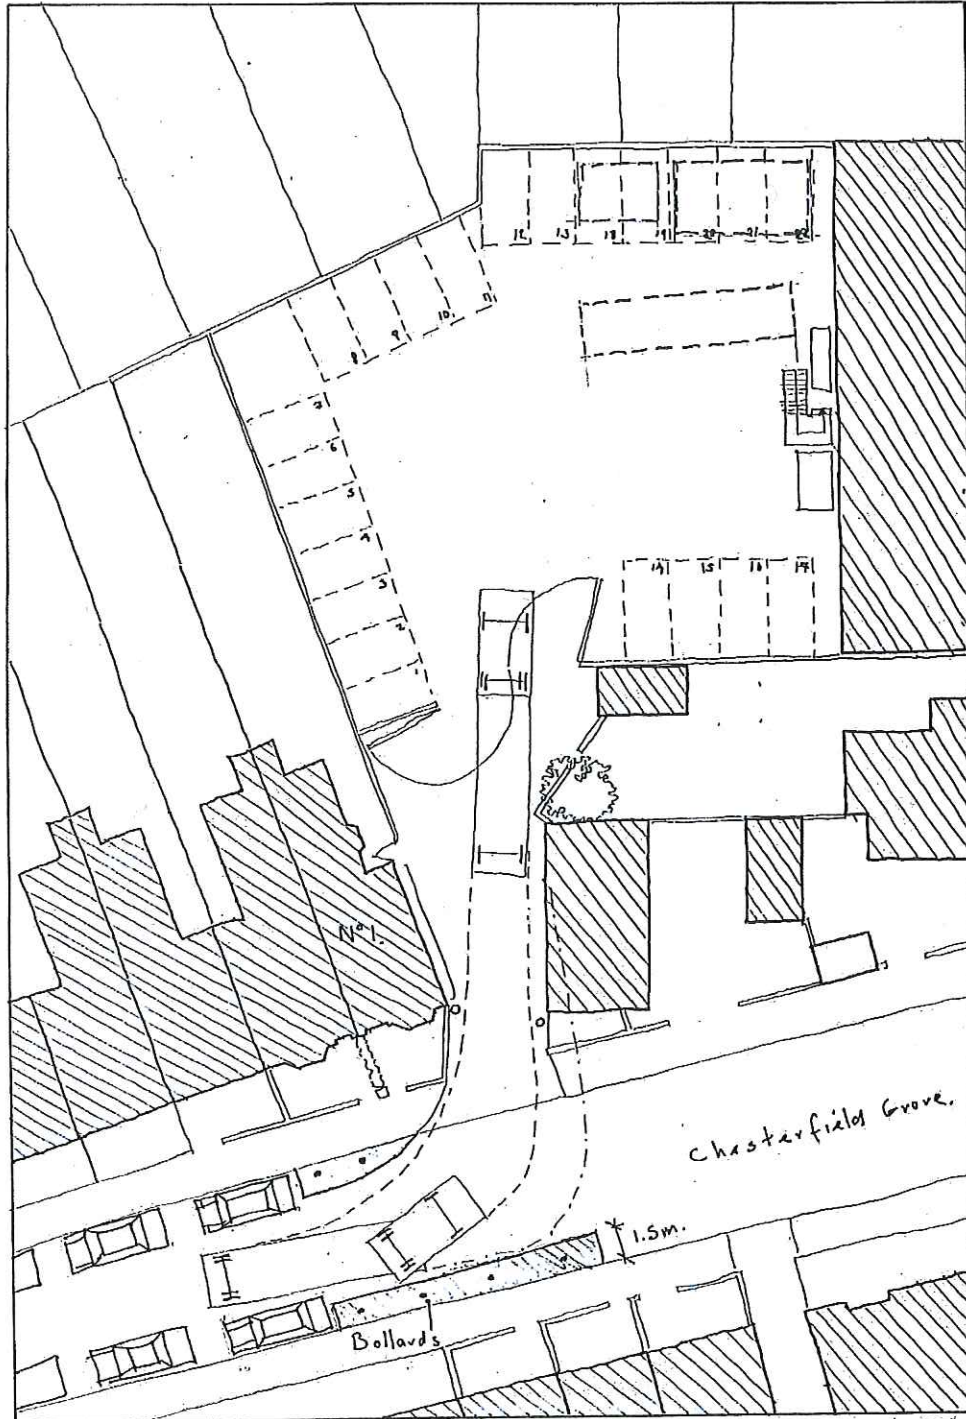
Diagram 3.

Access could be improved, by extending the pavement with bollards, to maintain clear access at all times. Note this would also provide some protection to the house south on Chesterfield Grove.
