London Borough of Southwark

June 2014

Mint Street Park, Southwark Stage 1/2 Road Safety Audit

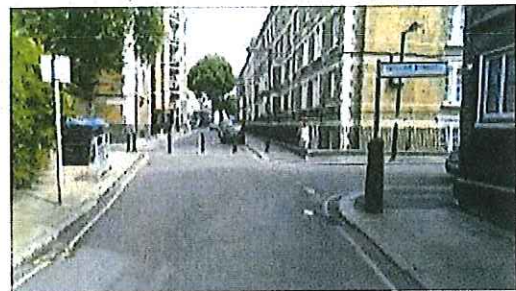
Problem: 3.1

Location: Mint Street / Weller Street

Summary: Removal of vehicle turning head could result in large vehicles having to reverse long distances risking collisions with vehicles and pedestrians.

The hammerhead at the northern end of Mint Street is to be converted to park land. The proposals would remove the turning head facility at this end. Large vehicles such as refuse or delivery vehicles will have to use a smaller area to reverse out of Mint Street into Weller Street. Whilst it is acknowledged that parking bays on Weller Street have been removed to facilitate turning movements it is unclear from the proposals whether this will provide sufficient space for the types of vehicle expected to use this road. The reduced turning facility may result in large vehicles having to reverse down Weller Street risking collisions with other vehicles, cyclists or pedestrians, particularly children who were observed to be using the road carriageway to approach the park.

Undertake a swept path exercise to demonstrate the suitability of the turning facility at the junction with Weller Street. Provide a turning head suitable for the likely type of vehicles that would serve the properties on Mint Street.

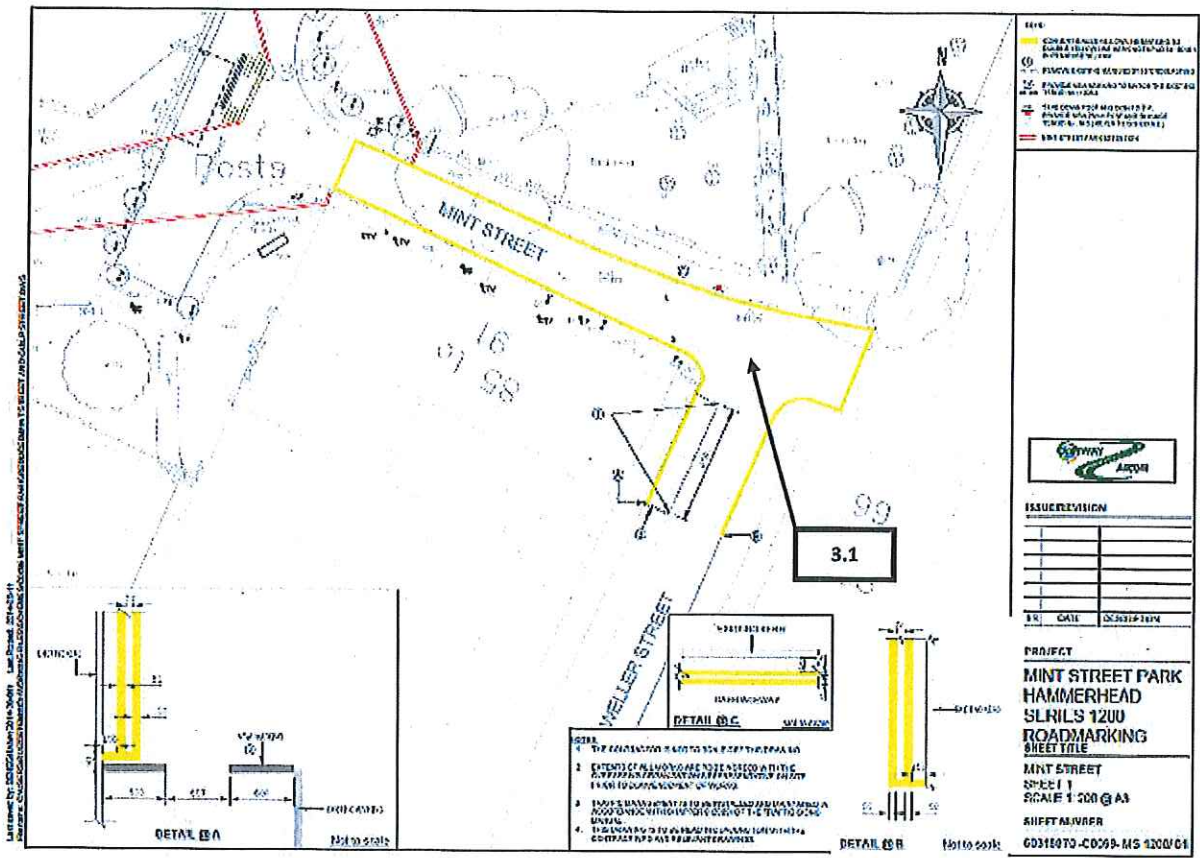
Appendix B – Location of Problems Drawing

- 1.1.12 The locations of problems are shown in conjunction with the scheme proposals in Appendix B where the reference numbers relate to the problems identified in this report.
