Dulwich Village Junction Review

November 2015

1. Introduction

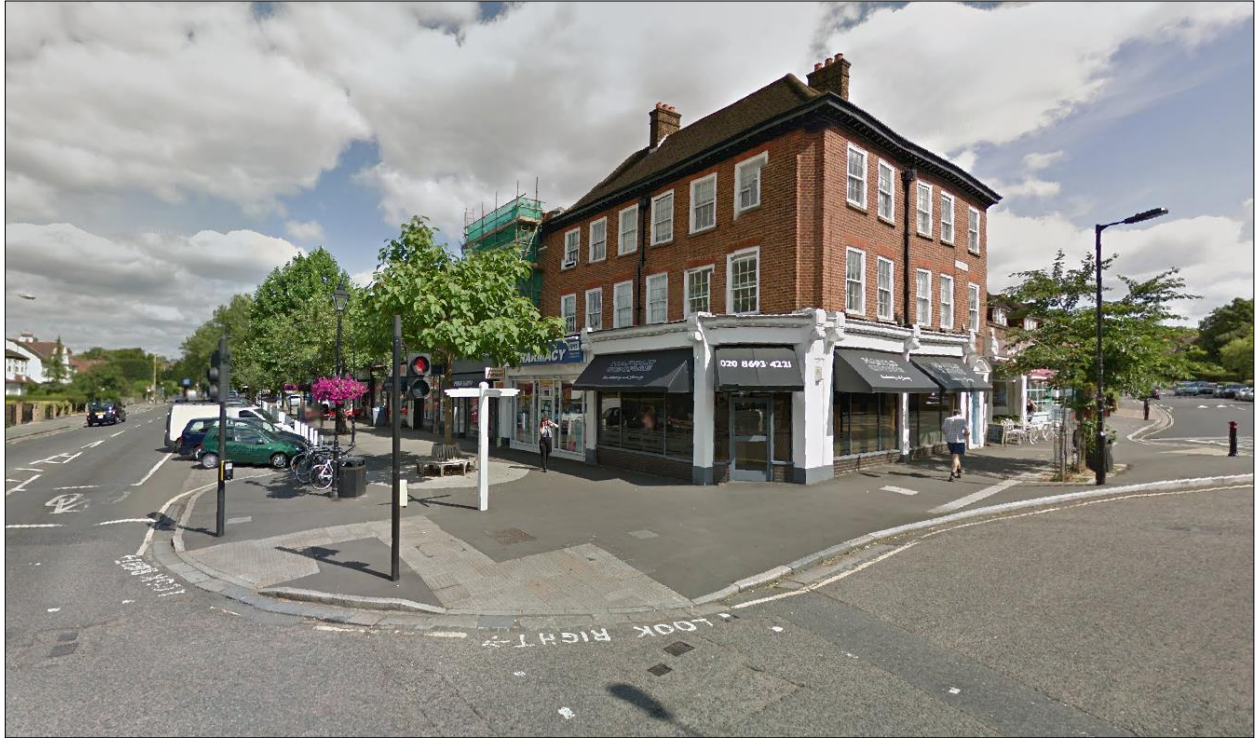
Figure 2.2: Intersection of Dulwich Village & Calton Avenue, looking north

Dulwich Village, to the north of the junction, is a village high street with retail premises making up much of the eastern frontage (see **Figure 2.2**, below). The western frontage is flanked by residential property and Dulwich Village Church of England Infants School, which is located on the corner of Dulwich Village and Turney Road.

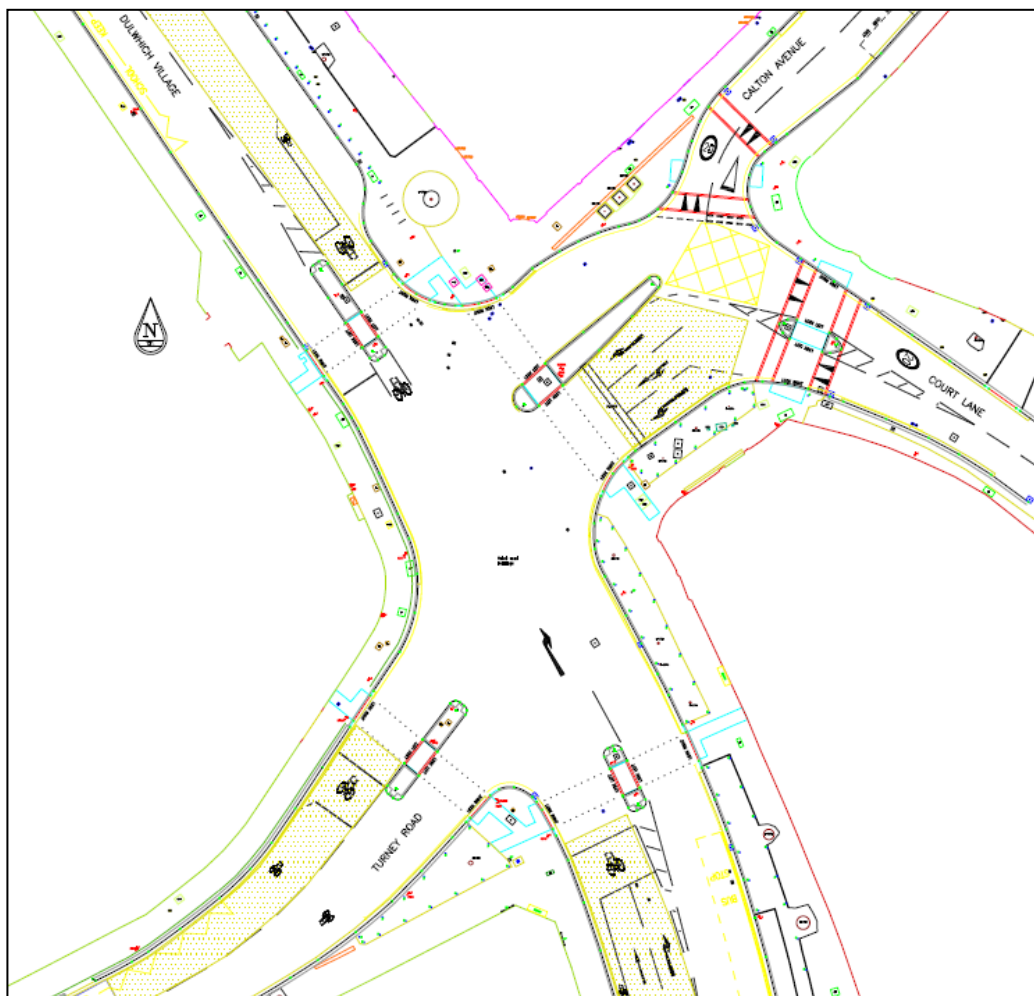
Figure 3.1: Topographical Survey of Junction

A topographical survey has been undertaken at the junction to record the existing layout. This is shown in **Drawing No.SWN-TOPO-401** (see **Figure 3.1**, below). The main junction is configured as a four arm crossroads controlled by traffic signals, however an uncontrolled intersection between Calton Avenue and Court Lane exists 20m east of the junction. For the purposes of this report the extent of the junction under review will include the Court Lane / Calton Avenue intersection, particularly given its location on the proposed cycle Quietway.

The northern arm (Dulwich Village) is marked as one lane in each direction. The southbound lane comprises of a 4.75m wide traffic lane which narrows to just over 3m at a point 11m in advance of the vehicular stop line. This is to accommodate a mandatory cycle feeder lane to an advance cycle stop line. An area of echelon parking approximately 15 bays in length also exists adjacent to the retail premises. All vehicle movements are currently permitted from the southbound lane. Right

turning traffic is opposed and waits in the centre of the junction away from traffic proceeding south and / or turning left.

The southern arm of the junction (Dulwich Village) contains a single southbound lane of 6m, which narrows to 3.2m as it passes a bus stop 15m south of the junction. A single northbound traffic lane exists, with an offside flare lane beginning 20m in advance of the vehicular stop line. Ahead and left-turning vehicles occupy the 3.1m wide nearside lane. The offside flare lane is 2.75m wide and is used by right-turning vehicles into Calton Avenue. All vehicle movements are permitted from the southern arm and there is sufficient space in the centre of the junction to accommodate right-turning vehicles without obstructing other movements.

The western arm, Turney Road, is marked with a single 6m wide lane in each direction. However given the wide inbound lane, it was noted that right turning vehicles occasionally use the offside space as an unofficial flare depending on how preceding vehicles are positioned at the stop line. All movements are permitted from the side road and, as with the northern and southern arms, there is sufficient space in the centre of the junction for right turning vehicles to wait for gaps without obstructing other movements.

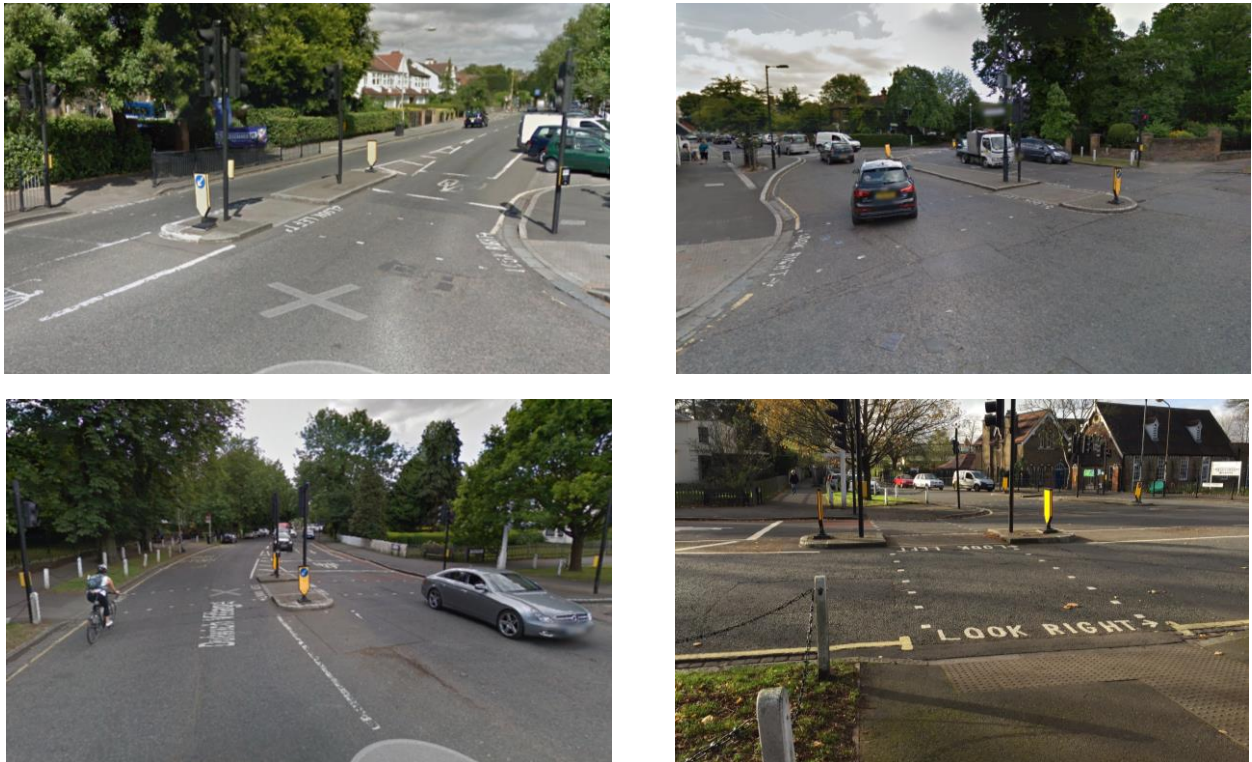
Figure 3.3: Controlled Pedestrian Crossing Arms (Clockwise from top left: Dulwich Village North, Calton Avenue, Dulwich Village South, Turney Road)

Controlled pedestrian crossing facilities exist on all arms of the junction. The layouts of the crossings are similar in that each crossing is between 2.6 and 3.0m wide and has a central refuge island that houses signal equipment and other street furniture. The crossing movements on all arms are undertaken in one phase during an 'all red' stage for vehicles, provided at least one of the four crossings is called. Pedestrian green time varies according to the combination of crossings activated. All four controlled crossings appear DA compliant and benefit from dropped kerbs, shallow footway gradients, and include the standard tactile paving configuration. **Figure 3.3** shows photographs of the crossing layouts.

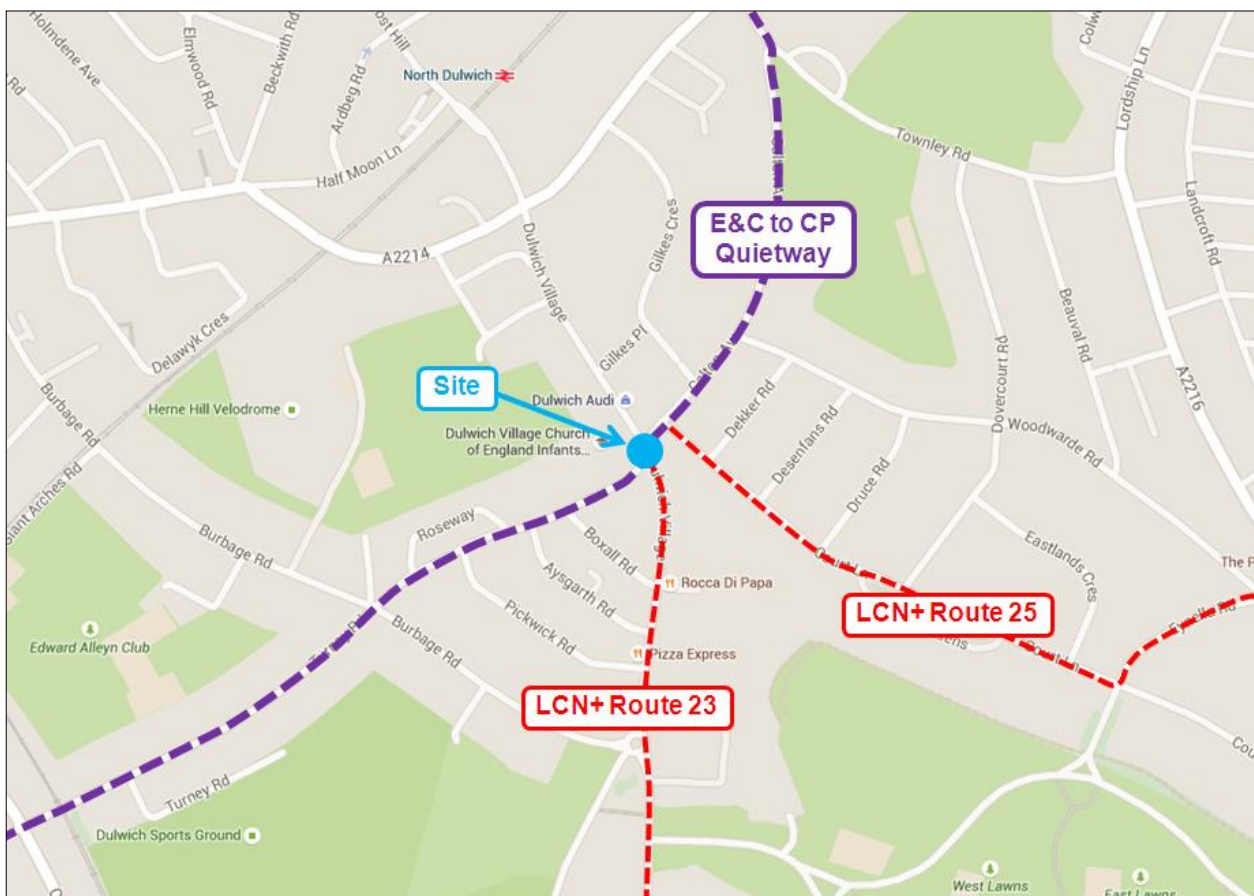
Figure 3.4: Existing Cycle Routes

Several designated cycle routes are provided in the locality, a summary of which is shown in **Figure 3.4**, below. In terms of the provision of cycle infrastructure, both the northern and southern arms (Dulwich Village) feature 5.0m advance stop lines and 1.5m wide mandatory cycle feeder lanes, although it was noted that entry into the advance stop line to the north of the junction was often obstructed by parked vehicles overhanging the echelon bays. Turney Road also features an advance stop line but without a feeder lane. There are no cycle facilities on the eastern arm (Calton Avenue). Facilities to enable cyclists to transverse the cycle Quietway are therefore limited, as are facilities to enable cyclists to access the Quietway from the northern and southern arms.

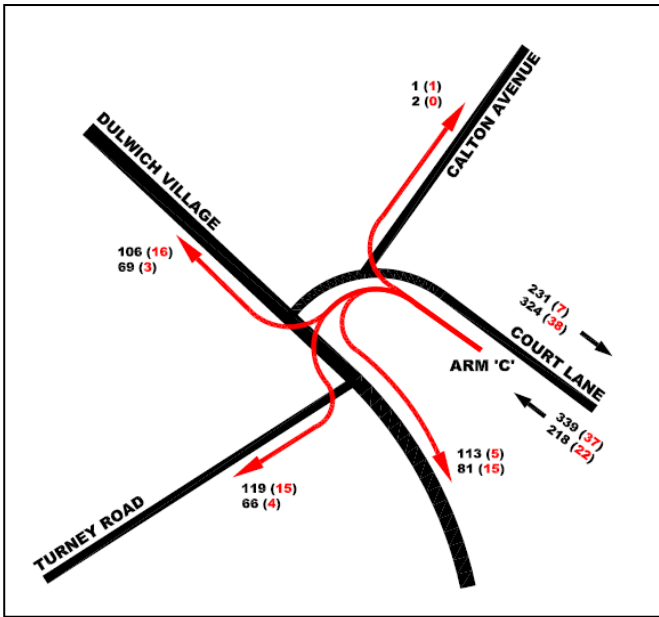
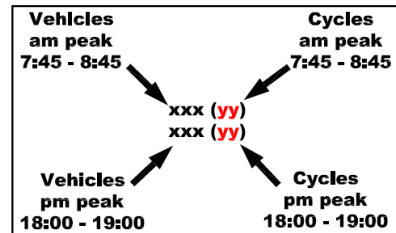
Figure 3.9: Origin & Destination Survey – Court Lane Arm

A summary of the origin and destination of vehicles entering the junction from Court Lane is shown in **Figure 3.9**, below:

Traffic on Court Lane is split equally between the AM and PM peak hours, with total bi-directional flow of about 600 vehicles recorded for each period. Cyclists make up about 10% of movements. Traffic entering the junction from Court Lane is roughly distributed equally amongst the three arms, with a very small proportion turning right in to Calton Avenue in advance of the signals.

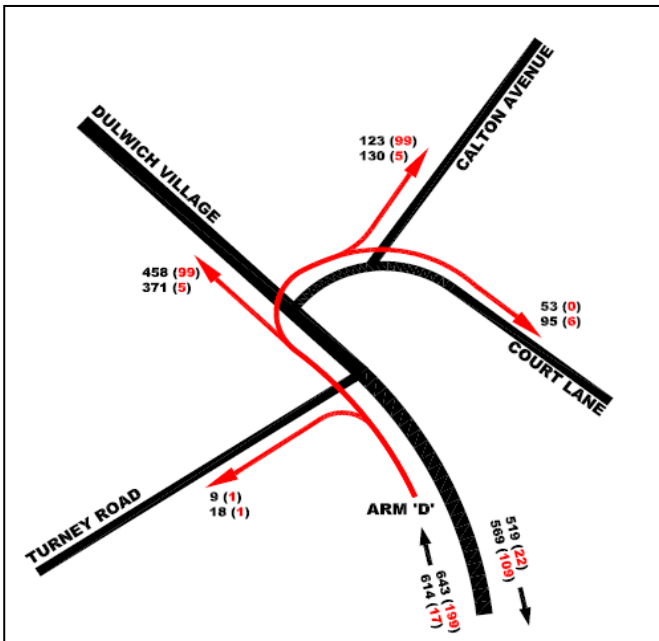
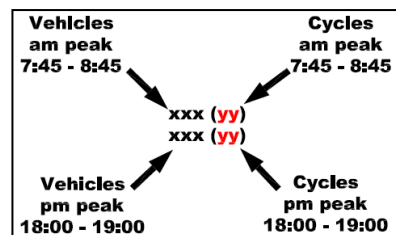
Figure 3.10: Origin & Destination Survey – Dulwich Village South Arm

A summary of the origin and destination of vehicles entering the junction from Dulwich Village South is shown in **Figure 3.10**, below:

Vehicle flows on Dulwich Village South are of an equal distribution during both the AM and PM peak hours. Cycle flows however, are more tidal, making up 24% of total northbound traffic during

the AM peak hour. Similarly, during the PM peak hour, cycles comprise approximately 16% of total southbound traffic.

In terms of the distribution of vehicles throughout the AM peak hour, about 65% of traffic entering the junction from the southern arm continues northbound to Dulwich Village, whilst 26% undertake the right turn into Calton Avenue, interestingly of which cyclists comprise 45%. 6% of traffic makes the right turn into Court Lane, and only a handful execute the left turn in to Turney Road.

Distribution of traffic during the PM peak hour is similar, with 60% continuing to Dulwich Village North, 21% to Calton Avenue, 16% to Court Lane, and 3% to Turney Road.

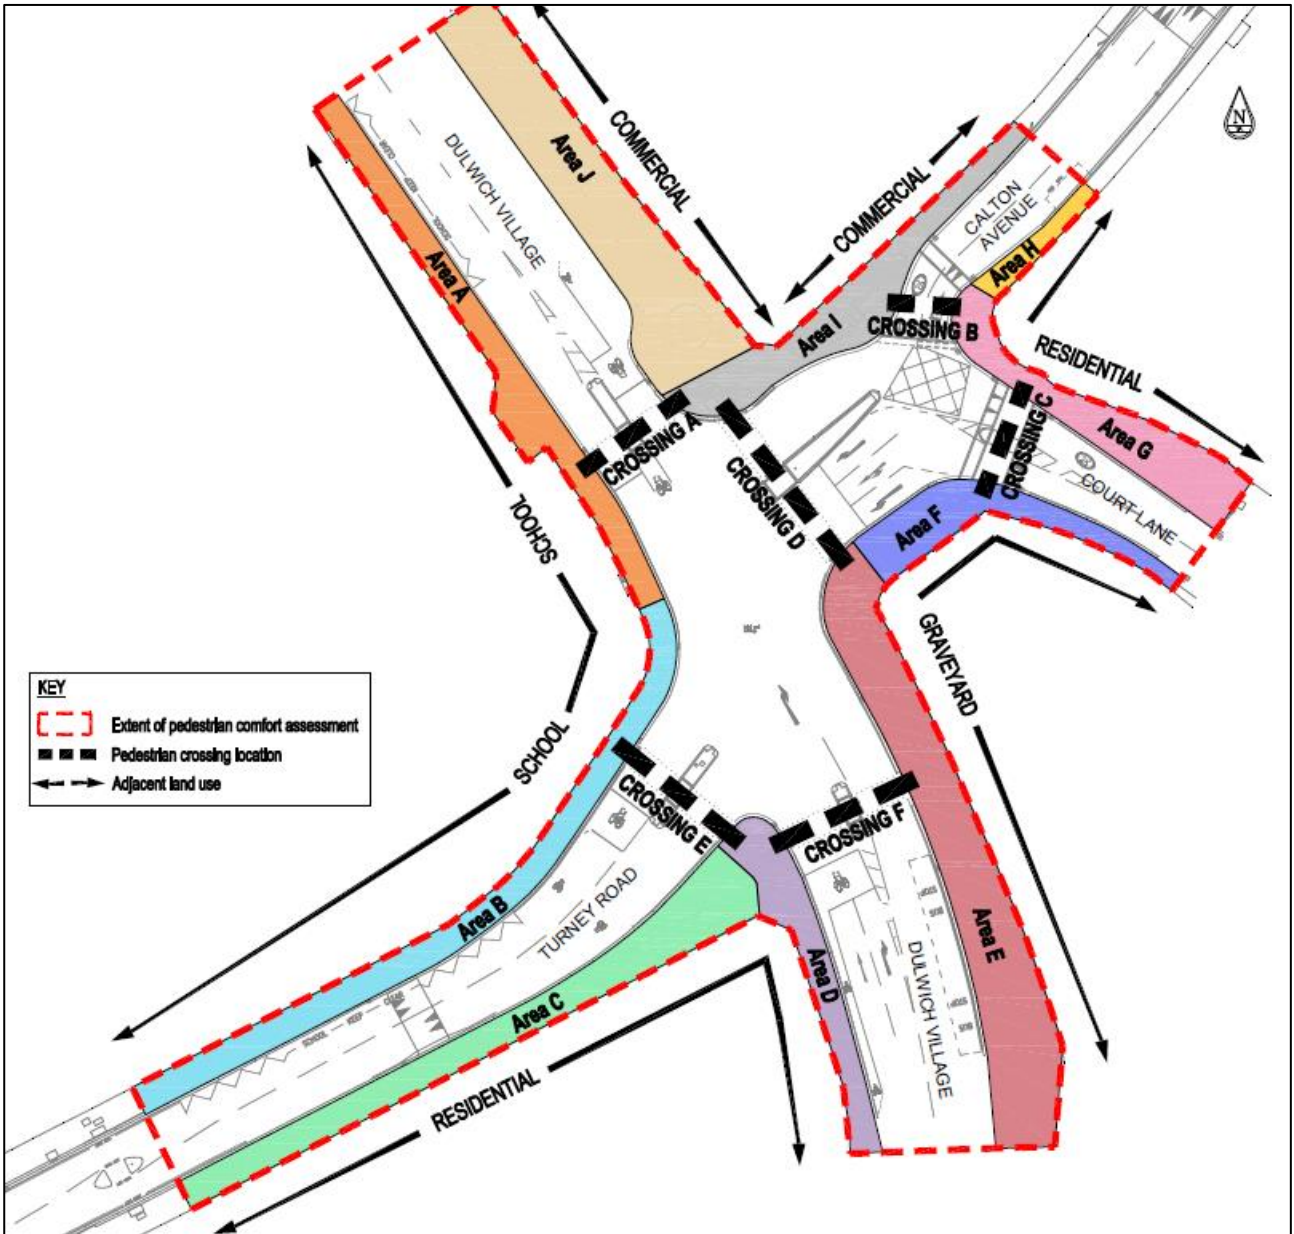
Figure 3.14: Footway Areas, Crossing Locations, and Adjacent Land Use

A Pedestrian Comfort Assessment (PCA) was undertaken in February 2015. The PCA forms part of wider pedestrian guidance produced by TfL that intends to improve pedestrian environments in London through appropriate footway assessment and provision. At Dulwich Village a PCA has been used to establish whether the existing footways and crossings are suitable for the level of pedestrian volume and type of users. The footways were divided into 10 parts which were

considered to have different characteristics as shown in **Figure 3.14**, below, in order to establish a PCA rating for each footway area:

The survey shows that the footways adjacent to the Dulwich Village C of E Infant School (Areas A & B) receive very poor Pedestrian Comfort Level (PCL) ratings. Area G on Court Lane also achieves an F rating. All other footways in the area are able to comfortably accommodate the peak hour footfall.

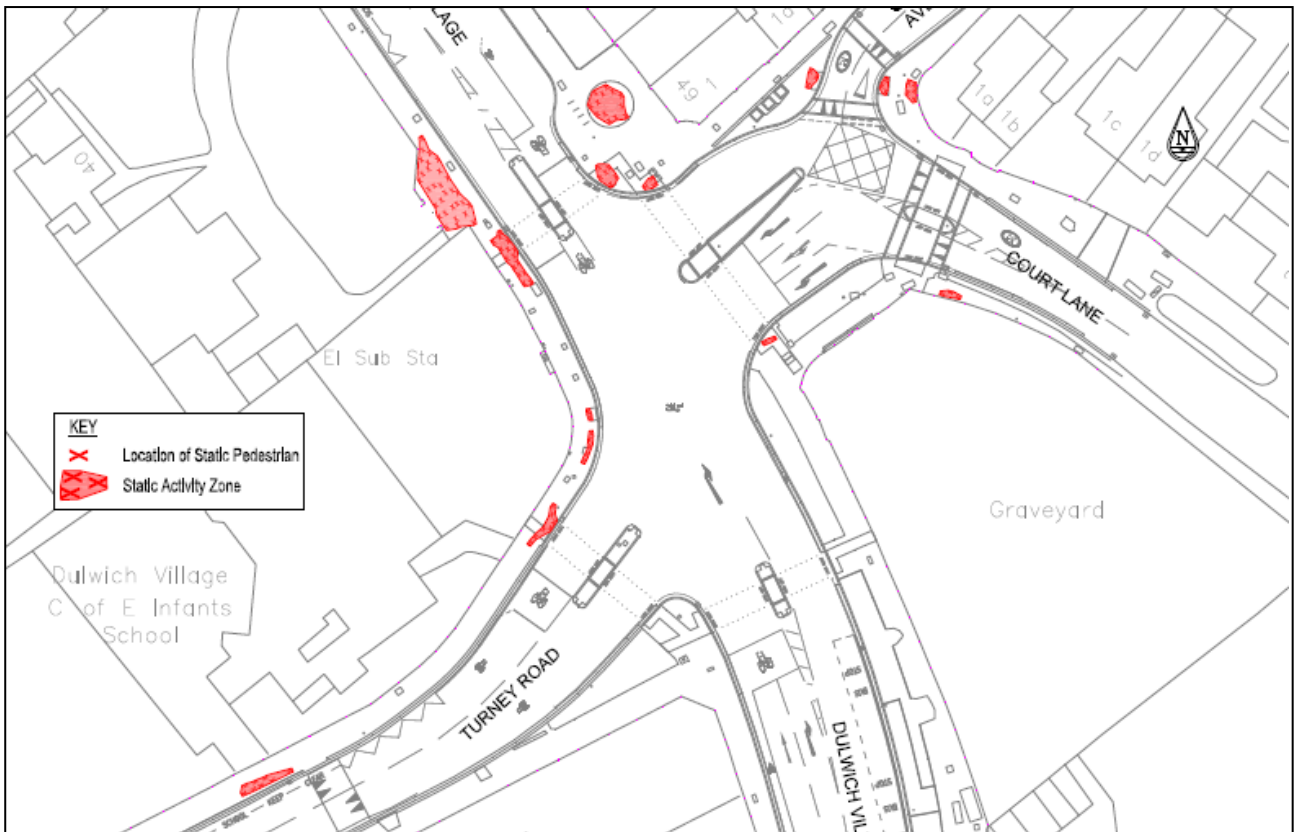
Figure 3.17: Static Activity Survey, February 2015

As part of the pedestrian comfort assessment, a static activity survey was also undertaken to establish those areas in which pedestrians tended to congregate. The results are shown in **Figure 3.17**, below:

The results show high static activity around the infant school entrances and the controlled crossing from Calton Avenue (Crossing A). Pedestrian congregation also tended to occur around the seating on the corner of Dulwich Village and Calton Avenue, and the uncontrolled crossing to the north of the site. It was noted that static activity around the frontage of the infant school was particularly obstructive to pedestrian flow owing to the narrow footway and pedestrian guard railing.

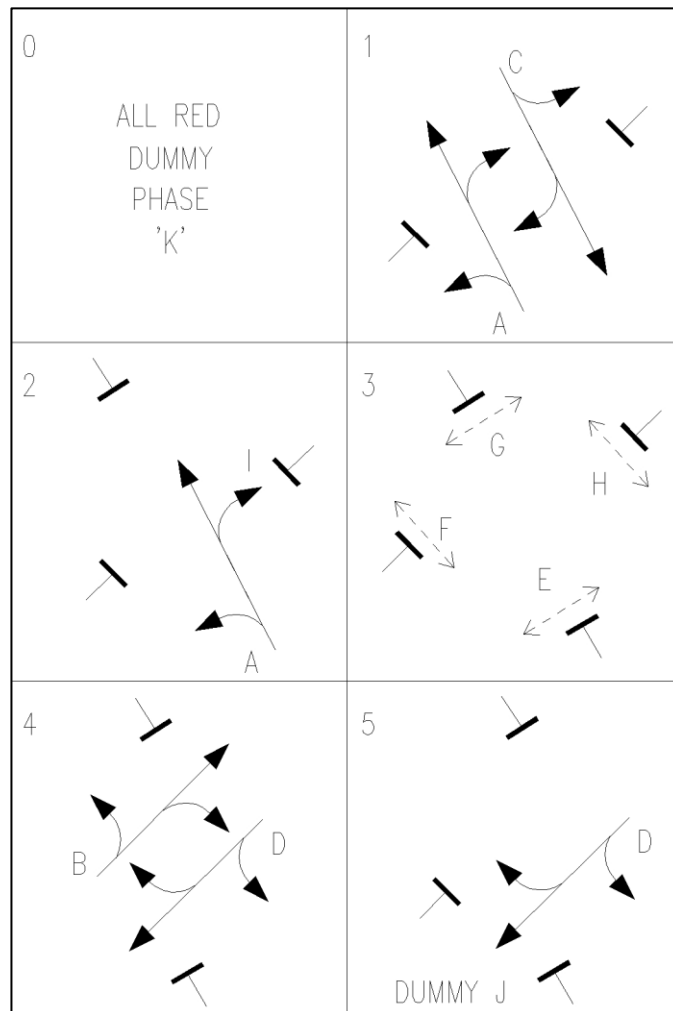
Figure 3.20: Existing Phasing Arrangement

The existing traffic signal timing sheets are contained in **Appendix A**. The current phase arrangement is shown below in **Figure 3.20**, while the existing minimum phase intergreens are shown in **Figure 3.21**.

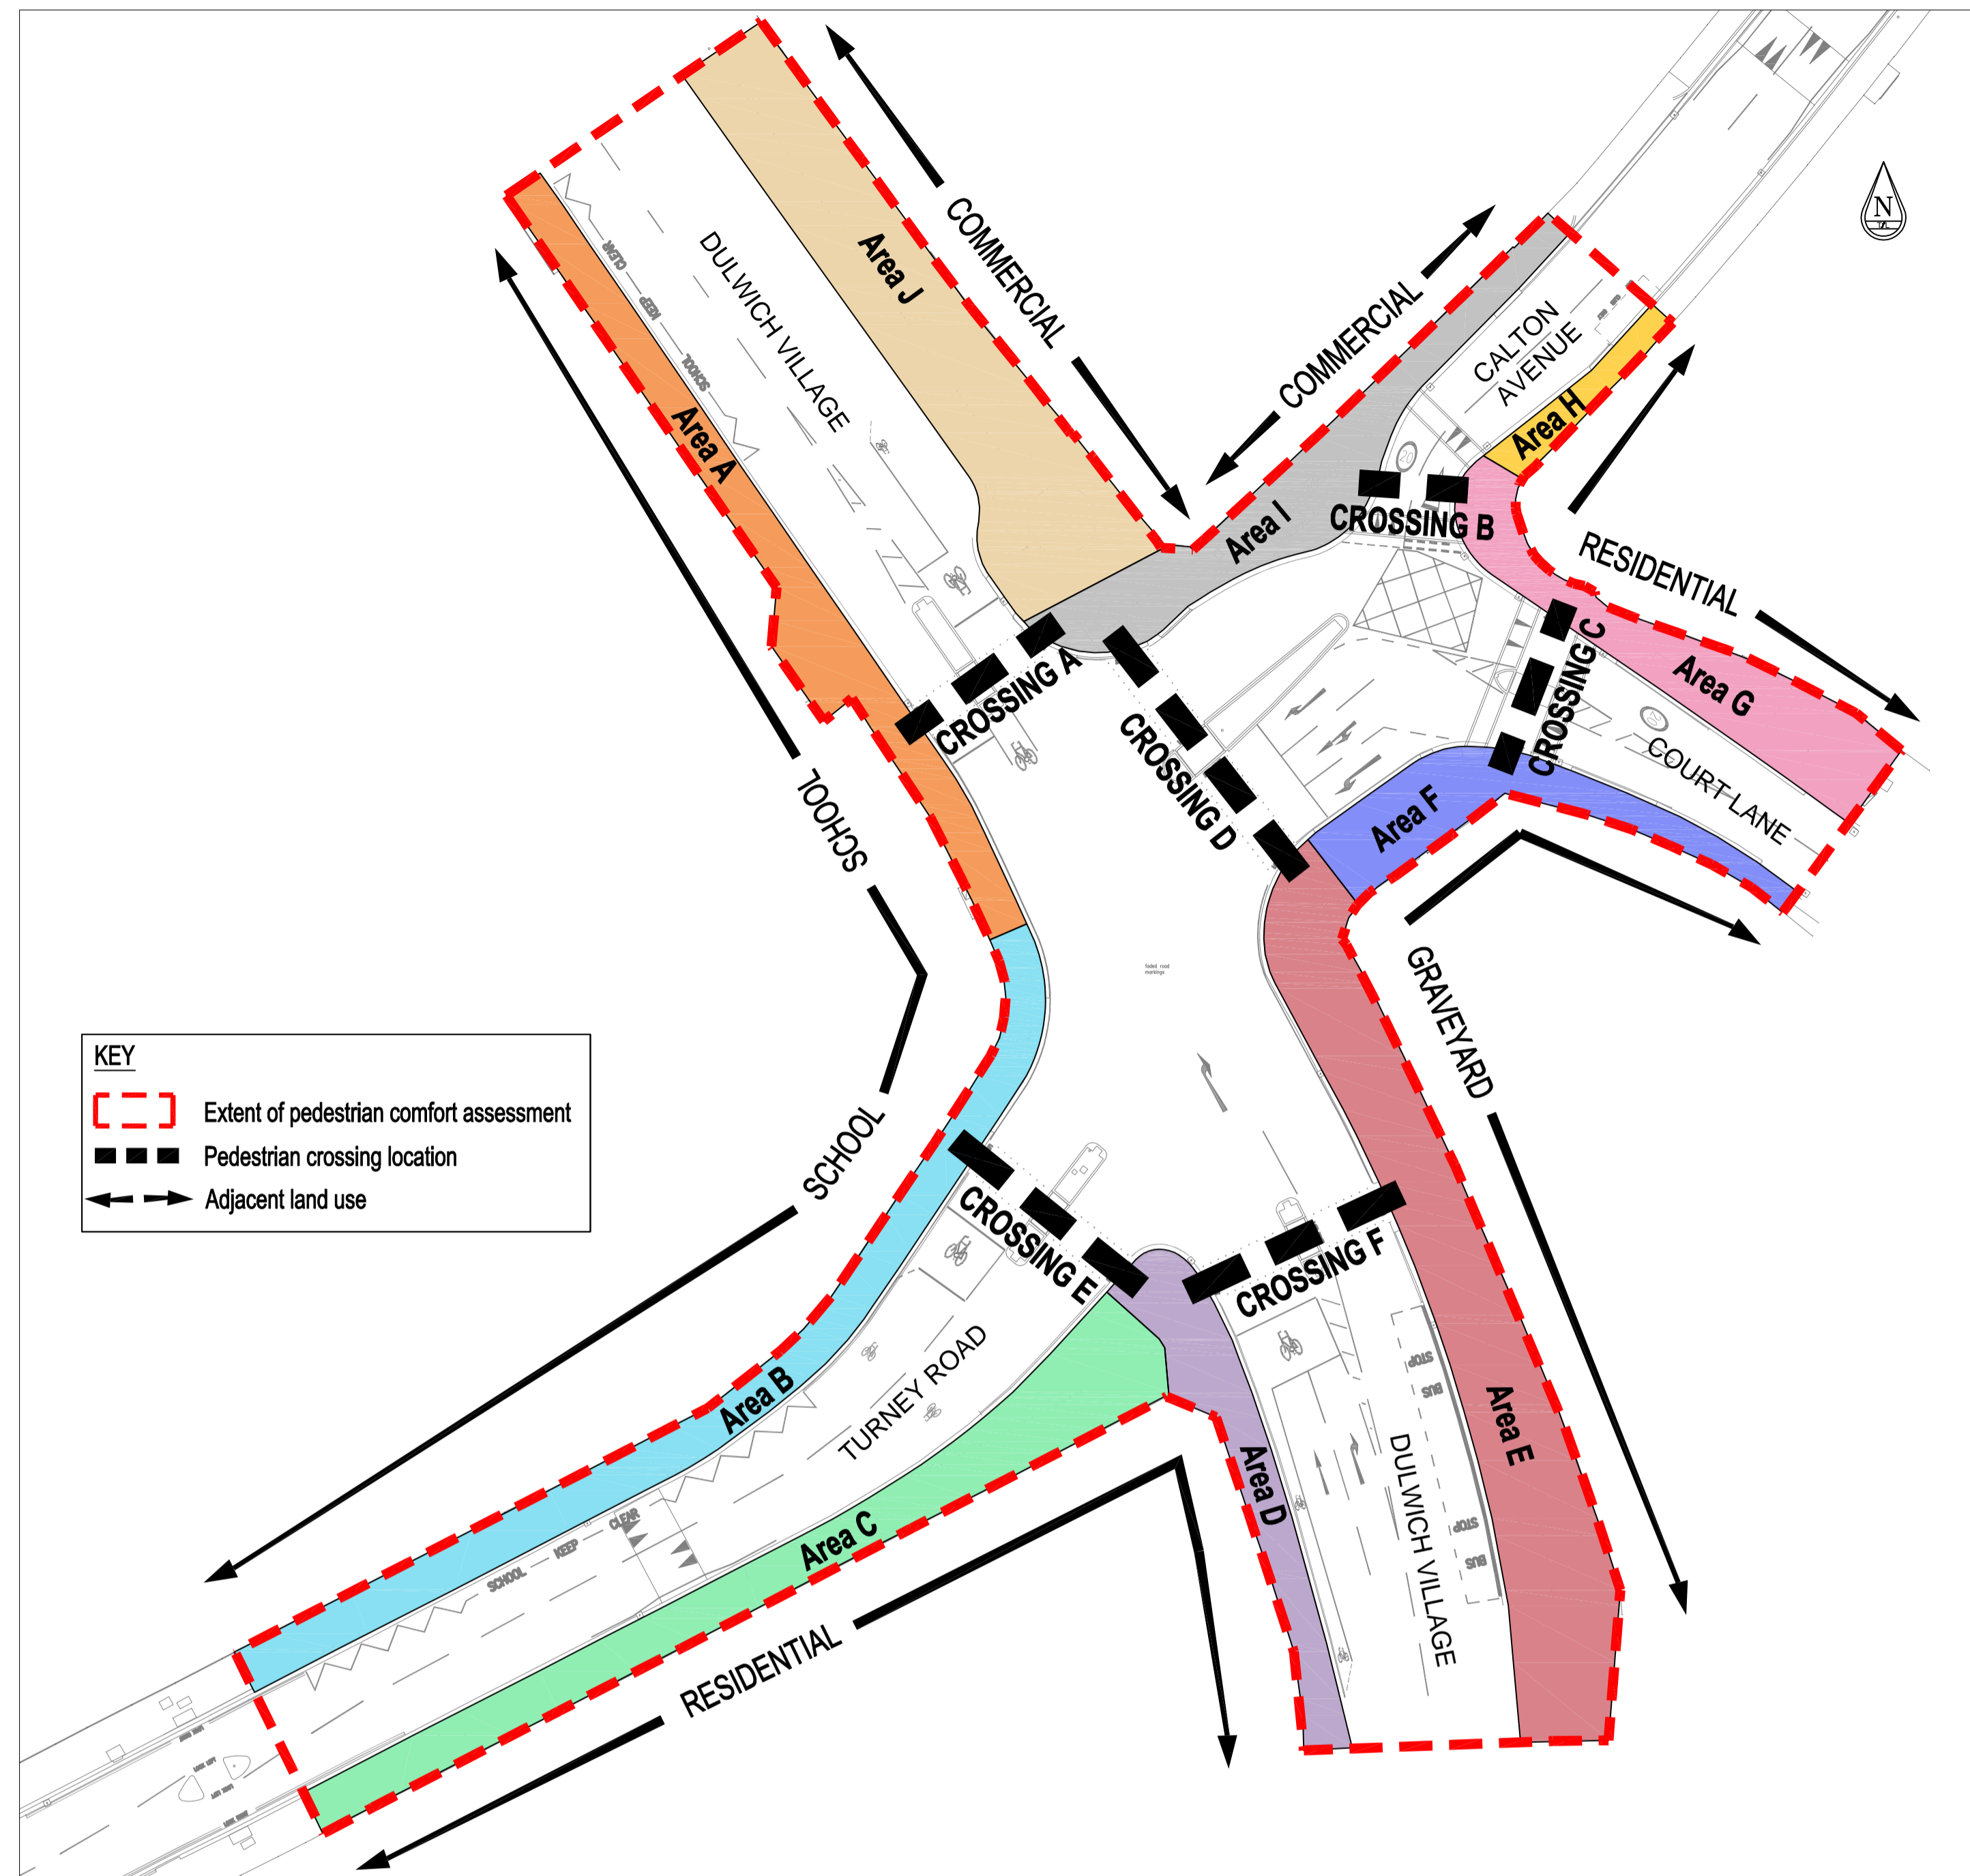
PEDESTRIAN COMFORT ASSESSMENT: FOOTWAY AREAS AND CROSSING LOCATIONS
