# The Dulwich Village Conservation Area

## The Character and Appearance of the Area

### Dulwich Village Conservation Area Appraisal.

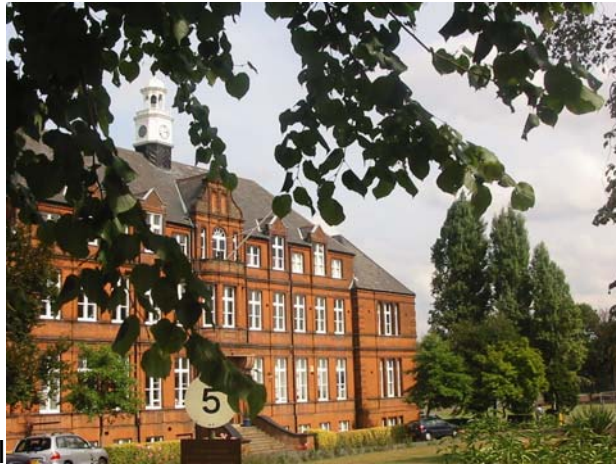
*Alleyn's School, Townley Road,  
An impressive late 19<sup>th</sup> century red brick educational establishment, set in and amongst large, open grounds. The original clock tower is mirrored by a modern clock tower on a new pavilion to the south. It is unlisted but is a key building as a focus to views across the sports grounds and as a counterpoint to the spire of St. Barnabas' Church on the ridge to the south.*

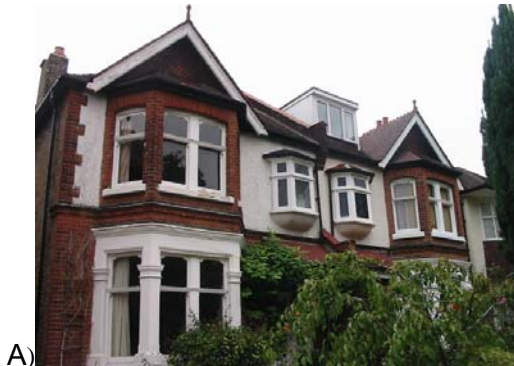
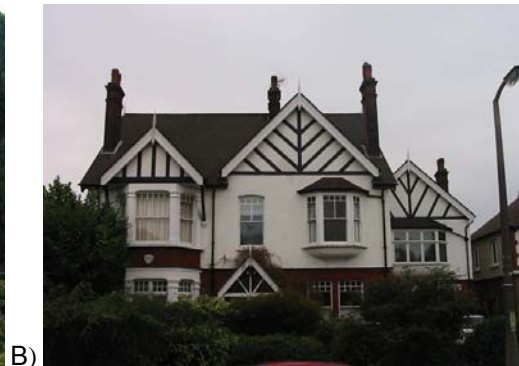
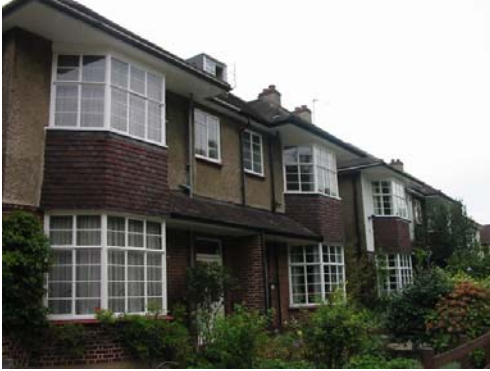
*Figure ~~~ Court Lane*

- 3.5.3 *Court Lane* is mostly lined by semi-detached pairs of late Victorian, Edwardian and inter-War houses of consistent quality. Recessed doors, pitched roofs with gable ends and projecting bays add architectural interest. Some properties have dormer windows at roof level, which have detracted from the rhythm of the rooflines and the symmetry of the pairs. The later houses are generally more plainly detailed but they respect the scale and rhythm of the earlier pairs.

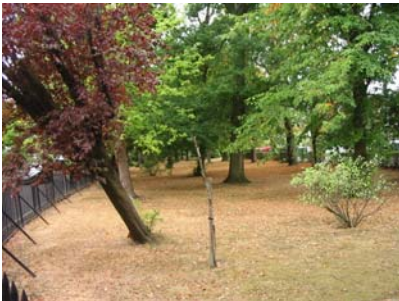
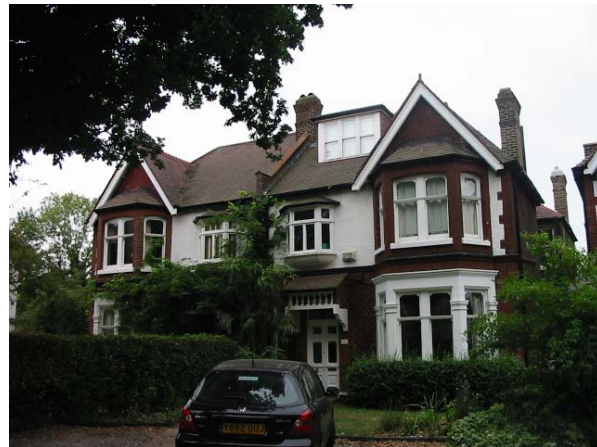
*Figure ~~~ Court lane Gardens*

*Grand and imposing Edwardian houses, set in a row behind a shared private garden, shown above, these houses and their setting are very pleasant and their contribution to the character of the conservation area is a positive one.*

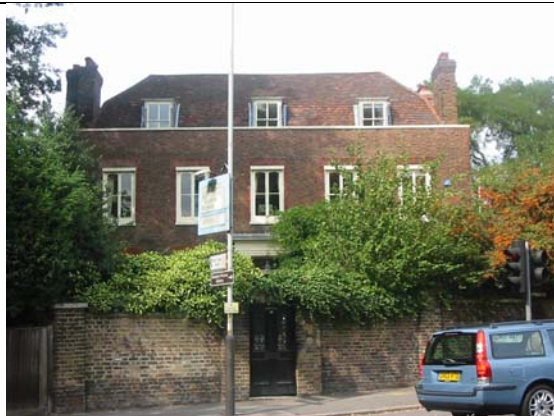
*'Lydenhurst', Red Post Hill / Village Way*

*A substantial early 18th century house, with a hipped, tiled, mansard roof and brown brick walls, seen from the south. There is also a good quality curved boundary wall built of stock brick facing Village Way and Red Post Hill.*

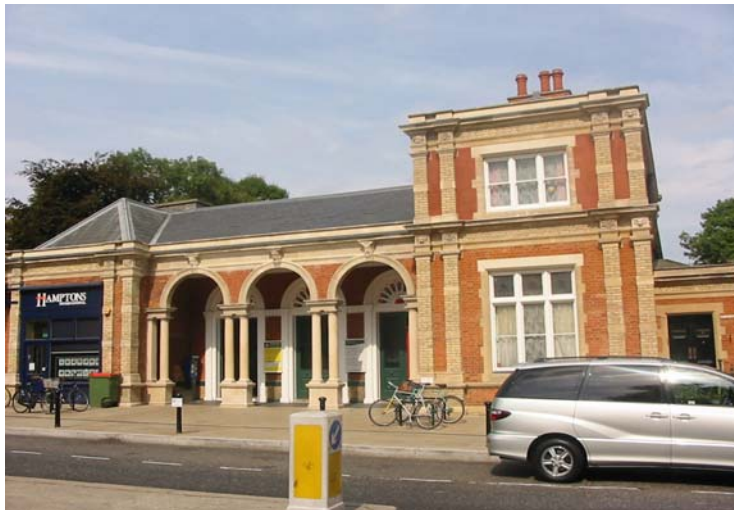
*North Dulwich Station.*

*Designed and built in 1866-8 by Charles Barry the younger, for the London Brighton and South Coast Railway. A fine building with a central loggia, built of brick with stone dressings.*

that pupils be carried for half the normal fare). Barry's station has its platforms in a cutting, with at street level an entrance building, which worthily signposts the northern entrance to the village (illustration No. ). This has an elaborate, asymmetrical elevation, faced with fine red and buff brickwork, with ashlar dressings and coupled Doric columns to the central loggia. Although it has recently been attractively refurbished, the building has lost its pierced Tudor parapets and moulded chimney stacks. Their reinstatement would be desirable.
