#### 4 ITEMS RAISED BY THIS STAGE 2- ROAD SAFETY AUDIT

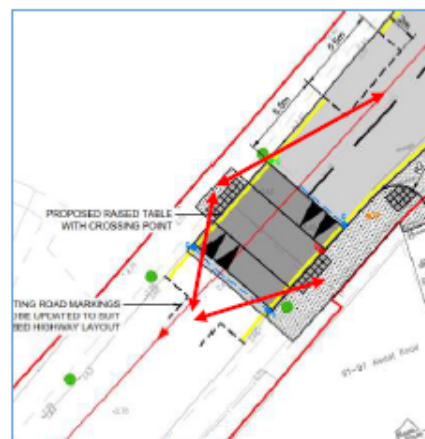
**Location:** On Alscot Road, at the southern raised platform uncontrolled pedestrian crossing

**Summary:** Reduced inter-visibility between pedestrians and approaching users may lead to pedestrian to vehicle collisions

At the uncontrolled crossing point inter-visibility between pedestrians waiting on the footways and approaching users will be restricted when vehicles are parked in adjacent marked parking bays. Restricted inter-visibility may lead to pedestrians (or other vulnerable users) walking into the path of approaching vehicles, with consequent risk of pedestrian to vehicle collisions.

It is recommended that adequate inter-visibility between opposing users is provided, consistent with likely approach speeds. Measures may include the removal or shortening of marked parking bays and extension of waiting restrictions.
